HCLJ510-000602	Air traffic incident
Place:	Final runway 27 at EKBI
Date/Time (UTC):	17-11-2008 / At 13:36:50 hrs
Classification:	C) No risk of collision

History of flight

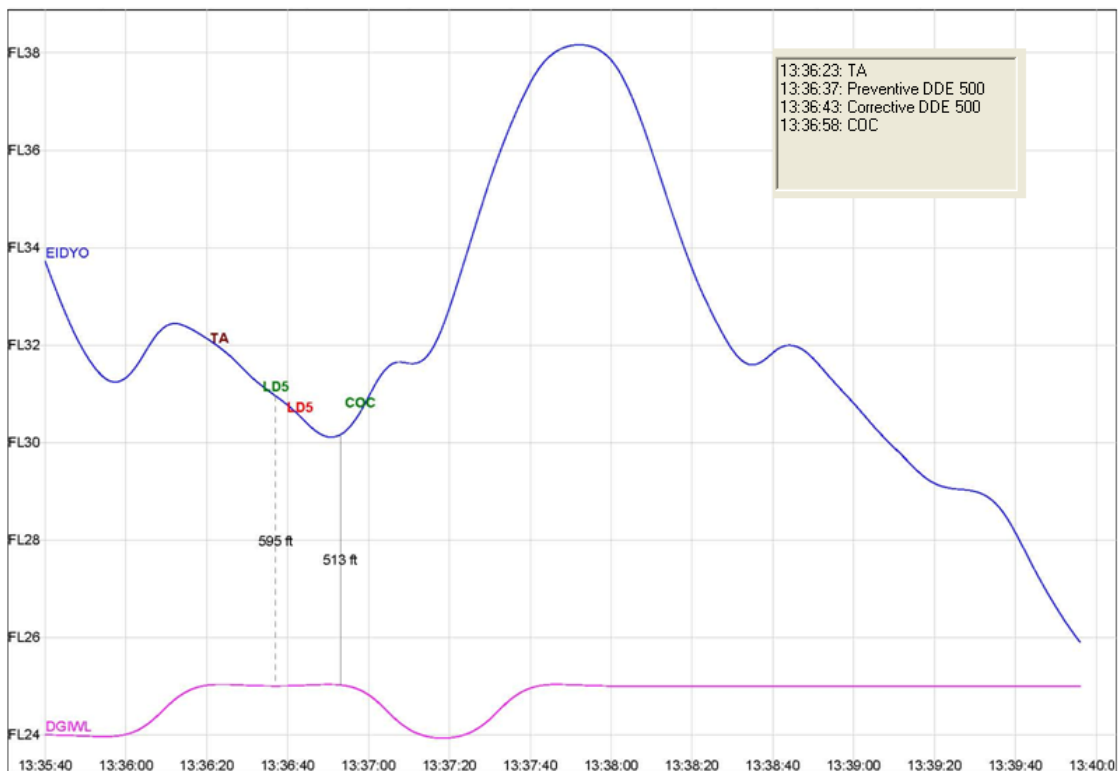
Enclosure 2

On final approach, the pilots of EI-DYO initiated a go-around based on a Traffic Collision Avoidance System Resolution Advisory (TCAS RA – “monitor vertical speed”) and reported to Billund Approach that D-GIWL came too close to EI-DYO.

A TCAS presentation based on radar data.
