**KOMITE NASIONAL KESELAMATAN TRANSPORTASI  
REPUBLIC OF INDONESIA**

**Aircraft Accident Investigation Report**

**Cessna 208; PK-FSO**

**Anem Mountain, Oksibil**

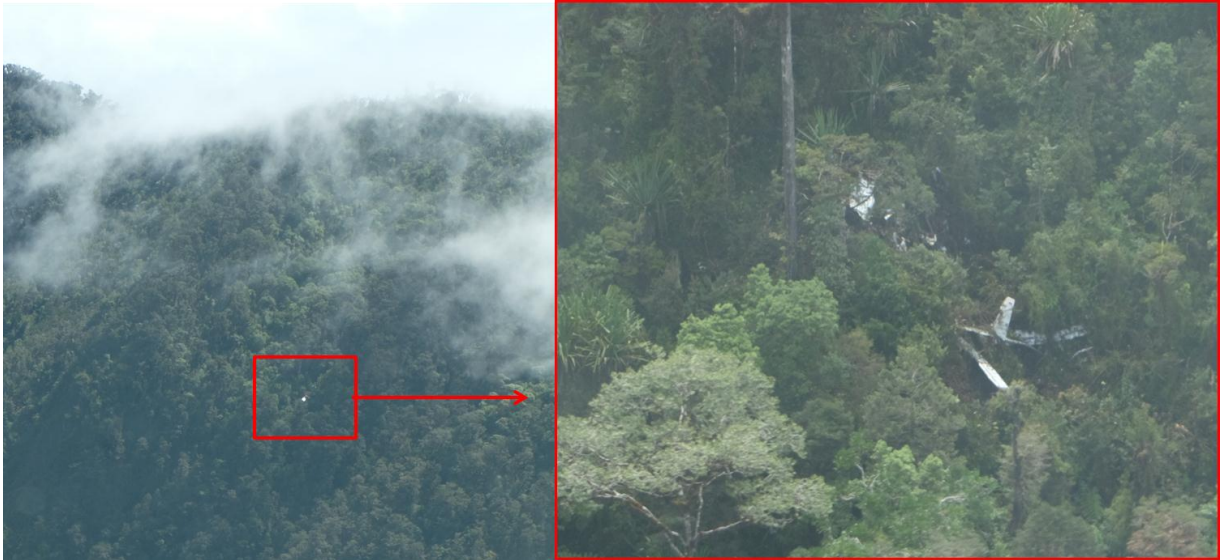
**Figure 8: The accident site**

The aircraft wreckage was found on a ridge of Anem Mountain at approximately 7,100 feet, which located at about 7 Nm north of Okisbil with coordinate S 04°47.79' E 140°39.77'.

The aircraft destroyed by impact forces and the wreckage distribution was found toward 010° direction.

11. On 13 April 2017, at 2211 UTC, the PK-FSO aircraft was found on ridge of Anem Mountain which located about 7 Nm north east of Oksibil.
12. The aircraft destroyed by impact forces and the wreckage distribution was found toward 010° direction.

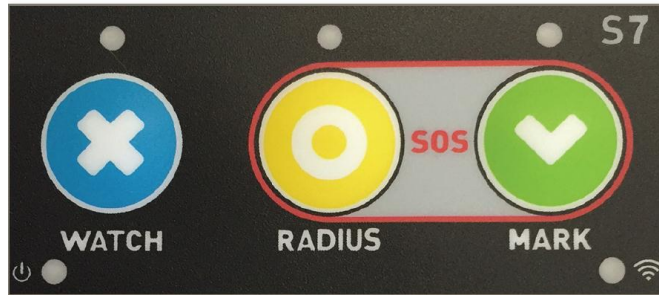
**Figure 9: Spider 7 keypad**

The Spider 7 utilises keypad with three different functions (figure 9).

The spidertracks provides two tracking capabilities, which are passive (NORMAL mode) and active (WATCH mode). Both modes will send positional information and flight data to the monitoring system in real time depends on the interval time subscription.

The WATCH mode could be activated either manually by pressing WATCH button or automatically triggers by aircraft speed. In either case, the WATCH button must be pressed to disable the WATCH mode and there is no auto-off system for the WATCH mode.

In both modes, pilot could send SOS signal by pressing the RADIUS and the MARK button together. While in WATCH mode, the SOS signal could be sent automatically to the system when the aircraft is unable to send flight data for a period of ten minutes. The SOS signal could be only disabled by powering cycle the Spider device.
