Interim Report

Type of Occurrence:	Serious incident
Date:	20 October 2015
Location:	Paderborn
Aircraft:	Airplane
Manufacturer / Model:	The Boeing Company / B 737-800
Injuries to Persons:	None
Damage:	Minor damage to aircraft
Other Damage:	Runway edge lighting damaged
Information Source:	Investigation by BFU
State File Number:	BFU 15-1465-EX
Published:	February 2016

During the landing on runway 24 of Paderborn-Lippstadt Airport the Boeing 737-800 touched down left of the runway centre line and veered off the runway. The crew manoeuvred the aircraft back onto the runway after approximately 260 m. No one was injured.

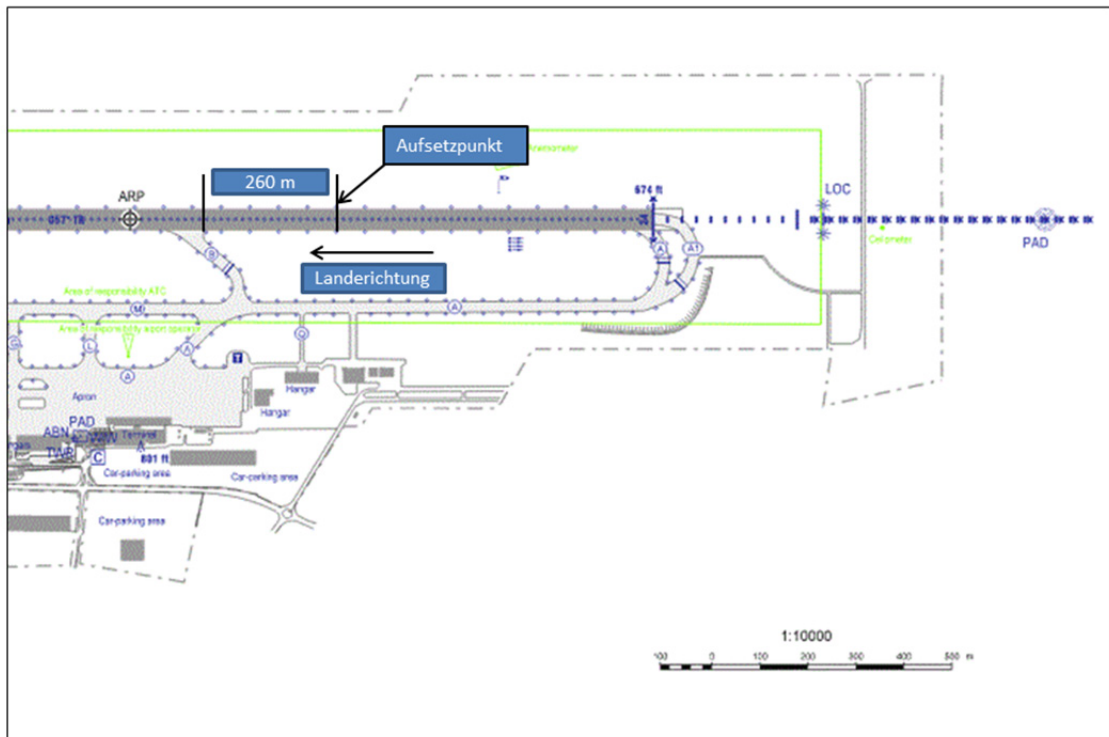
Detail of the aerodrome chart

Approximately 630 m after the threshold of runway 24 wheel marks of the right main landing gear were found on the left runway edge marking. Another 47.5 m farther along the trace of the nose landing gear was found in the grass south of the runway. In a distance of 74 m from the first visible wheel marks the impression of the left main landing gear was found in the grass. Over a distance of approximately 260 m the

impressions of the three landing gears were visible in the grass south of the runway. Abeam of the intersection of taxiway B the traces of the wheels in the grass ended.
