Interim Report

Type of Occurrence:	Serious incident
Date:	23 October 2017
Location:	Near way-point JUIST
Aircraft:	Helicopter
Manufacturer / Model:	Sikorsky Aircraft Corporation / S-76B
Injuries to Persons:	None
Damage:	Aircraft not damaged
Other Damage:	None
State File Number:	BFU17-1441-7X
Published:	March 2018

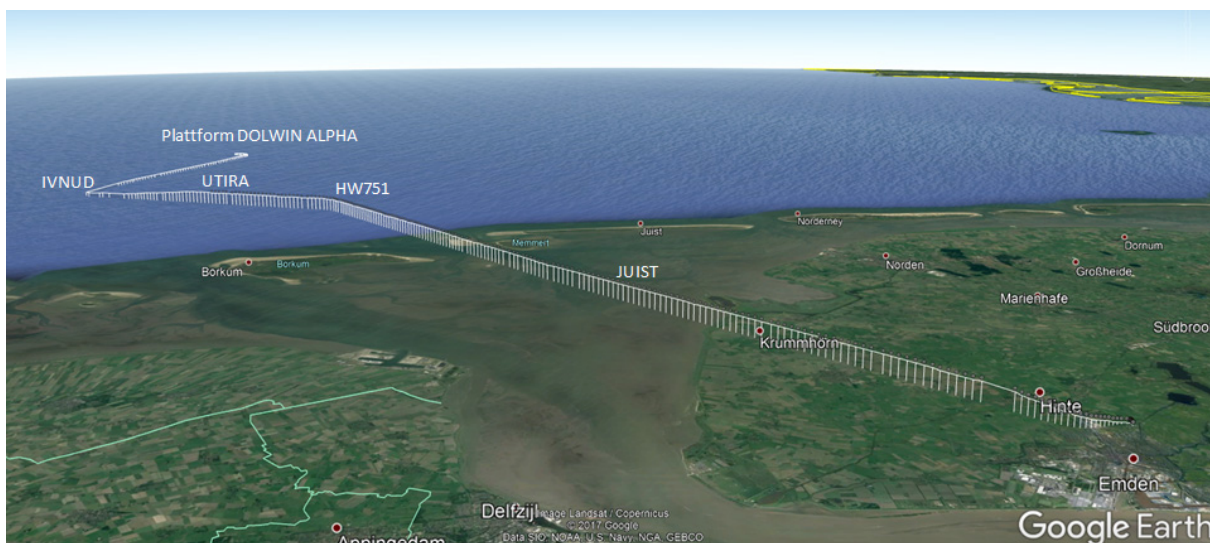
According to the flight plan and the FlightRadar24 recording the flight route was as follows: EDWE, JUIST, HW751, UTIRA, IVNUD and DOLWA. After take-off the helicopter climbed to 2,500 ft AMSL. From way-point UTIRA on the flight altitude was reduced to about 700 ft AMSL. At 0832 hrs the helicopter landed at the helipad of the convertor station DOLWIN ALPHA. While the engines were still running the cargo was unloaded and the passengers embarked for the return flight.

Course of the outbound flight

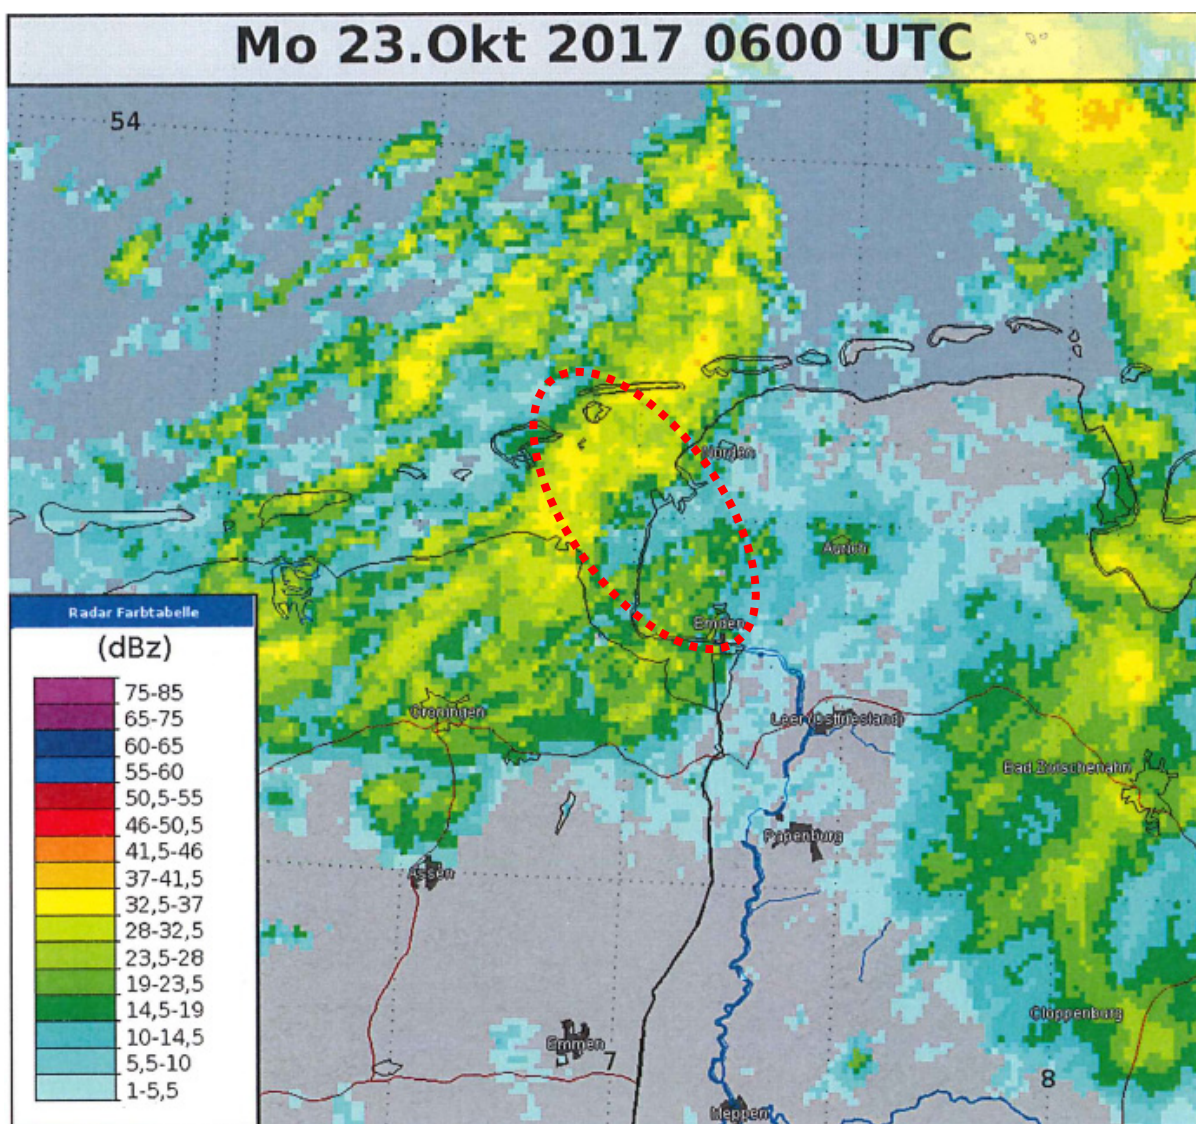
On the morning of 23 October 2017 a low pressure system was lying over the Deutsche Bucht (German Bay). During the morning it moved toward the Elbe estuary becoming weaker in the process. With the south-western to western current, relatively mild and very humid air was moved to the north-west of Germany.

Precipitation radar image at the time of take-off in Emden

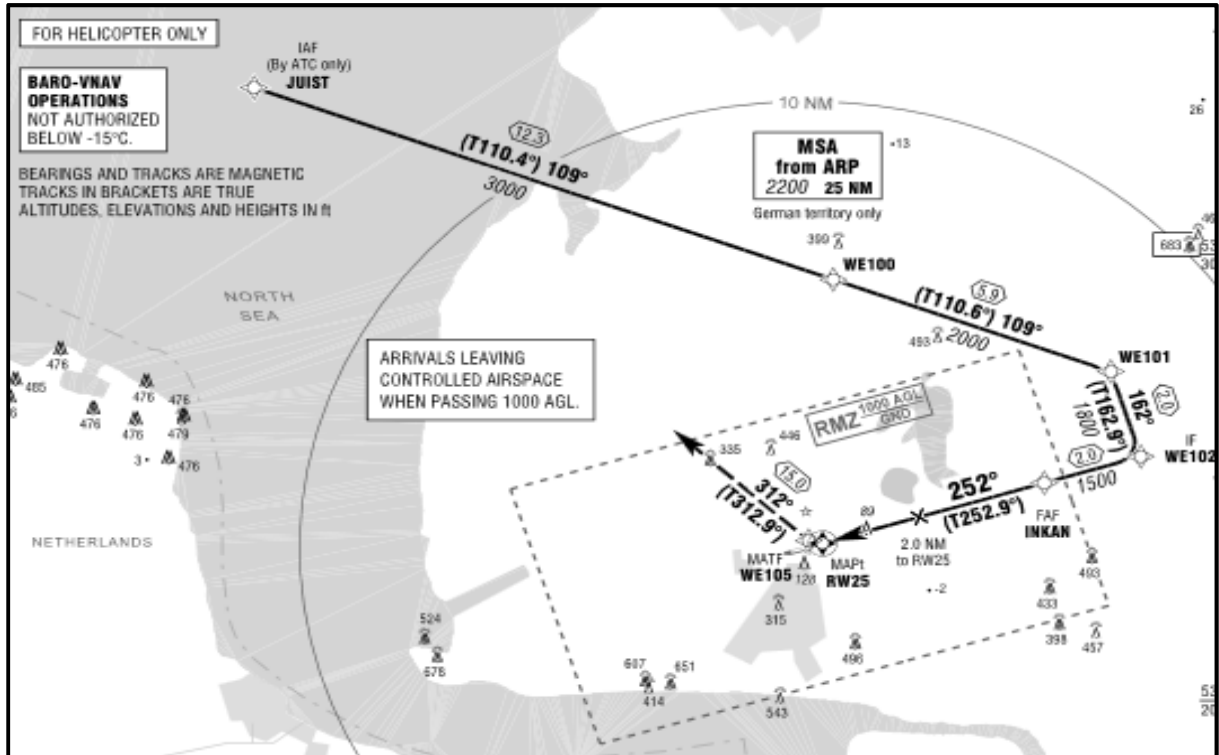
Both runway directions (07 and 25) are equipped with RNAV (GPS) and instrument approach and departure procedures. For helicopters approaching from the north way-point JUIST is the Initial Approach Fix (IAF) for RNAV (GPS) Y RWY 07/25 approaches.

RNAV (GPS) Y RWY 07/25 instrument approach procedure for helicopter
