# Investigation Report

1X002-06  
November 2011

Type of Occurrence:	Accident
Date:	15 May 2006
Location:	Frankfurt / Main
Aircraft:	Transport aircraft
Manufacturer / Model:	Boeing / B747-400
Injuries to Persons:	No injuries
Damage:	Aircraft severely damaged
Other Damage:	None
Information Source:	Investigation by BFU

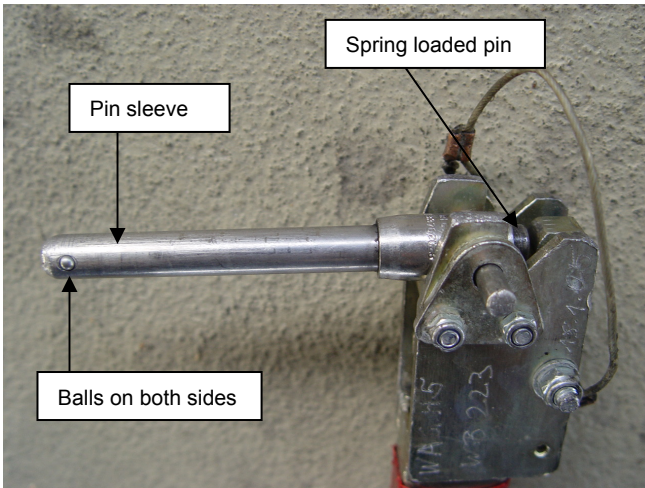
Ground Lock Pin

The ground lock pin from Boeing is a ground lock pin intended for this aircraft type to prevent the nose landing gear from retraction while on the ground.

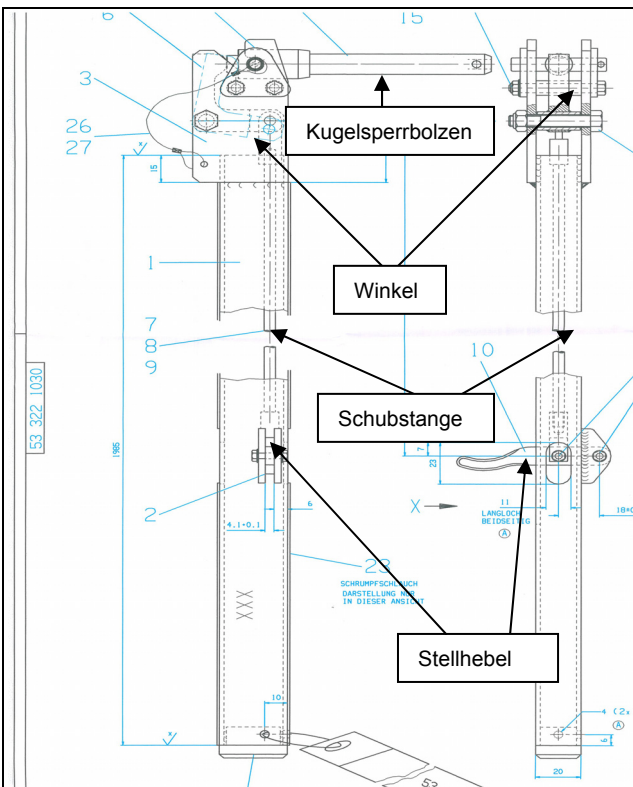
Detail drawing of the ground lock pin including bar  
Source: Maintenance Organisation

To insert the pin the operating lever at the end of the bar is pulled back so that the two balls are pulled inside and the pin can be inserted in the drag brace hole. Once the pin is fully inserted in the drag brace hole, the operating lever is released. The spring loaded pin pushes the two balls at the pin sleeve end

outward and therefore retains the pin in the drag brace hole.

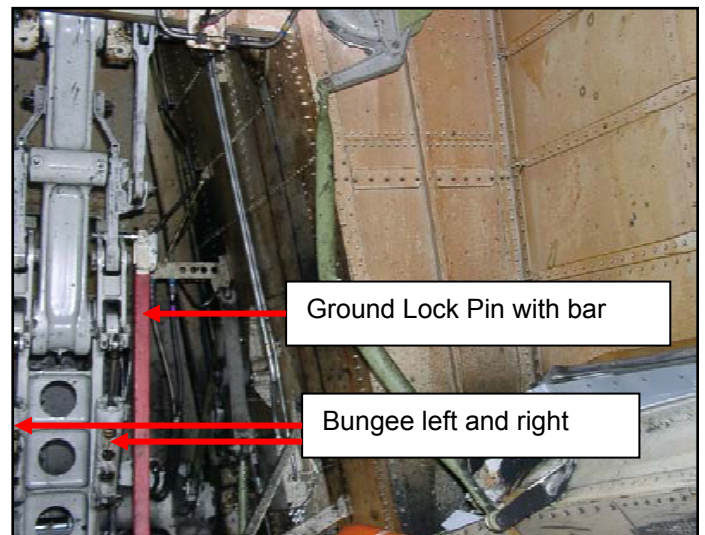
Assy area of the examined components  
Photo: Lufthansa Technik AG, Hamburg

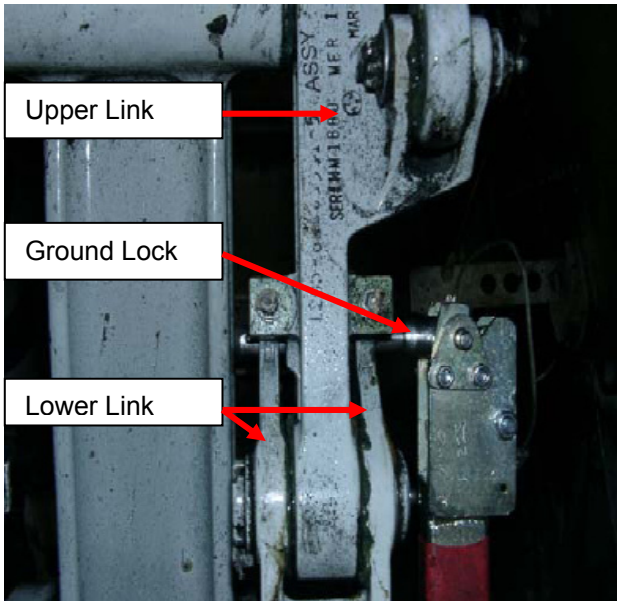
Detail views of the component assembly

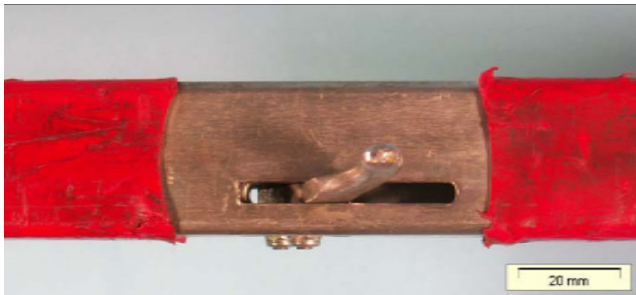
The safety bar is bent and shows damage on the total length of the plastic hose. The ground lock pin locking/unlocking lever is bent and jammed in the unlocking position (safety globes loose). It can only be moved by force (safety globes locked). This condition had existed for an extended period of time as indicated by wear marks on the lever and on the elongated hole in the rectangular tube.

Guidance of the operating lever in the safety bar

Examination of the safety bar and the GLP showed that long-time use caused abrasive wear so that a correct functionality of GLP including bar was no longer given.

Due to the missing overhaul and maintenance procedures this tool was used in defective condition.

The cause for the retraction of the nose landing gear was a malfunction in the lever mechanism within the safety bar in connection with the GLP. Hence the GLP remained unlocked in the inserted position.

Implementing Safety Recommendation 02/2006, the operator involved has issued an instruction stating that the short original pin is to be used exclusively.
