Investigation Report

Identification

Type of Occurrence:	Accident
Date:	19 February 2006
Location:	Close to Dakar / Senegal
Aircraft:	Transport aircraft
Manufacturer / Model:	Boeing Commercial Airplanes / Boeing MD-11/MD-11F
Injuries to Persons:	One crew member seriously injured One crew member and one passenger slightly injured
Damage:	None
Other Damage:	None
Information Source:	Investigation by BFU
State File Number:	BFU 2X004-06

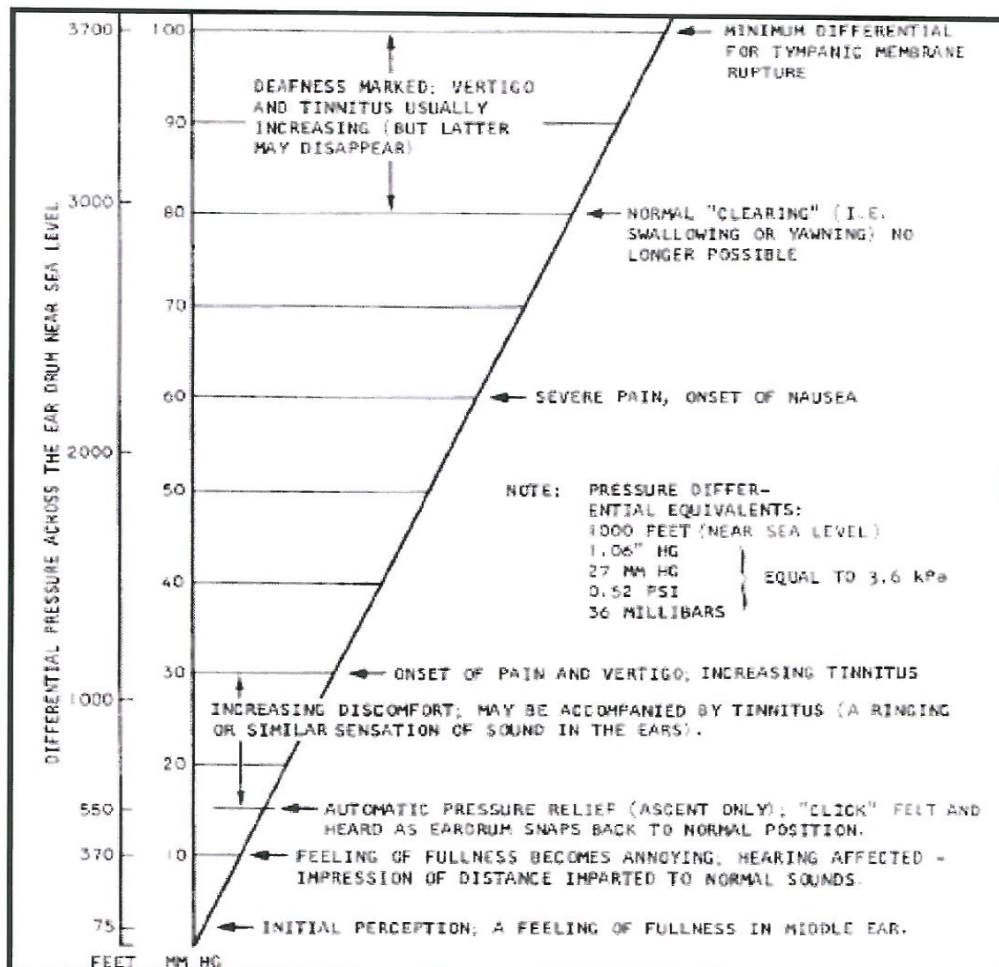
The results of the simulation were compared with the possible physiological effects of cabin altitude changes on the ears of aircraft occupants described in the Aerospace Recommended Practice 1270, Rev. A of the Society of Automotive Engineers.

Physiological effects of cabin altitude changes.

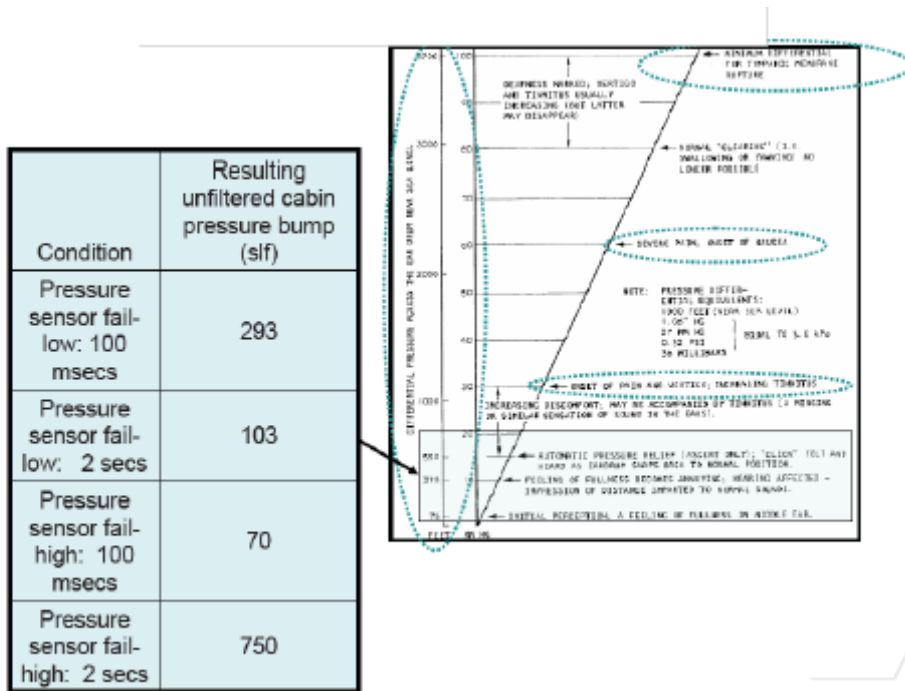
The manufacturer deduced the possible physiological effects on the ears of aircraft occupants during the simulation of cabin altitude changes from the *Aerospace Recommended Practice 1270*.

Physiological effects of cabin altitude changes on the ears

The simulation by the manufacturer where initially the pressure sensor failed for 100 ms and then for 2 s resulted in perceptible physiological effects on the ears as was described in the graph *Aerospace Recommended Practice 1270*. According to which permanent, organic injuries are not caused with these failure times.
