# Investigation Report

Type of Occurrence:	Accident
Date:	13 September 2006
Location:	Frankfurt / Main
Aircraft:	Airplane
Manufacturer / Model:	Fokker BV / Fokker F 28 MK 100
Injuries to Persons:	None
Damage:	Aircraft severely damaged
Other Damage:	None
Information Source:	Investigation by BFU
State File Number:	BFU AX002-06

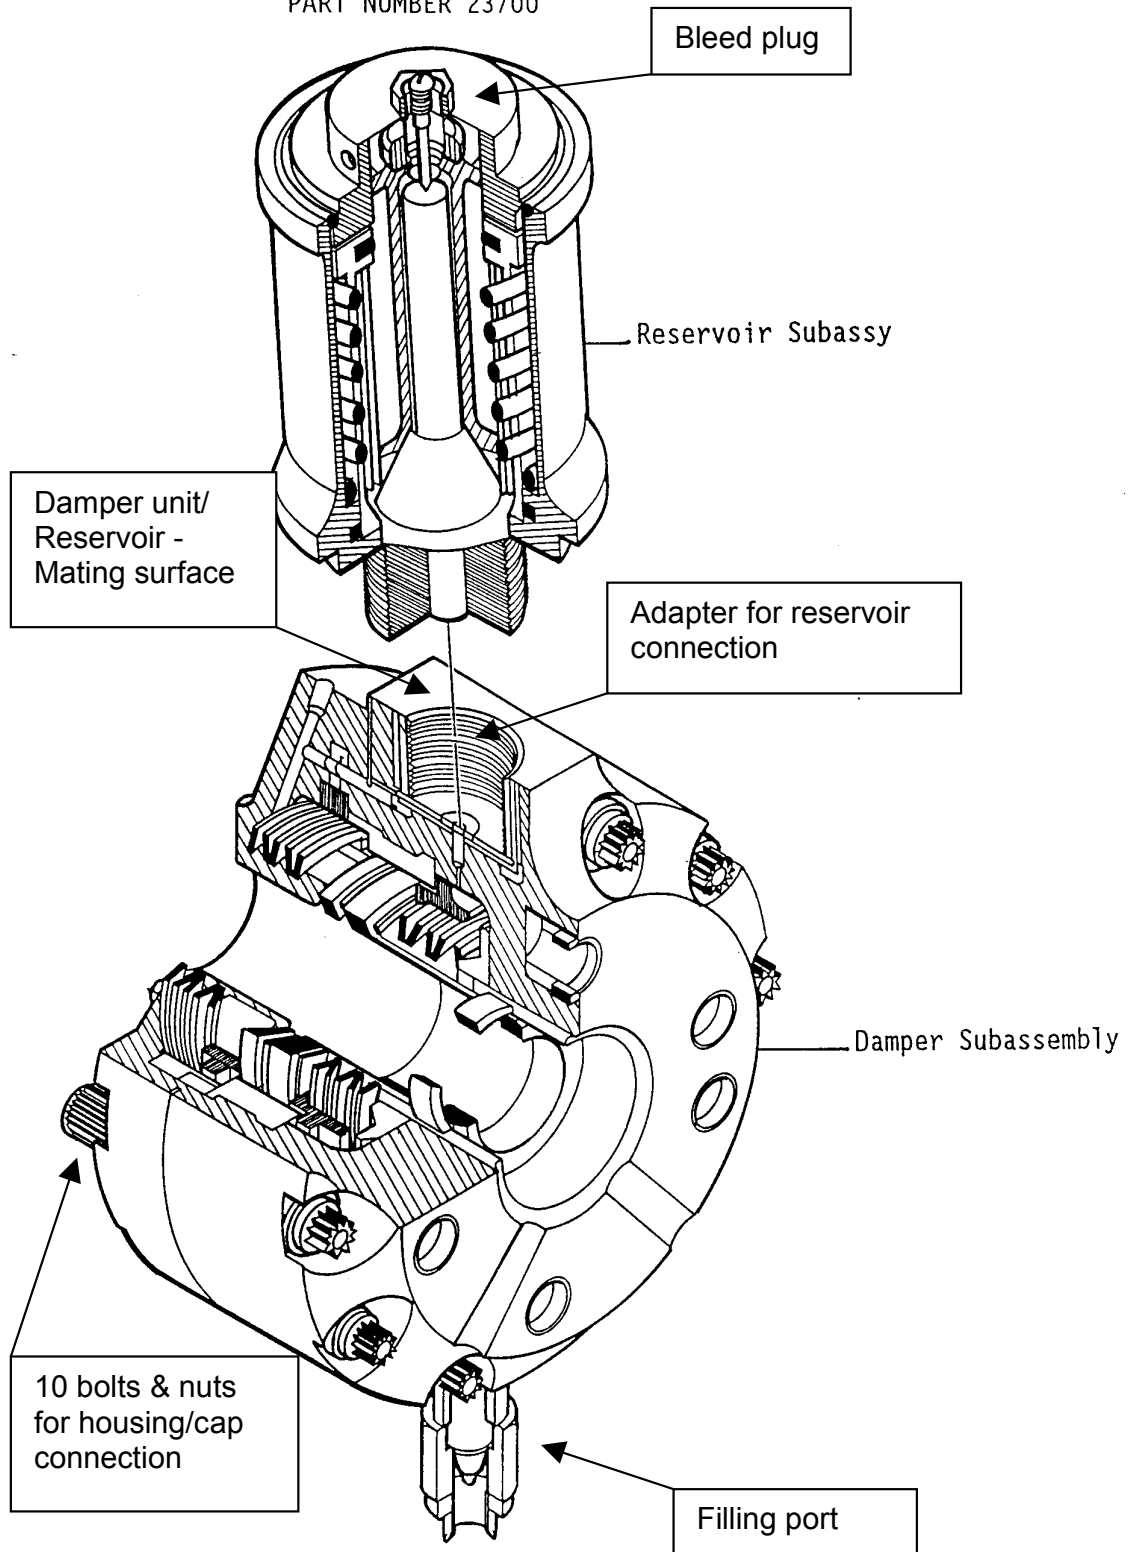
Appendix 2: Drawing of the shimmy damper

An examination of the shimmy damper, onto which the reservoir had been fitted manually, to determine pressure and leak tightness revealed a leakage between damper housing and hydraulic reservoir.

The shimmy damper was emptied and disassembled. Thereby, residue of the jelly-like substance and dirt particles were found on all parts. In the area of the piston a metal chip the size of 2 mm was found.

The results of the flow tests, where the determined failures were gradually eliminated, showed that the incorrectly mounted O-ring and the contamination and/or the metal chip had an essential influence on the performance of the damper. The contamination and the metal chip caused an increase in flow rate of 0.8 Gallon Per Minute (GPM); whereas the incorrectly mounted O-ring led to an increase of 0.16 GPM.

The examination of the damper showed that the incorrectly mounted O-ring in connection with the jelly-like substance and the metal chip within the damper housing caused the failure of the damping and then the fracture of the torque link.

The shimmy damper was cleaned, fitted with a correctly mounted O-ring and filled with hydraulic fluid. The function test revealed no failures.
