Investigation Report

Type of Occurrence:	Serious incident
Date:	14 May 2008
Location:	Zweibrücken
Aircraft:	1. Transport aircraft 2. Military transport aircraft
Manufacturer / Model:	1. Airbus Industry / A319-112 2. Transporter Allianz / C-160 Transall
Injuries to Persons:	None
Damage:	Aircraft not damaged
Other Damage:	None
Information Source:	Investigation by BFU
State File Number:	BFU 5X006-08

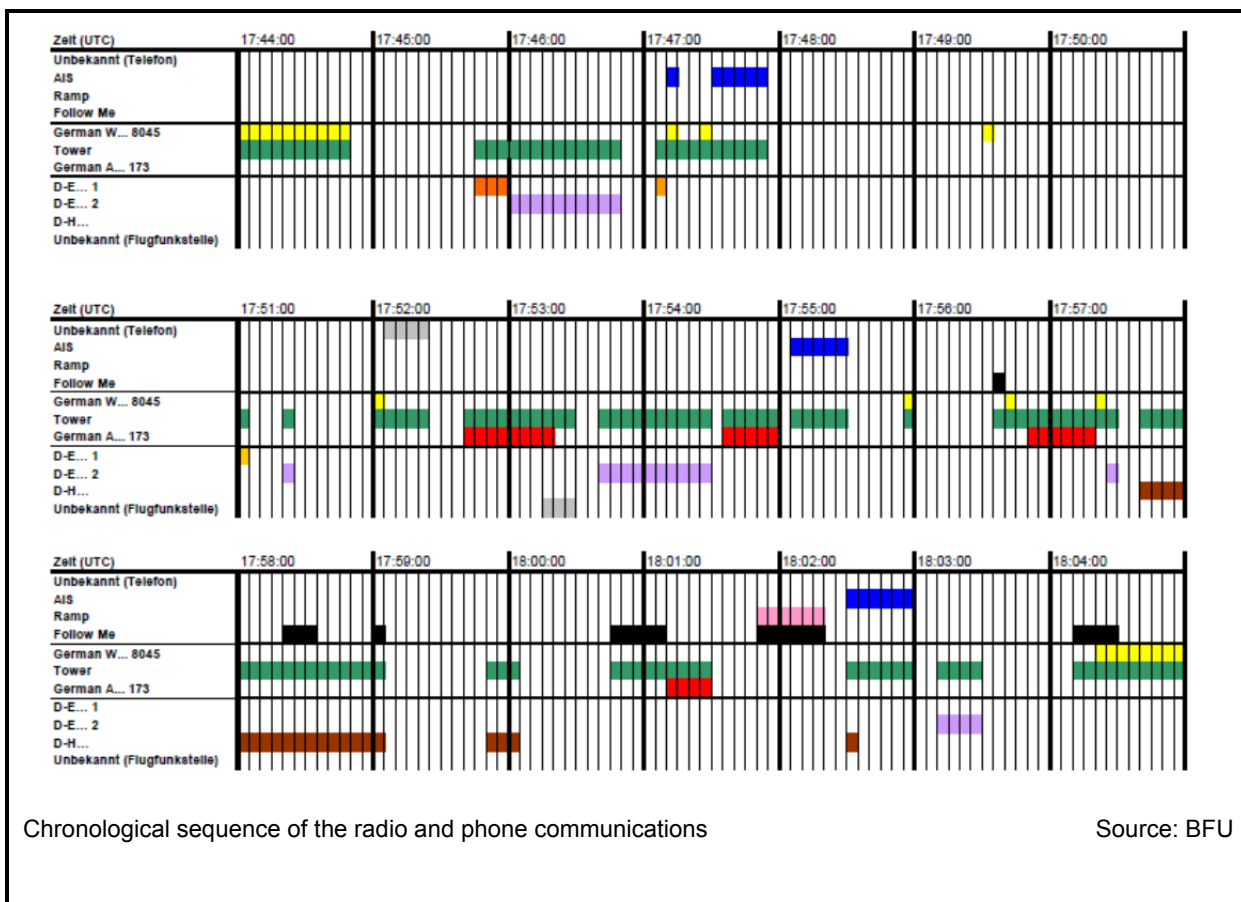
For analysis purposes, the chronological sequence of the recorded radio and phone communications were illustrated graphically. A transcript of the conversations was prepared.

The recorded radio communications showed that during the time the Airbus A319 and the C-160 Transall were processed by ATC, two VFR flights and one helicopter were on the radio frequency. The IFR flights were coordinated by phone with Langen Radar. In addition, there were phone conversations with the Aviation Information Service (AIS).

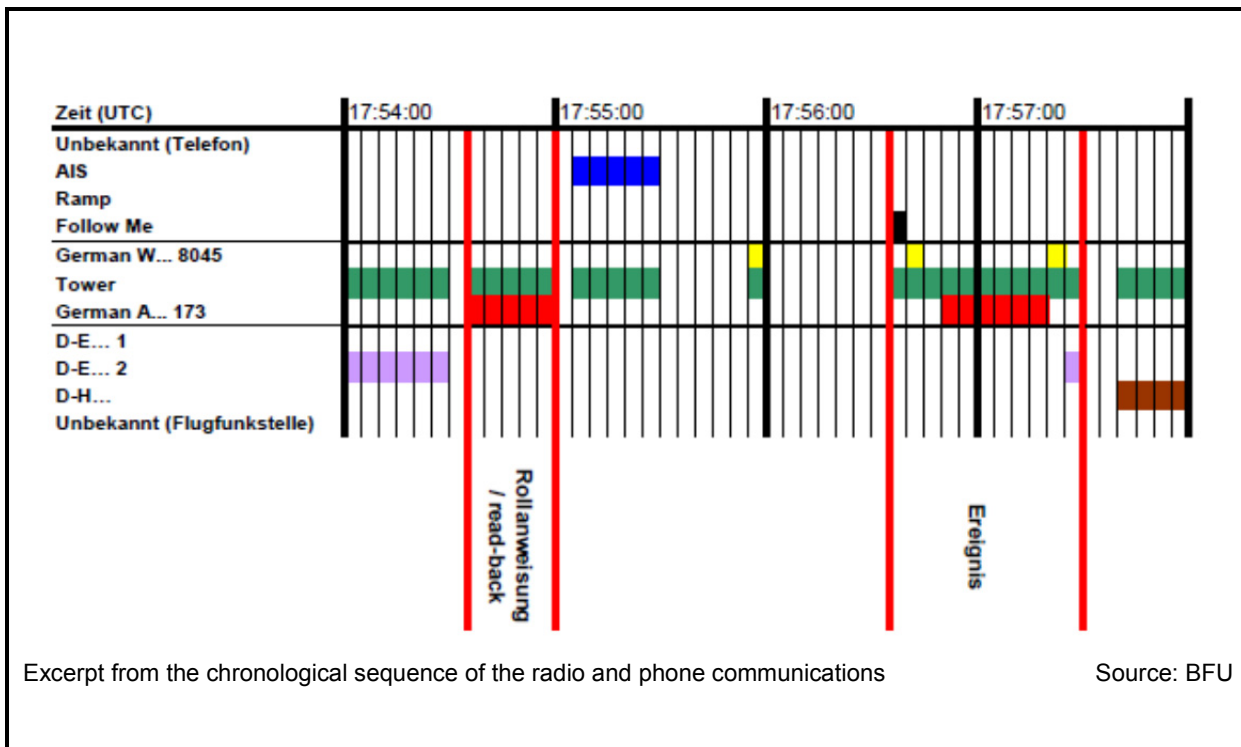
The BFU is of the opinion that this work load of a controller was not unusual or generally unsafe. But the analysis showed quite clearly that in this situation a deviation from or an exception to the stipulated operating direction 03 was not appropriate. The BFU is of the opinion that the conscious deviation from the operating direction 03 was a deviation from standard operating procedures which resulted in a risk situation.

The BFU assumes that the C-160 Transall crew did not mentally register the Airbus A319 cleared for take-off and taxiing to take-off point runway 03. A human factors analysis of the event sequence revealed that the Airbus had initially been in the area of the terminal, then received taxi instructions and clearances via radio and been visually detectable except for one part of runway 03. It is improbable that the airplane was confused with another transport aircraft because there was none this large. Presumably, neither member of the C-160 Transall crew did recognise the Airbus because of a feeling to be the only ones using the airfield and thinking oneself safe because the tower controller had everything under control.
