Investigation Report

Type of Occurrence:	Accident
Date:	10 April 2009
Location:	Schmoldow Special Airfield
Aircraft:	Airplane
Manufacturer / Model:	PZL-104 „Wilga 35"
Injuries to Persons:	Both pilots fatally injured
Damage:	Aircraft destroyed
Other Damage:	None
Information Source:	Investigation by BFU
State File Number:	BFU 3X020-09

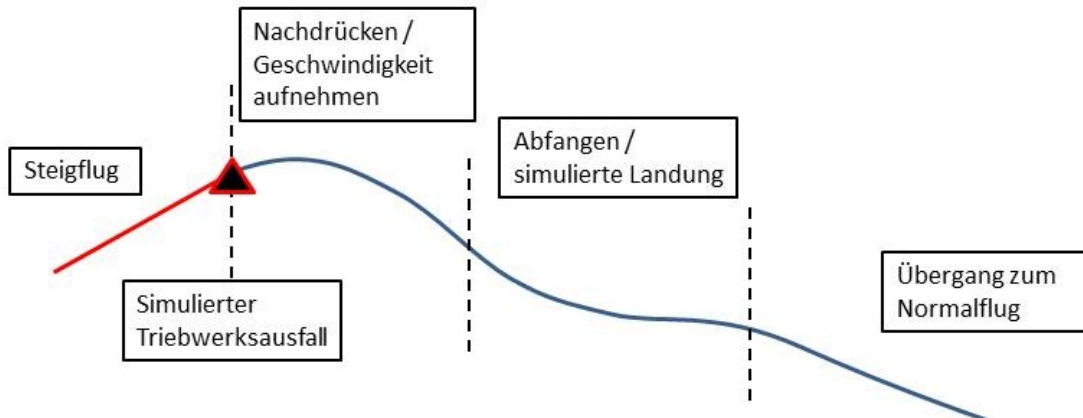
Planned flight profile

- Airspeed: 115 km/h
- Flaps: 21° (0° during two flights)
- Engine thrust: 2,350 min⁻¹, maximum thrust
- Simulation of the engine failure: reduce power lever

The analysis showed that the mean loss of altitude was 40 m between the initiation of the simulated engine failure and the simulated landing. Depending on the pitch angle the loss of altitude changed significantly. Under favourable conditions the loss was 24 m and under the most unfavourable 115 m.

The results of the in-flight tests conducted during the investigation showed that the mean loss of altitude between initiation of the simulated engine failure and the landing was approximately 40 m. But there is also a variance between 115 to 24 m. Especially if the forward stick motion is stronger and the pitch angle increased the loss of altitude is greater. On the other hand the airplane lost airspeed if the forward stick motion was not strong enough. With a real engine failure in approximately 40 m the pilot's challenge is the small range available for the forward stick motion (control column track and speed) to safely land the airplane. Otherwise significantly larger losses of altitude are to be expected. This shows that engine failure in such low altitudes cannot be safely trained.
