Investigation Report

Type of Occurrence:	Accident
Date:	8 May 2009
Location:	Frankfurt/Main
Aircraft:	Airplane
Manufacturer / Model:	The Boeing Company / B 747-400 F
Injuries to Persons:	None
Damage:	Aircraft severely damaged
Other Damage:	None
State File Number:	BFU AX001-09

During the approach to Frankfurt/Main parts of the left wing inboard fore flap separated and damaged the pressurised fuselage.

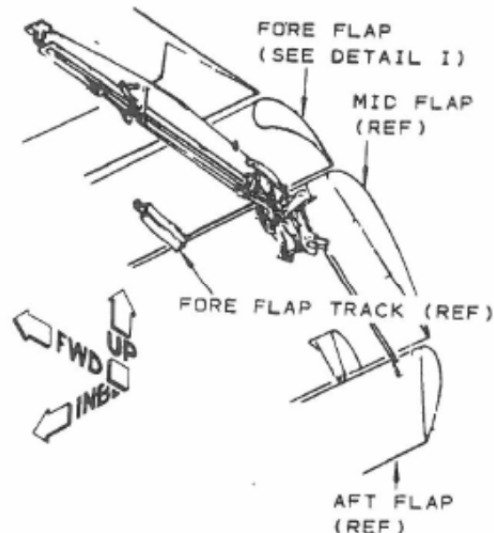
VIEW LOCKING UP AT INBOARD TRAILING EDGE FLAPS

A fatigue crack was found in the horizontal flange of the inboard fore flap outboard attach fitting on the fatigue test airplane after 12,000 simulated flights. Subsequently, three in-service cracks were reported at 2300 to 3500 flights. Undetected cracking could result in complete fracture of the fitting and loss of the fore flap in flight. Subsequent to Revision 1, three fore flap losses have been reported. The most recent loss, at 5508 flights, resulted in considerable damage to No. 4 door.

Inspect outboard sequence fitting for cracks on airplanes with over 2000 flights. Repeat inspection every 200-300 flights until the existing inboard fore flap outboard attach fitting is replaced with an improved fitting with thicker flanges.

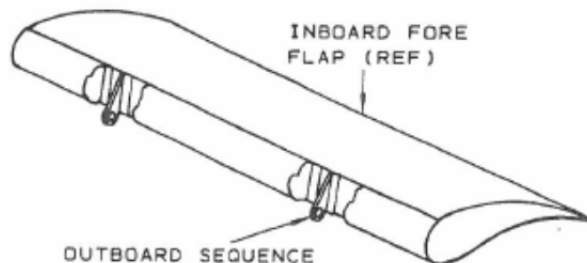
DETAIL I

OUTBOARD SEQUENCE FITTING (REPLACE)

A fatigue crack was found in the fillet radius between the lug and the horizontal flange of the fore flap outboard attach fitting on the fatigue test airplane after accumulation of 12,000 simulated flights. An undetected fatigue crack in a fore flap attach fitting could eventually result in complete fracture of the attach fitting. Complete fracture of the fore flap attach fitting would leave the outboard end of the fore flap unrestrained and partial or total loss of the fore flap could occur in flight, possibly causing damage to other airplane structure.
