# Investigation Report

Type of Occurrence:	Serious incident
Date:	28 August 2009
Location:	Münster-Osnabrück Airport
Aircraft:	Cargo airplane
Manufacturer / Model:	Antonov / AN-12 BK
Injuries to Persons:	None
Damage:	Minor damage to aircraft
Other Damage:	None
Information Source:	Investigation by BFU
State File Number:	BFU EX007-09

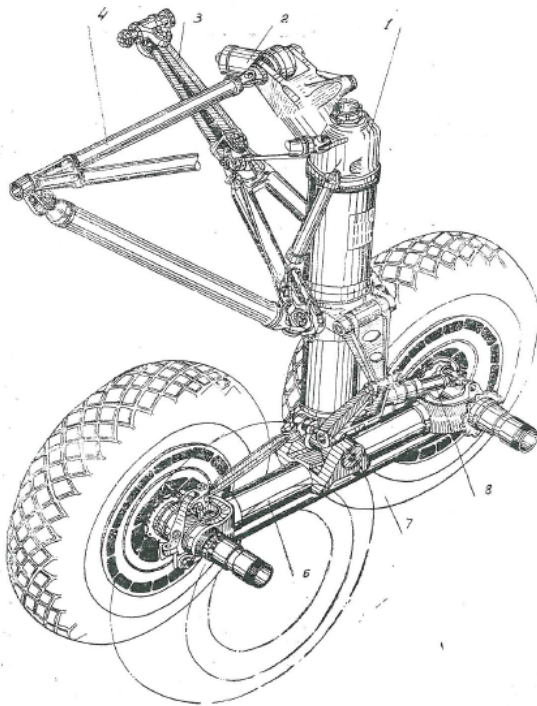
The landing gear bogie beam was, without doubt, destroyed by hydrogen induced stress corrosion cracking. Thereby, hydrogen was atomically produced directly at the "Crime Scene" by partly cathodic reaction and penetrated the steel. The underside of the bogie beam was subject to intense tensile stress, which is required for crack propagation, any time the aircraft was parked. The fracture occurred at the force transmission point; the pivot pin lug for the landing gear leg. The required time span was sufficiently given since the landing gear was mounted to the aircraft (1983). Furthermore, the steel used exceeds the minimum tensile strength required for this kind of damage. Obviously, the initial corrosion crack propagated far enough during the last parking phase on 28 August 2009 that the additional load induced at the start of engine number 3 directly above the right landing gear was sufficient to initiate a critical situation for unstable crack propagation (final rupture). The ratio of crack cross section parts and the final rupture parts is reasonable, given the limited fracture toughness of high-strength steel.

The landing gear bogie beam was, without doubt, destroyed by hydrogen induced stress corrosion cracking. It was caused by moisture entry (water in connection with de-icing salt) into the inside of the bogie beam and the expanded time period in which the corrosion was not detected.

Appendix 5: Parts of the fractured landing gear bogie beam

The State Aviation Administration of Ukraine should ensure that on all Antonov AN 12 main landing gears the inside of the landing gear bogie beams are inspected for traces of corrosions and the caps on the ends are inspected for liquid tightness.

Furthermore, the manufacturer should determine actions which remedy corrosion or defects in liquid tightness.
