Investigation Report

Type of Occurrence:	Accident
Date:	25 March 2012
Location:	Near the county Gelsdorf
Aircraft:	Helicopter
Manufacturer / Model:	Aerospatiale / AS 350B2
Injuries to Persons:	Pilot severely injured, three passengers and one ground crew member with minor injuries
Damage:	Aircraft severely damaged
Other Damage:	Crop damage
Information Source:	Investigation by external expert for field investigation and BFU staff members
State File Number:	BFU 3X014-12

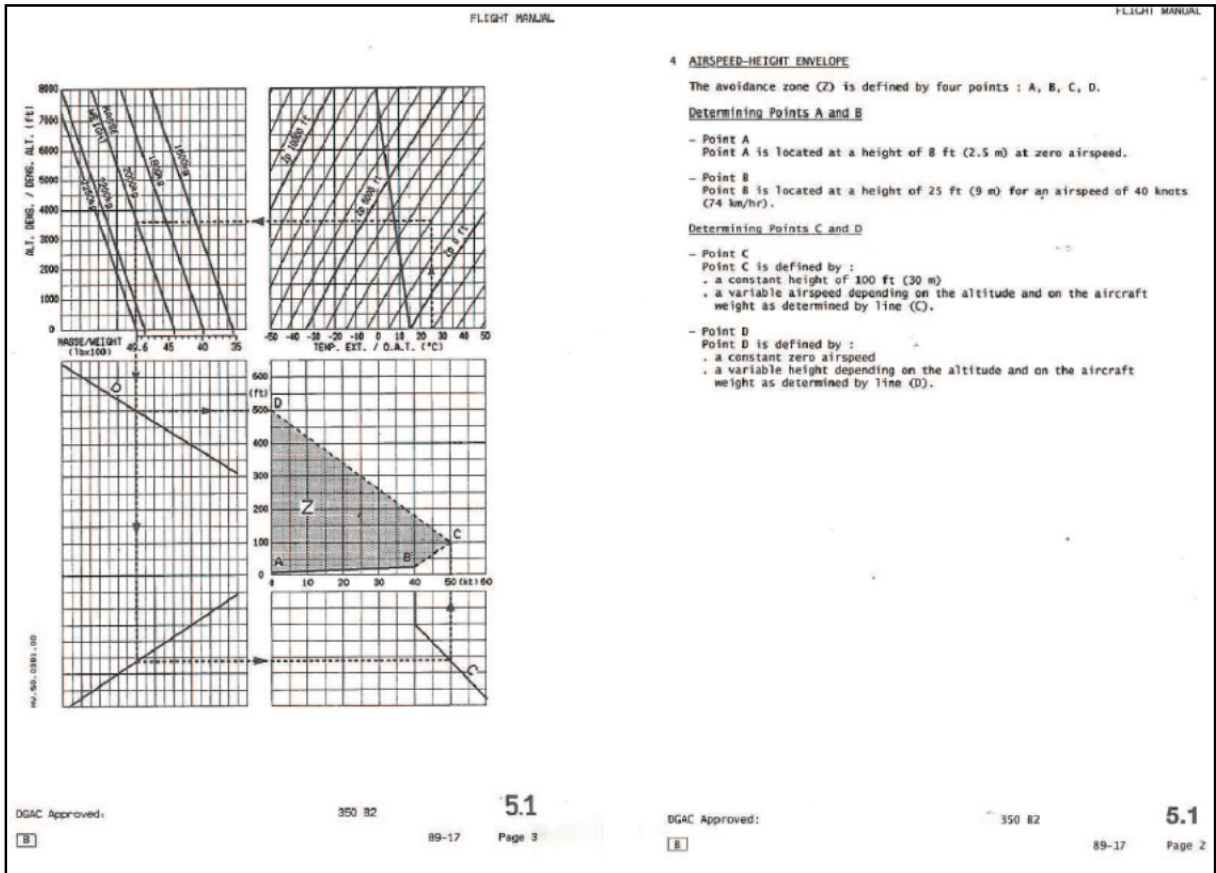
Appendix 1: Recommended airspeed-height envelope diagram of the manufacturer

The video illustrating the course of events shows the take-off, the engine failure and the subsequent descent. The turbine failed at a time when the altitude and airspeed were problematic for a controlled and successful autorotation and emergency landing, respectively.

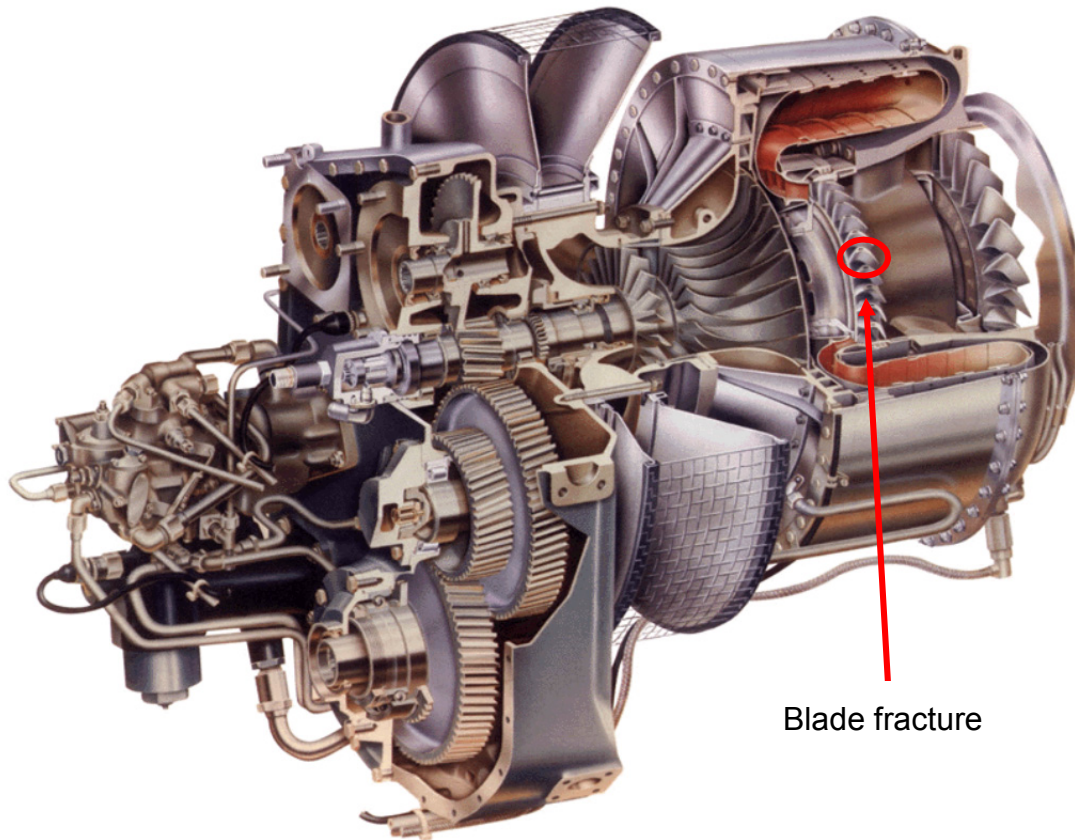
Appendix 2: Cross section LTS 101 turbine

The engine examination at the manufacturer's facilities determined that one blade of the gas producer turbine separated and caused the turbine failure. Further investigation of the engine showed it is highly likely that the short-term unbalance and the subsequent vibrations caused several screw connections to come loose as well as the massive bearing failure. This is supported by the fact that the engine had been operated for more than 1,200 hours after the last overhaul and the experiences of the engine manufacturer during certification tests. The loose screw connections

would have made operation of the engine impossible due to pressure and fuel loss and a progressing bearing failure would have produced chips and metal abrasion. The oil supply was free of chips, however. Further examination of the remaining blade base revealed unambiguous signs of fatigue fracture, so-called high cycle fatigue, probably caused by a faulty coating of the cooling duct within the blade.
