Investigation Report

Type of Occurrence:	Accident
Date:	27 May 2013
Location:	Wolfsbehringen
Aircraft:	Airplane
Manufacturer / Model:	Piper Aircraft Corporation / PA39
Injuries to Persons:	Pilot fatally injured
Damage:	Aircraft destroyed
Other Damage:	Crop damage
State File Number:	BFU CX006-13

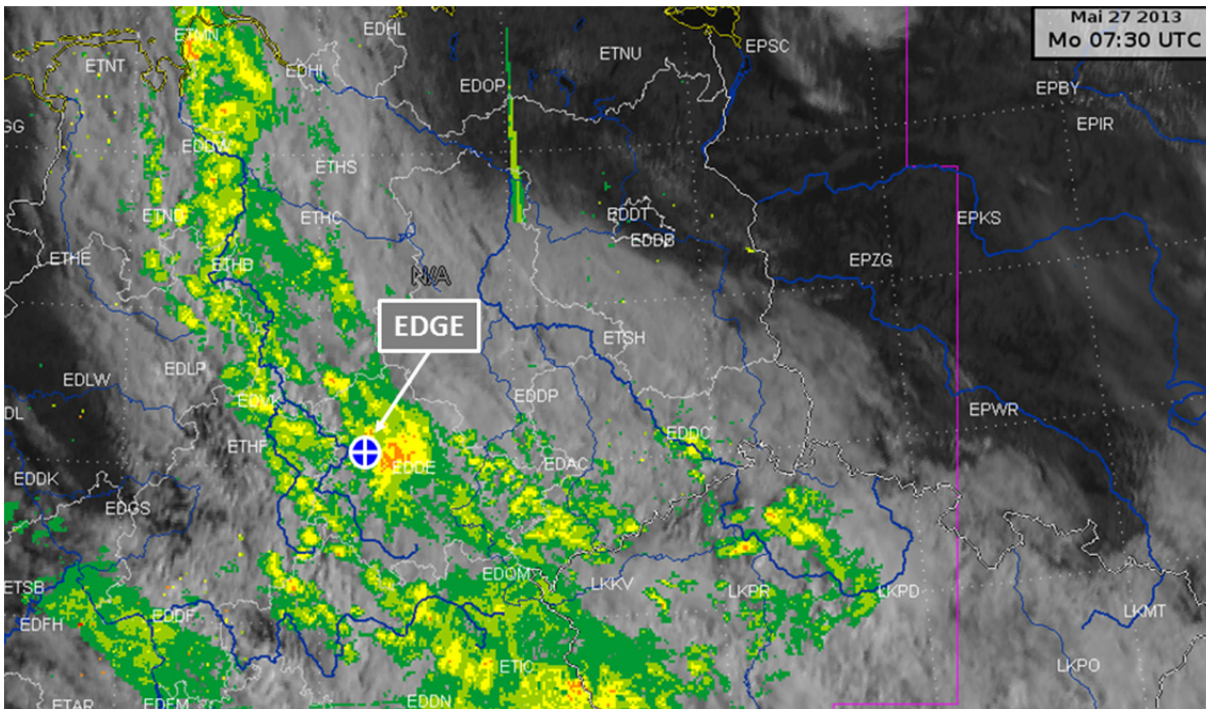
According to the expert opinion of the DWD prefrontal weather conditions prevailed. At 0930 hrs Eisenach was directly subject to the front area. At 0900 hrs the station in Eisenach reported visibility 3.3 km, and 5 to 8 oktas clouds at 600 ft and 900 ft GND. Moderate rain and drizzle occurred.

Cloud tops were probably above FL100 and could tower up to FL180. From 6,000 ft AMSL on moderate icing could occur.

Satellite image of western Thuringia: low clouds (grey) and precipitation (yellow-green)

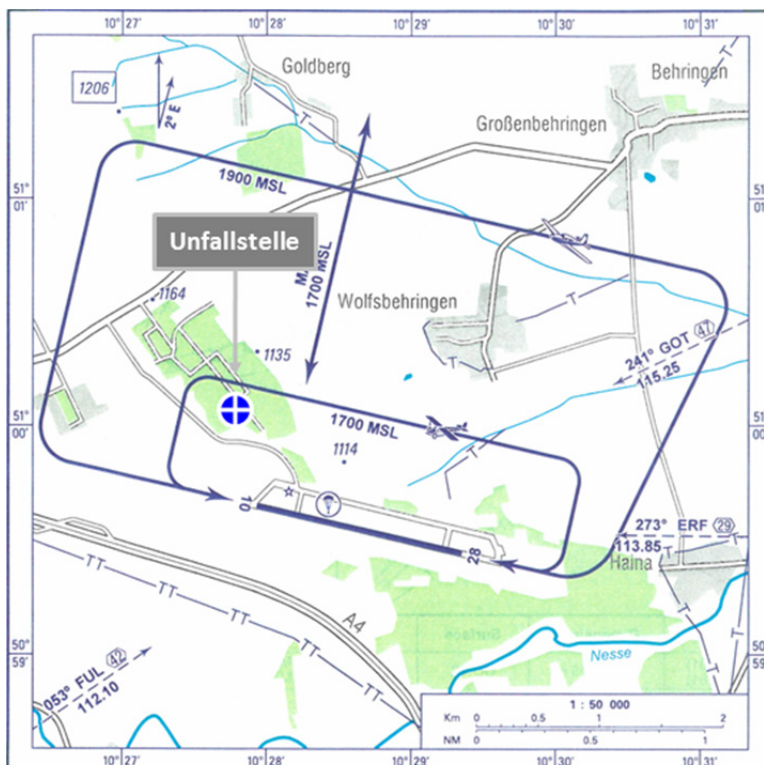
The accident site was located about 900 m north of the threshold of runway 10 of the aerodrome of departure.

Visual approach chart (excerpt, 4/2013) including location of the accident site
