Investigation Report

Type of Occurrence:	Accident
Date:	26 August 2013
Location:	Gerbach
Aircraft:	Ultralight Aircraft
Manufacturer / Model:	Evektor Aerotechnik a.s. / EV 97 Eurostar 2000 R
Injuries to Persons:	Two persons fatally injured
Damage:	Aircraft destroyed
Other Damage:	Crop damage
State File Number:	BFU CX014-13

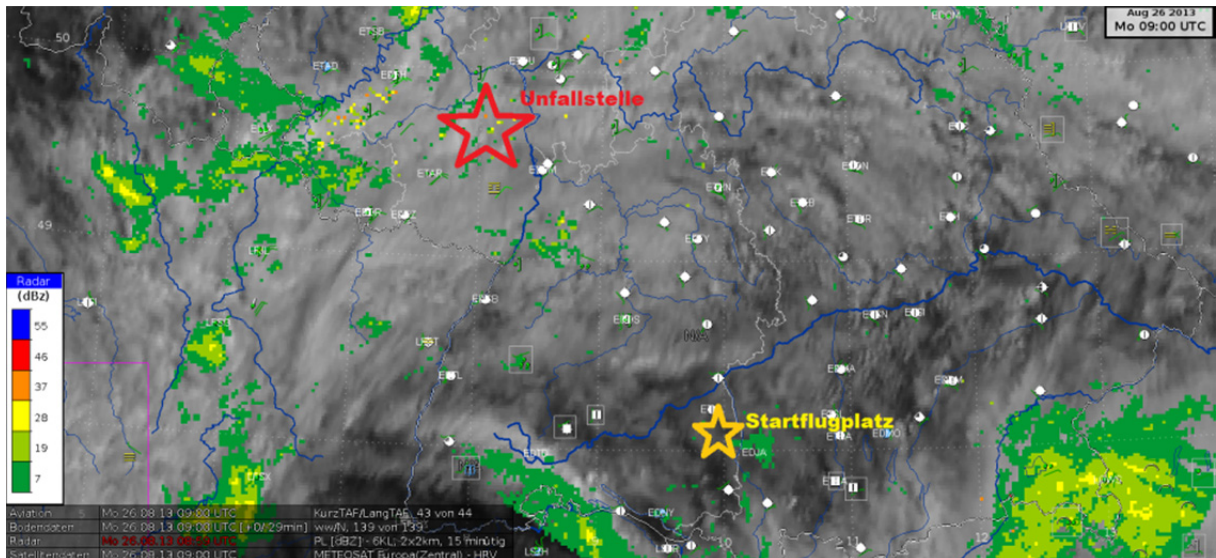
Weather radar image

Widespread BKN SC/AC/CI with a base of 2,500 and 3,500 ft AMSL, in the north from FL060 to FL080. The cloud tops are at FL200, often above FL245. The mountains are partially in clouds, locally BKN ST has formed at 300 to 800 ft AGL. Temporarily light to moderate rain is falling; in the furthest north of the forecast area it is mostly dry. Visibilities are between 8 and 15 km, partially hazy at 2 to 6 km.

During the day precipitation lessens initially, around noon and during the afternoon it assumes shower characteristics. The clouds begin to form stratus clouds, locally ISOL EMBD CBs is to be expected. During the day the ceiling increases somewhat, visibilities by day are often 10 to 20 km, will locally be reduced to 4 to 8 km.

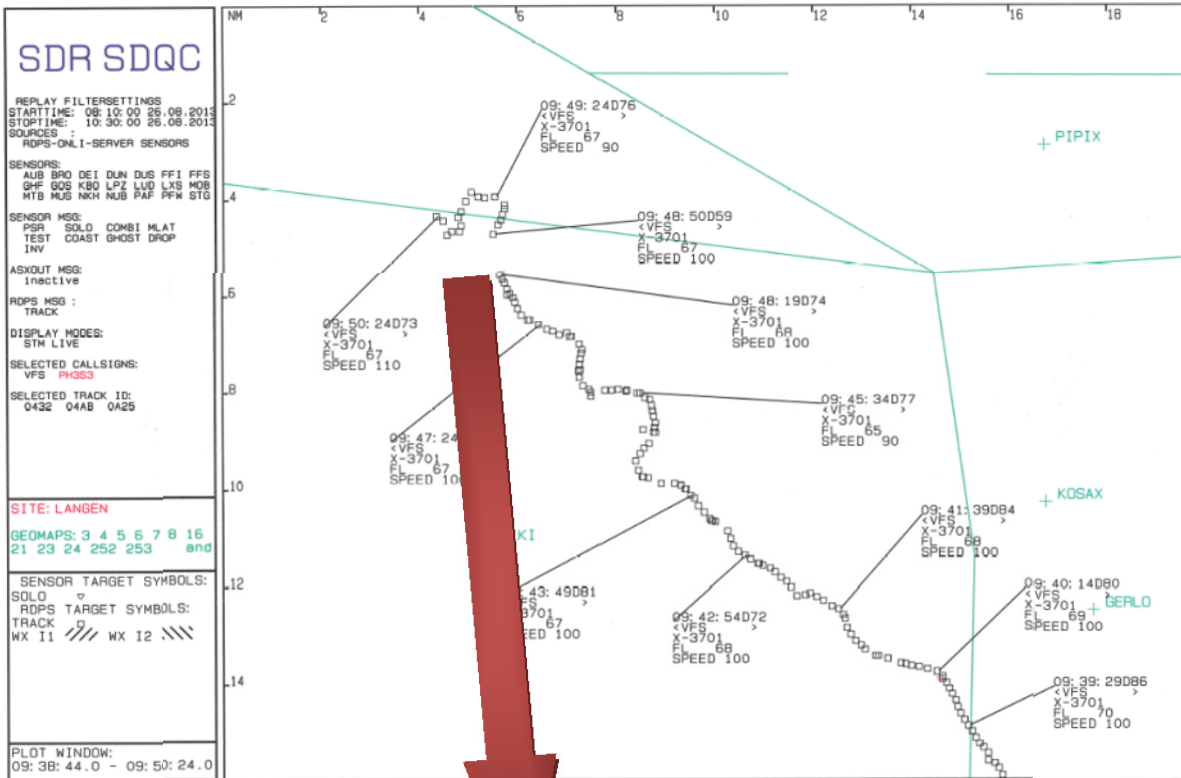
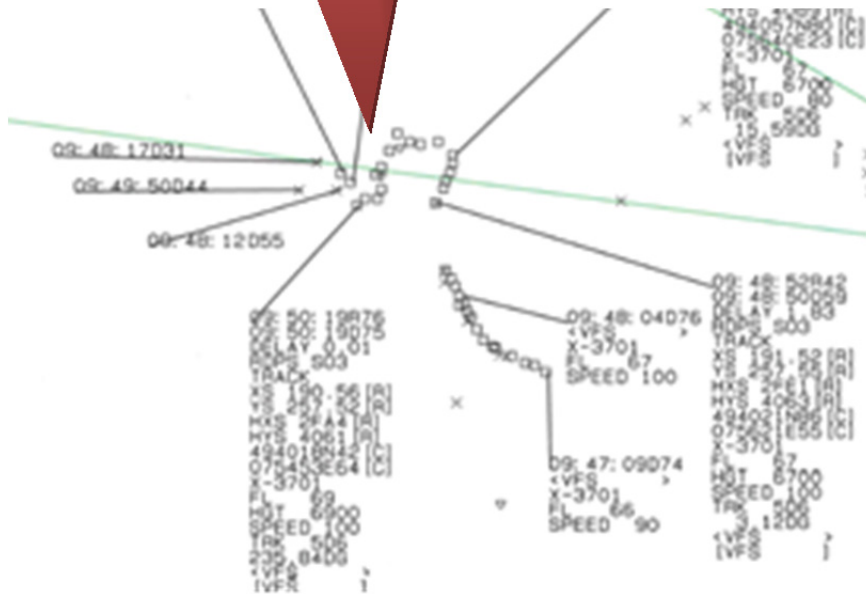
Radar recording of the accident area

The air traffic service provider radar data recording was available to the BFU for evaluation purposes. The engine monitoring system (FLYdat) recorded different engine parameters, such as oil pressure, oil temperature, and engine rpm (revolutions per minute). The BFU read out and analysed the FLYdat data.
