# Investigation Report

Type of Occurrence:	Serious incident
Date:	8 October 2014
Location:	Frankfurt/Main
Aircraft:	Cargo airplane
Manufacturer / Model:	The Boeing Company / B 747-400 F
Injuries to Persons:	None
Damage:	Minor damage to aircraft
Other Damage:	None
State File Number:	BFU EX007-14

During the approach to Frankfurt/Main Airport parts of the left wing flap detached from the airplane.

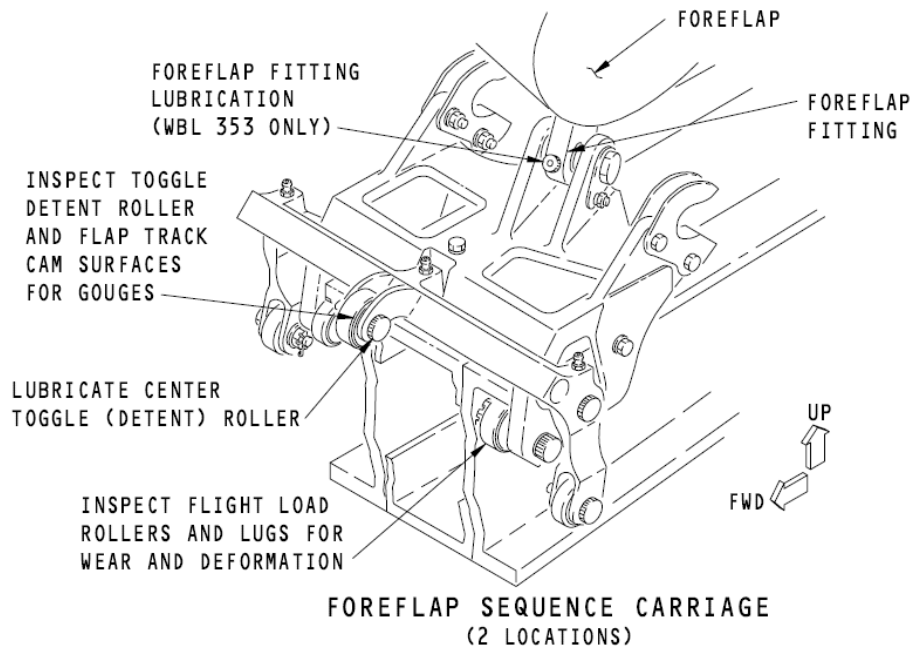
The fractured flap attach fitting was of the aluminium alloy EN AW 7075. On one side it had been screwed to the flap spar (Appendices Image 6). The bearing seat in form of a ball joint was located at the other end. A steel ball, through which a retaining bolt was guided, was resting in a bronze bushing (Image 6a). During assembly the bronze bushing was pushed up to the lap into the eye of the attach fitting. The side without lap was flared so that the bushing remained firmly in the eye and could not be pressed out. A circumferential groove ran along the outside of the bushing which was connected with the inside of the bushing via three drill holes. Via the groove and the drill holes the ball was supplied with lubrication. A fitting on the outside connected with the inside via a drill in the area of the groove guided the lubricant inside.

A bolt, which led through the drill hole to the ball, connected the attach fitting with the carriage, which moved the flap (Image 6a).

Image 6: Link between inboard fore flap and carriage

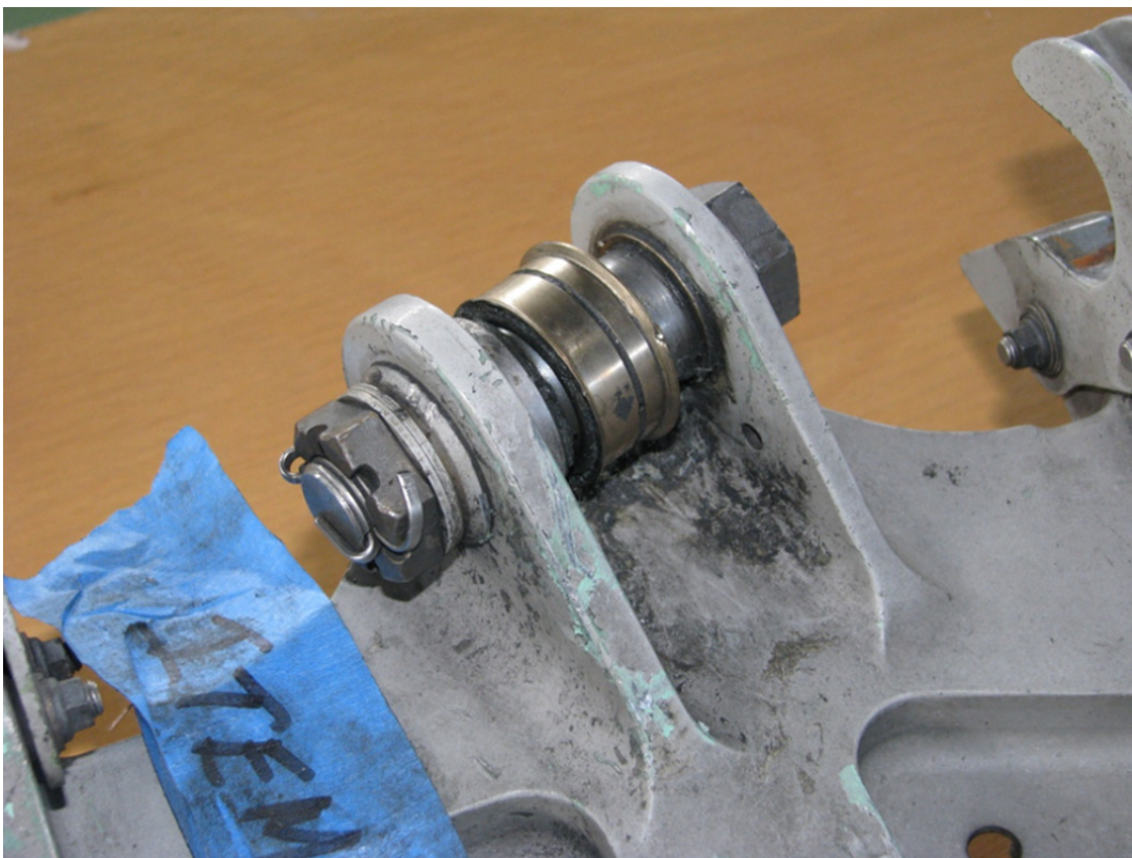
On the airplane part of the left wing inboard fore flap (approximately 4.5 x 1 m) was missing. The fracture had occurred approximately one metre left of the inner flap attach fitting (Images 1 - 3). The two outer fore-flap tracks, connecting the fore and middle inboard flap, were fractured or damaged. The cover panels of the fore-flap track's mountings showed damages. In the area of the carriage, which moves the outer bearing of the flap, a fracture piece of the bearing seat got jammed (Image 8). The bronze bushing was still connected with the carriage through the bolt (Image 9). Image 5 shows a drawing of the flap arrangement and the fractured attach fitting. The

Image 9: Pin with bronze socket at the carriage

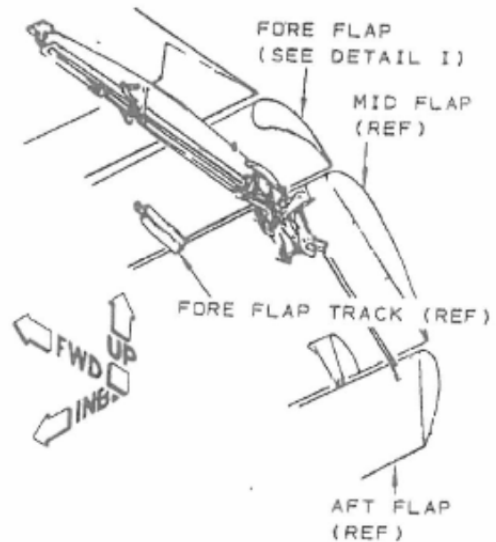
VIEW LOCKING UP AT INBOARD TRAILING EDGE FLAPS

A fatigue crack was found in the horizontal flange of the inboard fore flap outboard attach fitting on the fatigue test airplane after 12,000 simulated flights. Subsequently, three in-service cracks were reported at 2300 to 3500 flights. Undetected cracking could result in complete fracture of the fitting and loss of the fore flap in flight. Subsequent to Revision 1, three fore flap losses have been reported. The most recent loss, at 5508 flights, resulted in considerable damage to No. 4 door.

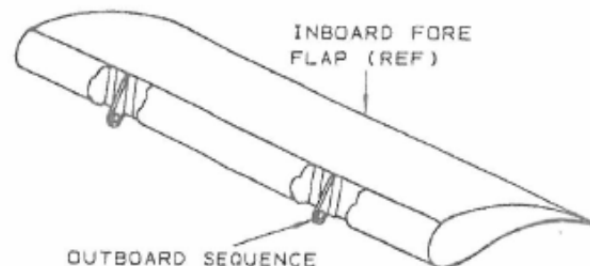
DETAIL I

OUTBOARD SEQUENCE FITTING (REPLACE)
