# Investigation Report

Type of Occurrence:	Accident
Date:	26 June 2016
Location:	Near Hofgeismar
Aircraft:	Helicopter
Manufacturer / Model:	Bell Helicopter Textron / Bell 407
Injuries to Persons:	None
Damage:	Aircraft severely damaged
Other Damage:	None
State File Number:	BFU16-0848-3X

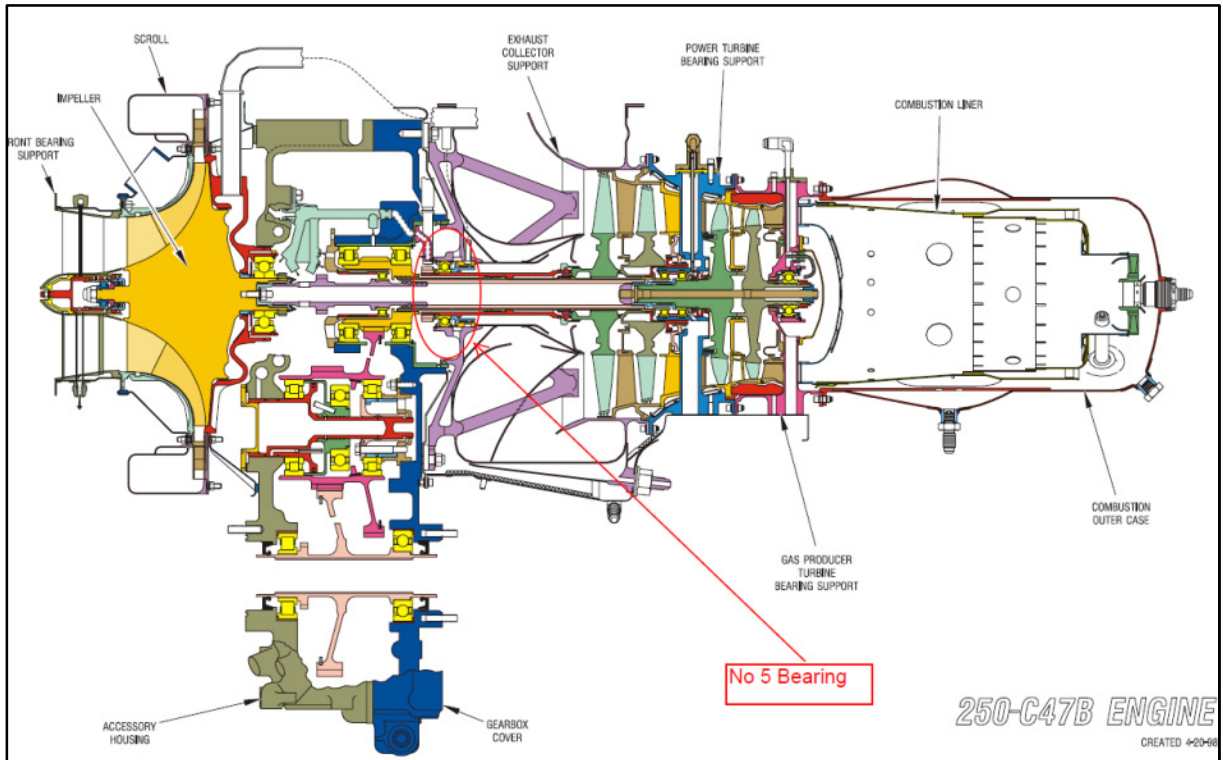
Engine structure and position of the No 5 bearing

The examination at the engine manufacturer occurred on 11 November 2016. The engine disassembly showed damage of the No 5 bearing (Version Part Number 6871505, operating time of about 1,341 hours and 1,479 cycles) and a damaged N2 sensor.

The cause for the bearing damage could not be determined.
