Investigation Report

Type of Occurrence:	Accident
Date:	26 July 2016
Location:	Senheim
Aircraft:	Helicopter
Manufacturer / Model:	MD Helicopters Inc. / HU 369E
Injuries to Persons:	Pilot slightly injured
Damage:	Aircraft severely damaged
Other Damage:	None
State File Number:	BFU16-1037-3X

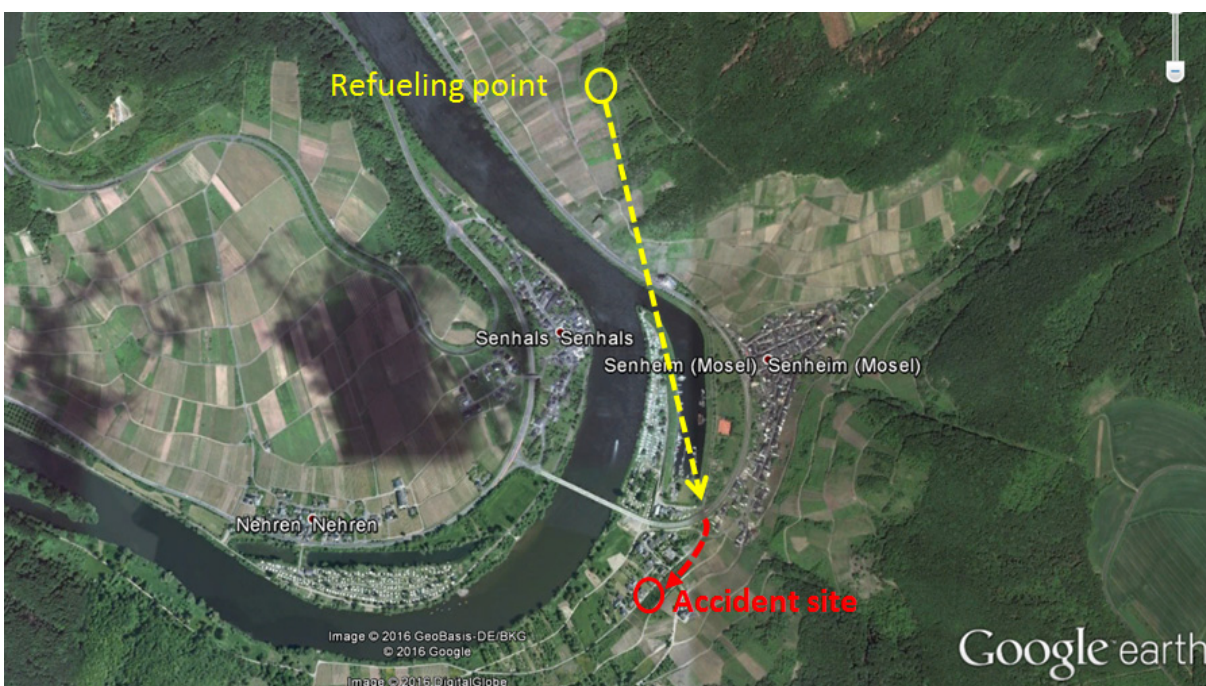
On the day of the accident the pilot conducted several vineyard spraying flights during the morning. After a break of several hours, in the afternoon he conducted another flight with a HU 369E helicopter above the vineyard at the eastern shore of the river Mosel in the vicinity of the towns of Mesenich and Senheim.

during the approach of the spraying area the following occurred: sudden bang, massive loss of engine power, indication of warning lights, and sounding of the engine-out warning horn. Then he immediately initiated autorotation in low altitude and turned parallel to the slope.

Overview flight path and local conditions

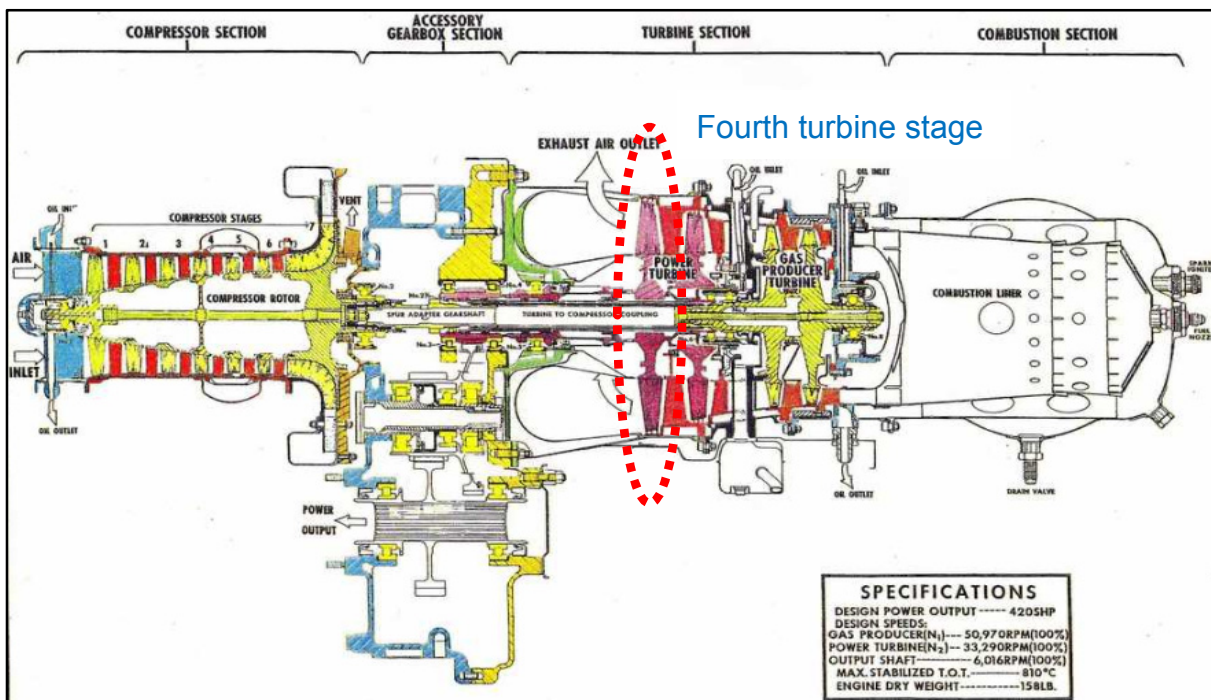
Engine structure and position of the fourth turbine stage

The disassembly of the engine occurred on 20 October 2016 at the engine manufacturer's facilities under supervision of the National Transportation Safety Board (NTSB). The examination revealed that the cause for the engine failure was a high-cycle fatigue fracture of one blade of the 2nd stage power turbine (or 4th stage turbine) wheel.

- A single blade on the 4th-stage turbine wheel fractured in fatigue from an origin at the trailing edge approximately 0.036 inch above the rim of the wheel. The fatigue initiated and progressed approximately 0.511 inch in high cycle fatigue before separating in overload. No material anomalies were present at the origin area and no additional fatigue cracks were present in the other blades.

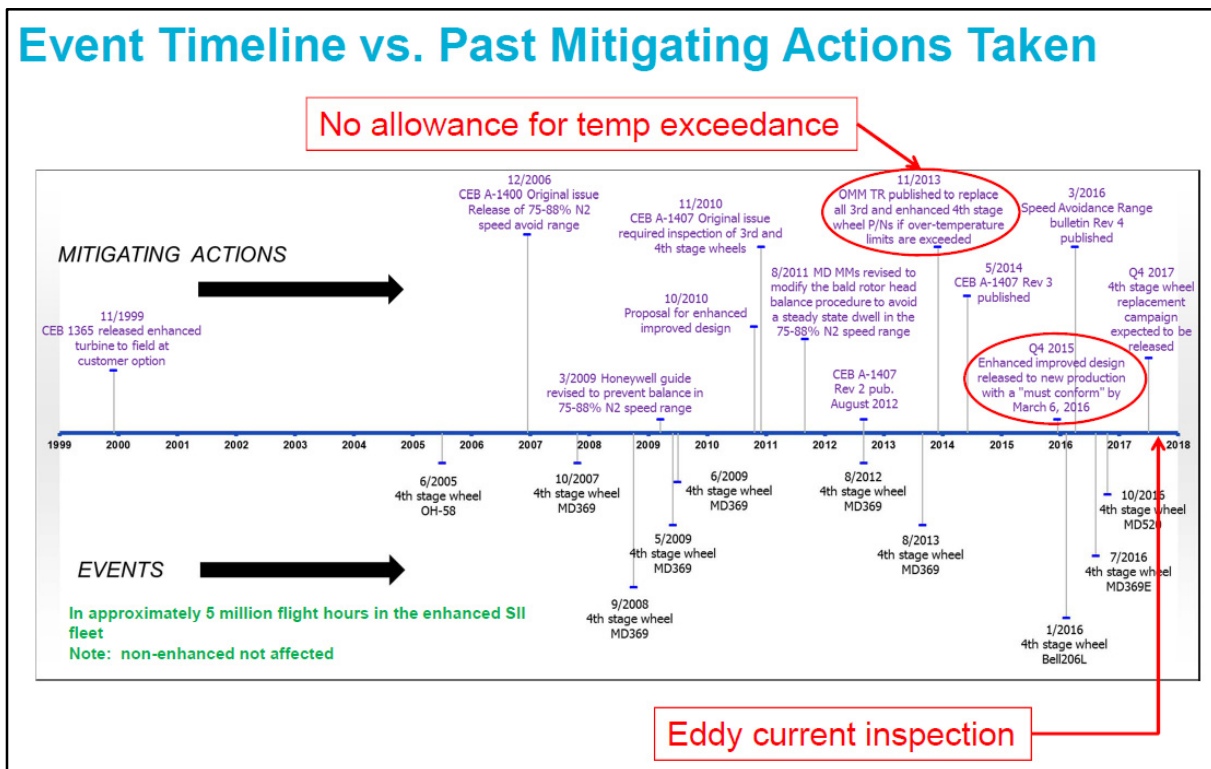
Between 2005 and 2016, seven other accidents occurred with HU369/MD520 (MDHI) helicopters and two with B206/OH58 (Bell) helicopters, all powered with Rolls Royce M250-C20 engines with the SB CEB-1365 enhanced power turbine assembly installed, sustained blade fractures on the third or fourth turbine stages, resulting in a sudden total power loss. So-called low-cycle and high-cycle fatigue fractures in the blade root were identified as causes.

In 2016 the NTSB published the latest investigation report (file number: WPR13GA374) in which the accidents, the history of the causal SB CEB-1365 enhanced power turbines and the characteristic damage pattern were

described. In addition, the corresponding actions of the engine manufacturer Rolls-Royce (Alert SB CEB-A-1400 Steady State Operation Avoidance Range Limit, CEB-A-1407 One-time Inspection of 3rd and 4th Stage Turbine Wheels), of the helicopter manufacturer MDHI (Revision 16 and 17 of the 369E Flight Manual), and the issued Airworthiness Directives (AD 2012-14-06 and AD 2015-02-22) were stated in summary.

Since 2010 the engine manufacturer is making an effort to develop an improved fourth turbine stage. Due to casting problems the first design attempt was stopped in 2013. Since March 2016 the manufacturer produces a newly developed fourth turbine stage and fits new engines with them. Currently it is planned to stipulate through an Airworthiness Directive that beginning at the end of 2017 the old versions of the fourth turbine stage are to be replaced by the new design. In addition, the manufacturer plans to make the already developed eddy current inspection mandatory by the end of 2017 so that installed turbine wheels can be checked for cracks.

Comparison of the occurrences and actions
