Aviation Short Investigation Bulletin

Issue 11

ATSB Transport Safety Report
Aviation Short Investigations
AB-2012-088
Final

Report No. AB-2012-088

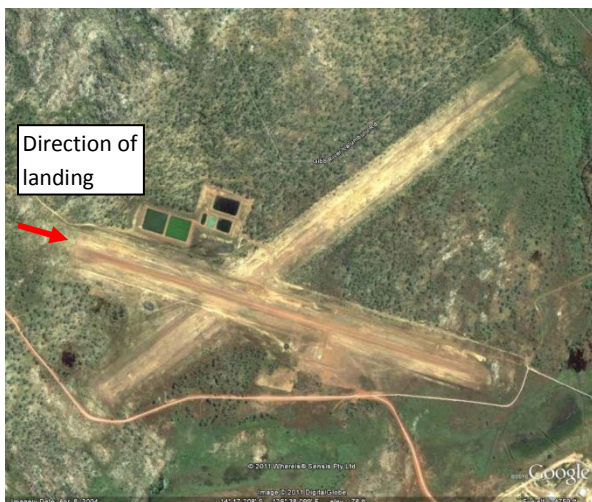
Figure 1: Kalumburu ALA

Inspection of the aircraft at the accident site determined that the left wheel brake system was operating while the right system had failed, resulting in the loss of pressure to the right wheel brake. The right brake reservoir appeared to be empty, with a quantity of oil or hydraulic fluid noted in the forward fuselage and on the cabin floor. A subsequent inspection confirmed that the fluid level in the right brake reservoir was very low. A pressure test of both brake systems did not indicate any leaks and an inspection of the master brake cylinders found the seals intact. It was not determined why the right hydraulic fluid reservoir level was low, nor why the pilot could not obtain any brake pressure from the left wheel brake system.

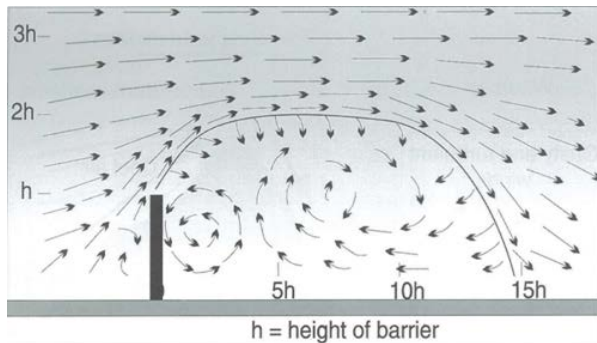
Figure 2: Airflow near a solid (impermeable) cross wind barrier

The BOM estimates that for smaller impermeable barriers, such as trees and buildings, turbulence occurs up to about twice the height of the barrier vertically, and an equivalent distance downwind of up to 15 times the height of the barrier (Figure 2)
