# Aviation Short Investigation Bulletin

Issue 24

**ATSB Transport Safety Report**  
Aviation Short Investigations  
AB-2013-202  
Final – 10 December 2013

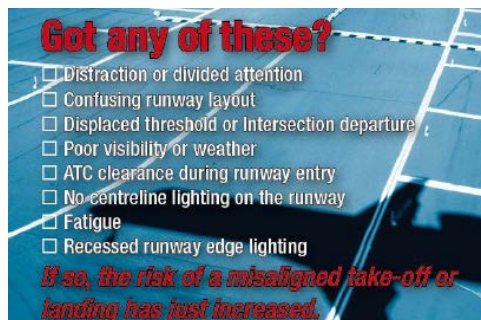
To promote awareness, knowledge and action, the ATSB also developed a pilot information card (above) to assist crews in identifying factors that increase the risk of a misaligned take-off.

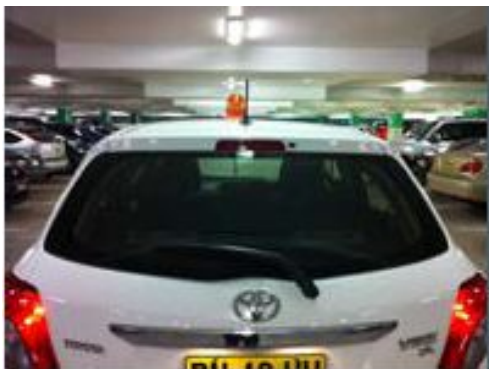
**Figure 1: Security vehicle**

At about the same time, the captain observed the lights of a white security vehicle<sup>4</sup> (Figure 1) approaching from about 50 m away and about 90° to the right of the aircraft. He estimated the speed of the vehicle was about 30km/h, about the same as VZA's taxi speed.

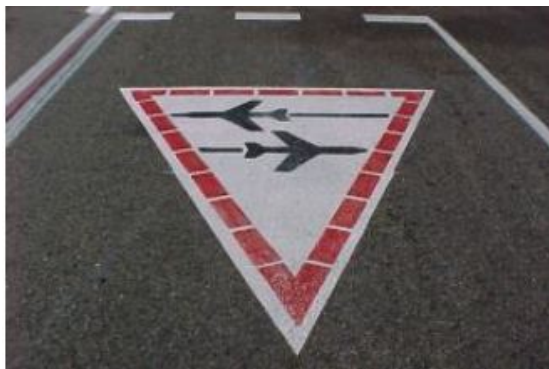
**Figure 2: Vehicle GIVEWAY sign on airside road**

The driver also reported that, once a vehicle on the airside road passes the give way point (Figure 2 and 3), the vehicle is angled to the right. This restricts sighting aircraft taxiing from the left, especially at night.

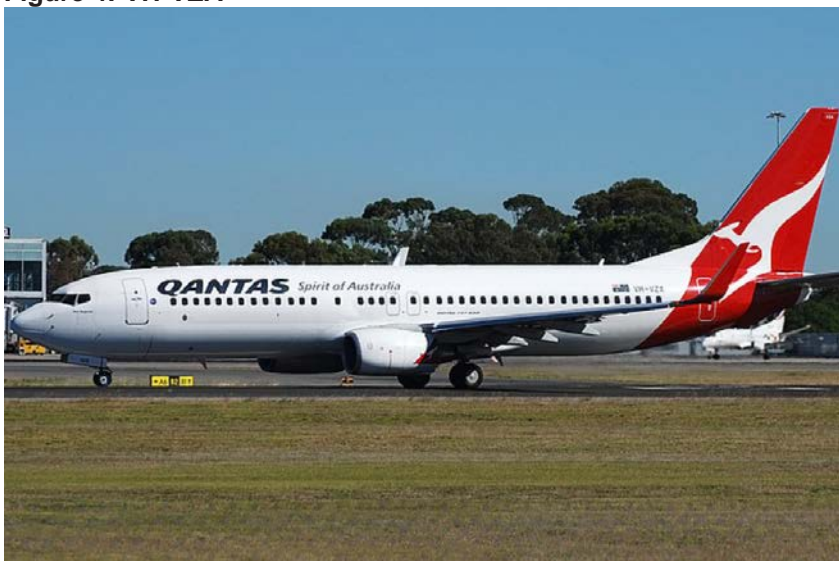
**Figure 4: VH-VZA**

On 26 August 2013, a Qantas Airways Boeing 737 aircraft, registered VH-VZA (VZA) (Figure 4), was completing a scheduled passenger flight from Cairns, Queensland to Sydney, New South Wales.

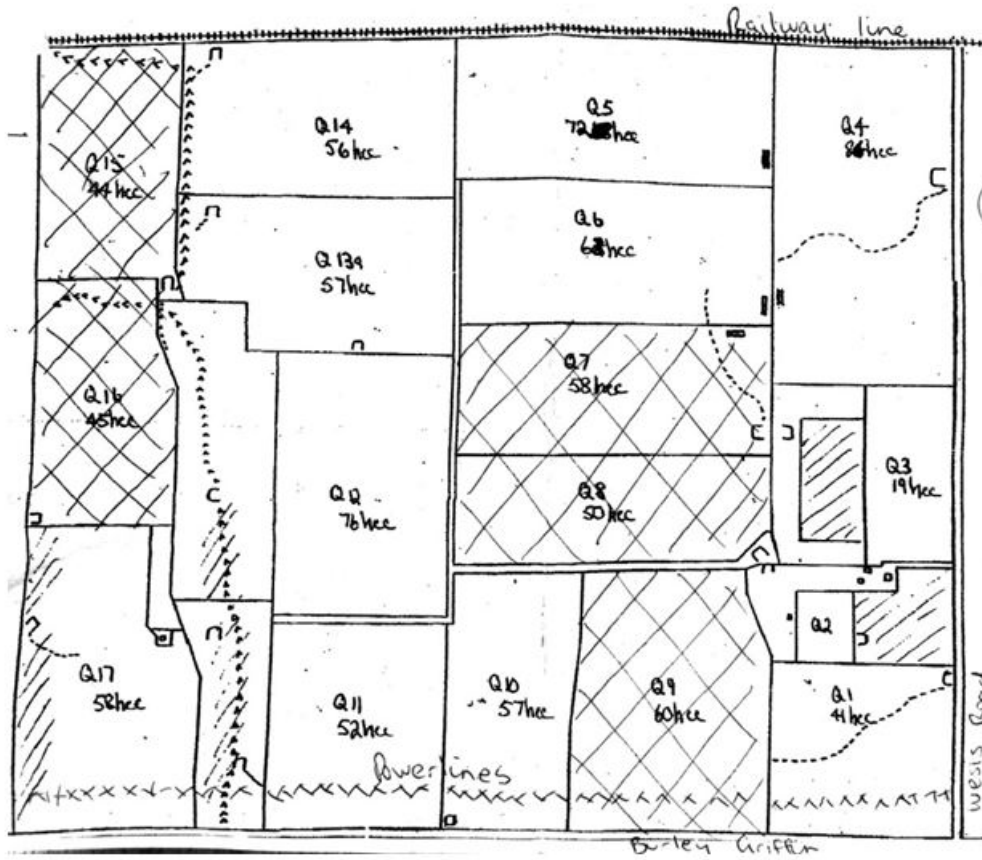
Figure 1: Map of property to be sprayed

Prior to commencing spraying, the pilot overflew the paddock twice, to formulate a spraying plan. The pilot identified the powerlines marked on the map and looked for others that may not have been depicted. The pilot reported that, as wires are generally difficult to see, he looked for clues that would indicate the presence of powerlines, such as poles, houses, cross arms and insulators. He observed a derelict homestead to the south of the paddock, but assessed that it was unlikely there would be any associated powerlines, and did not see any indications of other wires in the area.

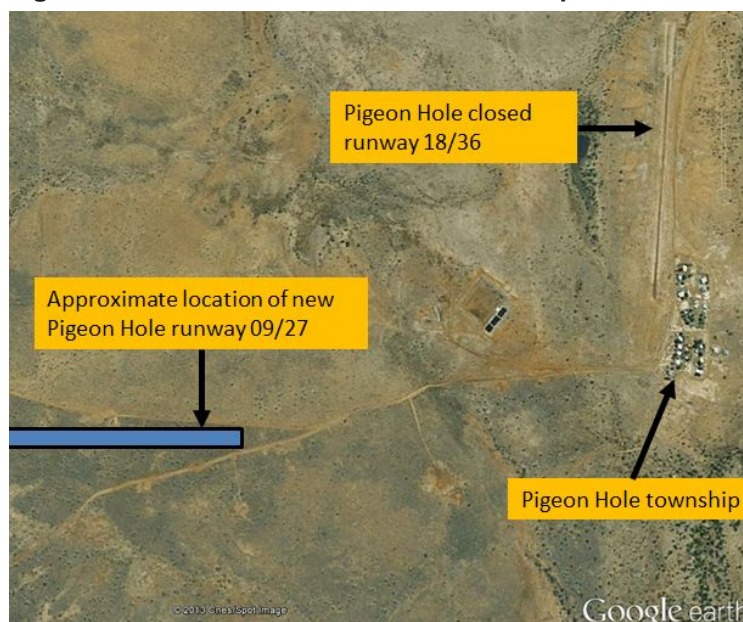
**Figure 1: Location of closed and new airstrip**

After landing, the pilot assessed the situation and elected to take off. During the take-off, the pilot confirmed that the engines were operating normally and after becoming airborne, observed the correct ALA about 2 km south-west of the Pigeon Hole Township (Figure 1).

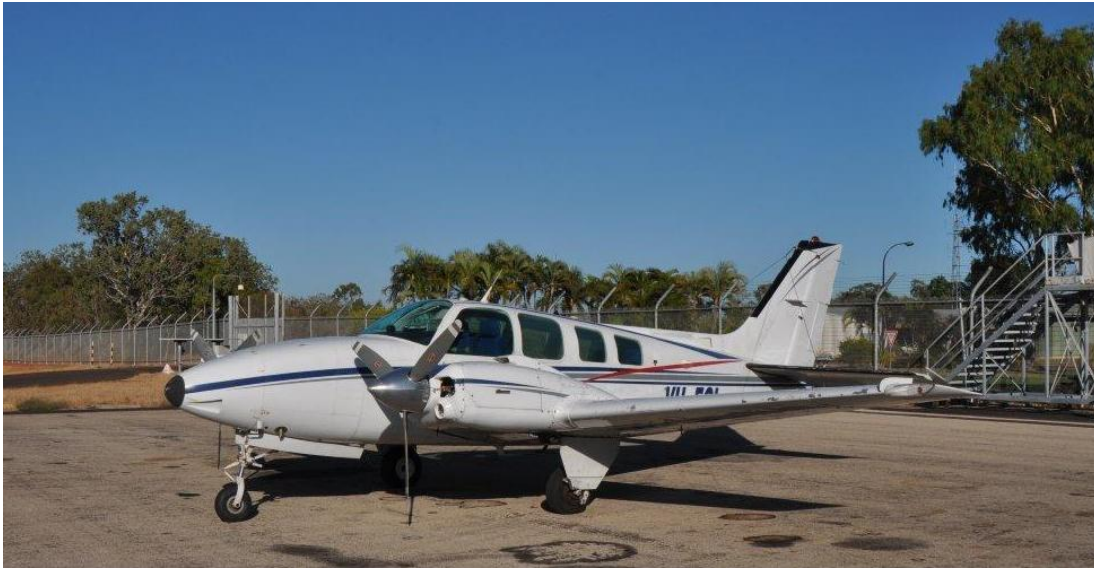
**Figure 1: VH-ECL**

On 14 August 2013, at about 0830 Central Standard Time,<sup>1</sup> the pilot of a Beech BE58 aircraft, registered VH-ECL (ECL) (Figure 1), was preparing for a charter flight from Tindal to the Borrooloola aeroplane landing area (ALA), Northern Territory.

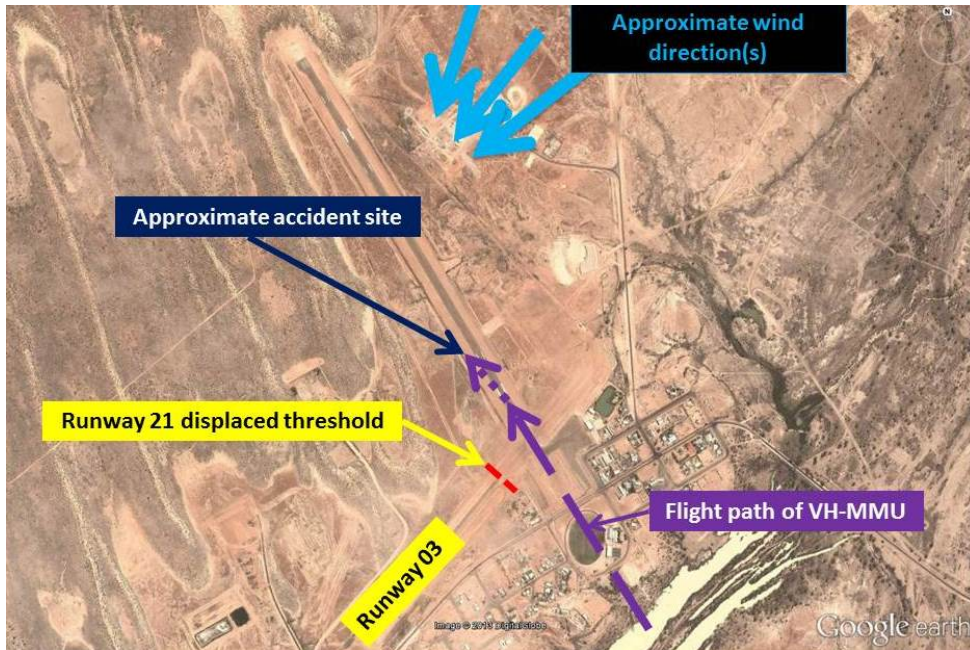
**Figure 1: Landing flight path of VH-MMU**

entering a ditch. The aircraft continued over the mound for about another 10 ft, before coming to rest (Figure 1).

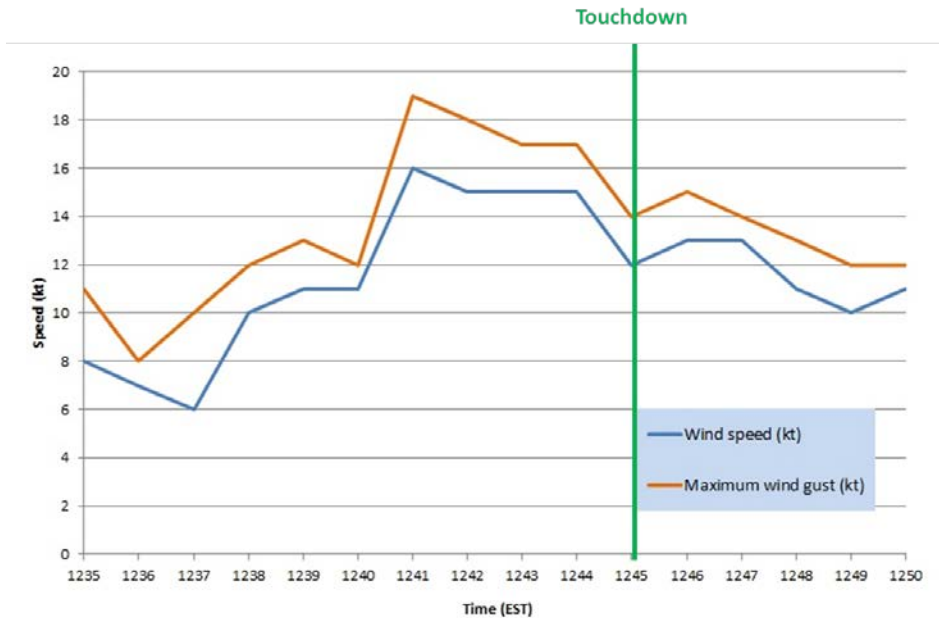
**Figure 3: Bureau of Meteorology one-minute data**

The Bureau of Meteorology (BoM) provided the ATSB with one-minute interval data recorded by the Birdsville automatic weather station (AWS). A graphical representation of the wind speed (kt) and maximum wind gust (kt) between 1235 and 1250 is shown in Figure 3

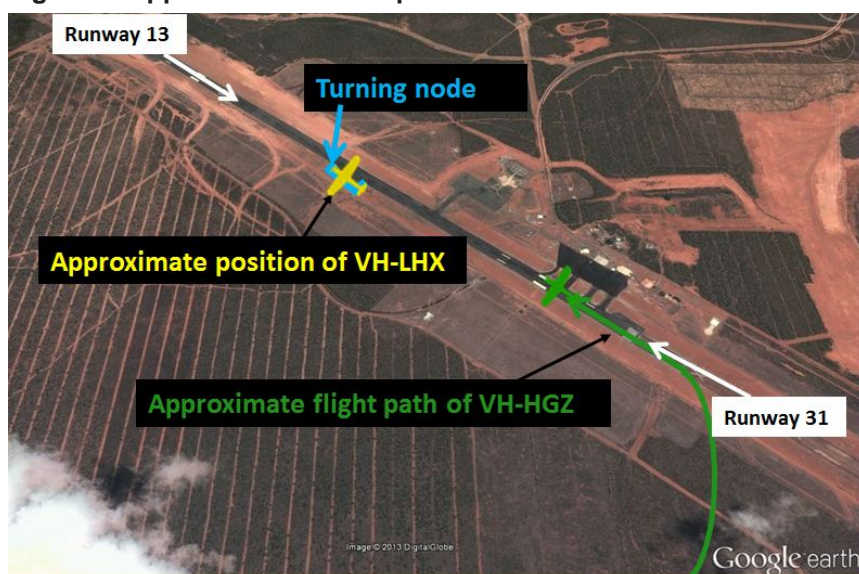
**Figure 1: Approximate aircraft positions**

HGZ landed on runway 31 and vacated the runway. At the time, LHX was positioned at the turning node, but the runway was still occupied. LHX subsequently departed from runway 13.

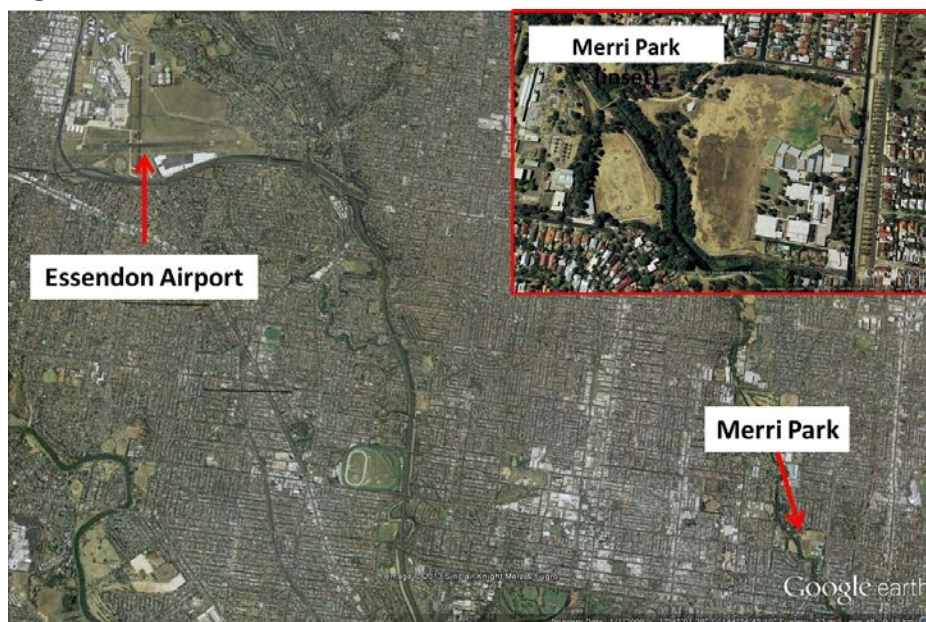
**Figure 1: Location of 'Merri Park'**

The pilot continued to manipulate the controls; however, as the helicopter was unable to maintain altitude and RRPM, he elected to conduct an autorotation. The pilot lowered the collective and rolled off throttle; the vibrations reduced, but the yaw continued. He then observed a park ('Merri Park') to his left, which was suitable for landing (Figure 1). The pilot broadcast a 'MAYDAY'<sup>3</sup> call, which was acknowledged by ATC.

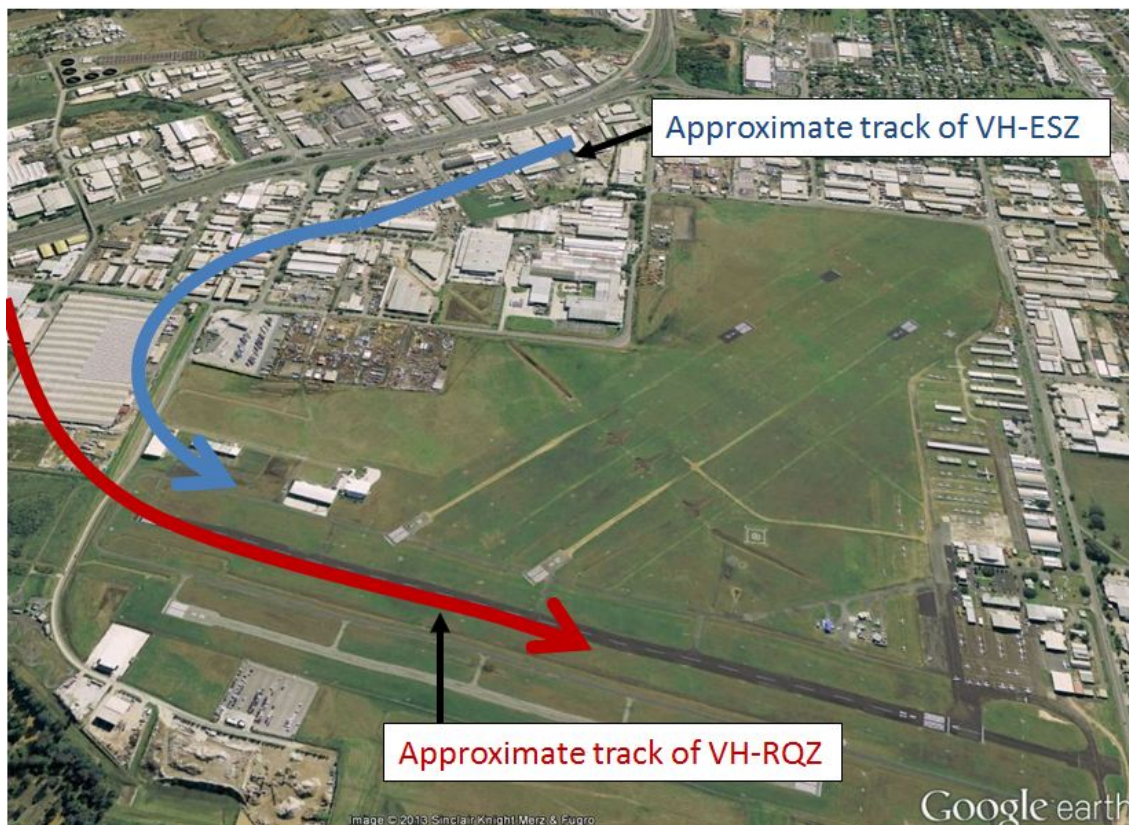
**Figure 1: Approximate aircraft tracks**

When at about 300 ft above ground level (AGL), the pilot of ESZ scanned for aircraft prior to turning onto final. He then sighted RQZ in his 4 o'clock position, about 100 ft below and 100 m behind ESZ and reported that RQZ appeared to have commenced a turn. The instructor of RQZ then broadcast that they were going around. The pilot of ESZ tightened the turn onto final and elected to land on the taxiway parallel to runway 10 (Figure 1). He had not received a TCAS alert on any aircraft other than the IFR aircraft, which was on downwind. The pilot of RQZ reported that they had their transponder turned on and it was operational at the time.
