Australian Government  
Australian Transport Safety Bureau

# Aviation Short Investigation Bulletin

Issue 27

**ATSB Transport Safety Report**  
Aviation Short Investigations  
AB-2014-024  
Final – 19 March 2014

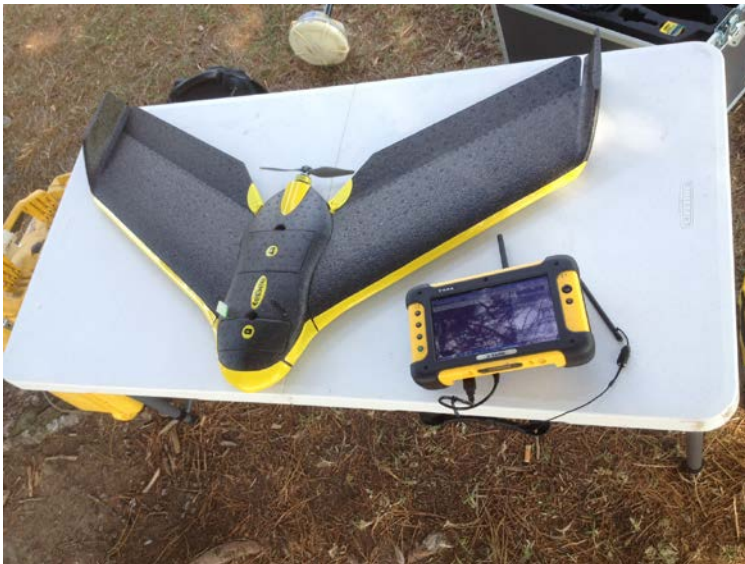
**Figure 1: Sensefly eBee 178**

At about the same time, the operator of an unmanned aerial vehicle (UAV), Sensefly eBee 178 (Figure 1), arrived at the 'Iluka Echo' (Echo) mine site to conduct an aerial photography survey of the site. After having completed his pre-flight preparations and a risk assessment of the operation, the operator heard an aircraft operating about 1-1.5 km away on a neighbouring property to the north-east of the UAV launch site (Figure 2).

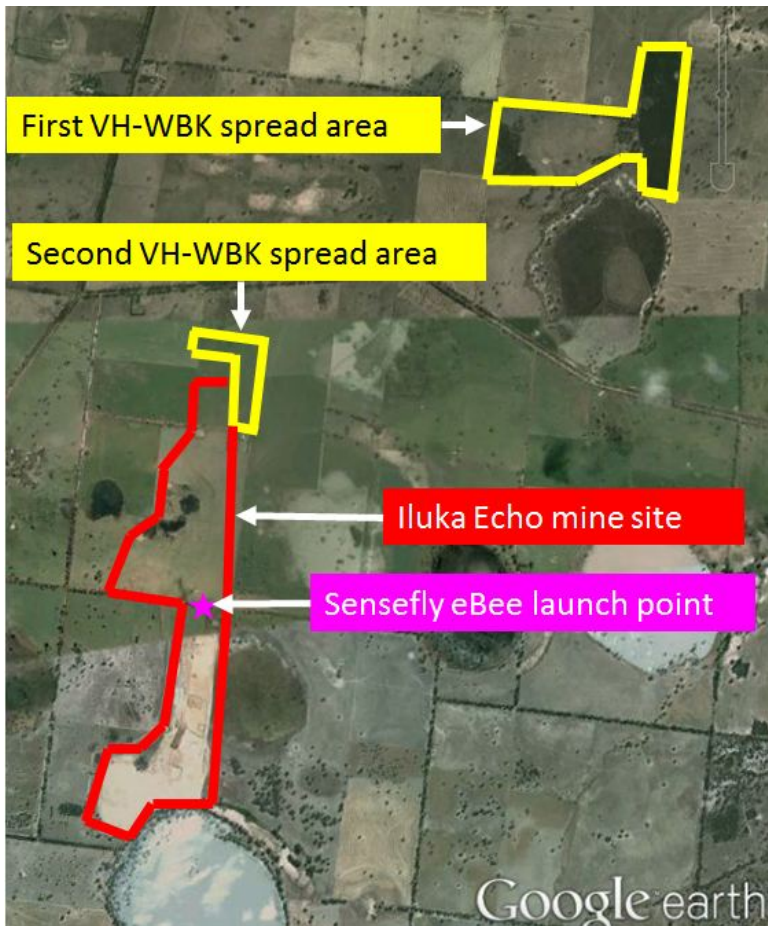
**Figure 2: Operating areas for VH-WBK and the UAV**

At about 1000, the UAV operator heard increasing noise from WBK and observed the aircraft cross the site boundary from the north, conduct a 180° turn about 150 m north of the UAV, then complete one full 360° turn before it departed again to the north. At the time, the UAV was on approach to land, at about 380 ft AGL. The operator immediately put the UAV into a holding pattern to maintain its current position. He estimated WBK was at about 100-150 ft AGL and came within about 100 m horizontally of the UAV. He attempted to contact the pilot of WBK on the radio but did not receive a response.

The pilot of WBK reported that, after completing spreading on the first paddock, he then returned to the airstrip about 3 NM to the north-east, where the aircraft was re-loaded with fertilizer. He subsequently spread the fertilizer on the second block, about 2 NM south-west of the first area, operating at about 50-100 ft AGL. He finished operating in the area by about 1200. He reported sighting a white vehicle on the road on the mine site, but did not see the UAV at any time. The next day the UAV operator contacted the pilot of WBK and advised him of the incident.

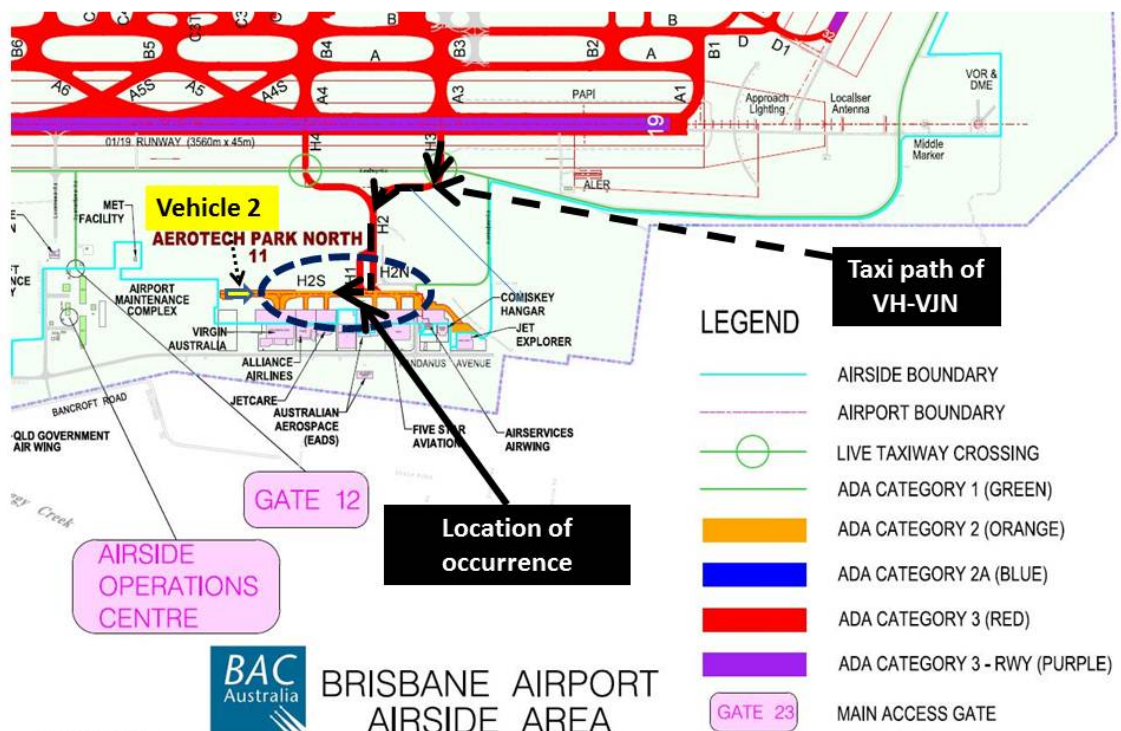
Figure 1: Brisbane Airport

The crew taxied VJN via taxiway 'Hotel 3' (H3), 'Hotel 2' (H2), and then via a right turn onto 'Hotel 2 South' (H2S) (Figure 1). As per company policy, the aircraft was taxied at a maximum speed of 9 kt during turns. During the 90° turn from H2 to H2S the pilot saw a vehicle approaching from the opposite direction along H2S. The vehicle had headlights on, but no flashing light. The captain reported he manoeuvred the aircraft to the right by 2-3 m and braked firmly. During this manoeuvre the captain observed the vehicle brake, and turn right onto the grass. The vehicle passed close to the aircraft's left wingtip.

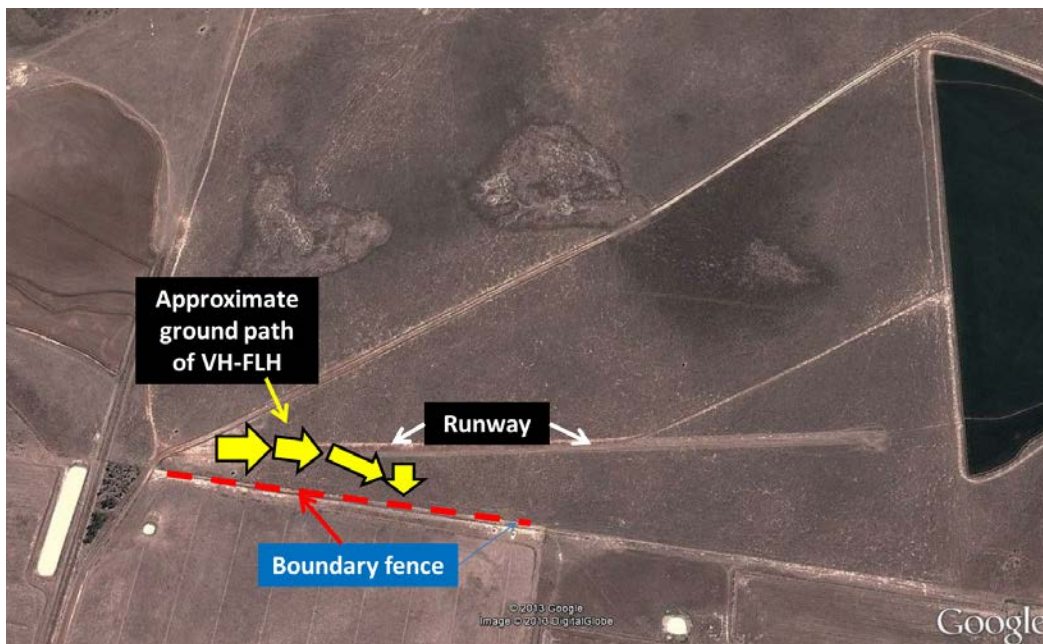
**Figure 1: Accident site**

During the landing, the main wheels touched down first, followed by the tail, which was locked into place. Shortly after, the aircraft suddenly veered right about 45°. The pilot considered a go-around, but was concerned that the aircraft would not clear the boundary fence (Figure 1). Consequently, he elected to continue the landing and selected reverse thrust, applied left brake, left rudder and left aileron in an attempt to re-align the aircraft with the runway. The aircraft did not slow down as the pilot expected. The wheels began to 'grab' and the left undercarriage leg became detached which caused the aircraft to rotate facing about 90° away from the runway. The left wingtip and propeller subsequently contacted the ground. The pilot shut down the aircraft and exited. The pilot was not injured, but the aircraft was substantially damaged (Figure 2).

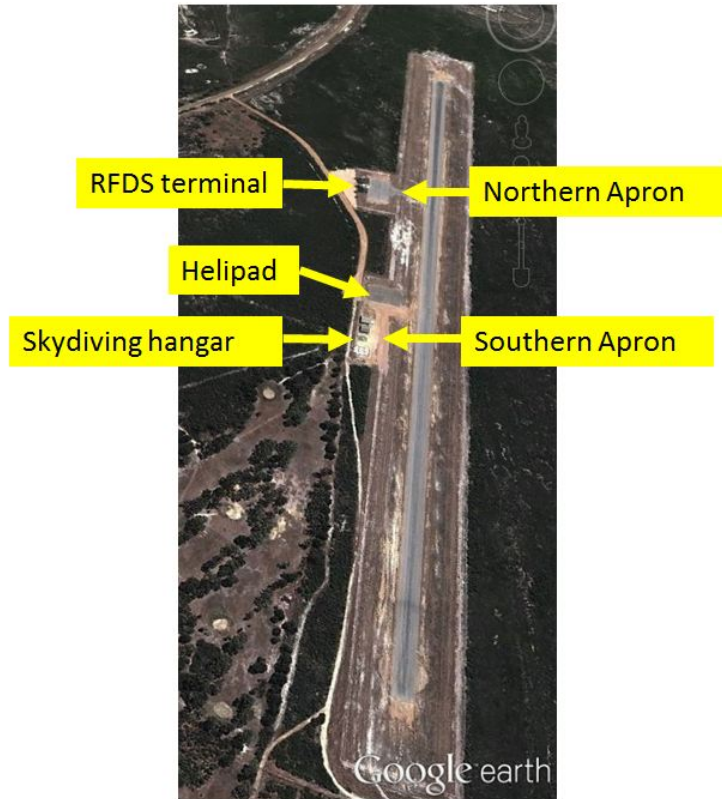
**Figure 1: Jurien Bay (ALA)**

again deviating around the stationary aircraft maintaining a safe distance. The pilot of LNI reported that when he sighted the ambulance returning he immediately stopped taxiing and that the ambulance passed within about 2 m of the aircraft wingtip.

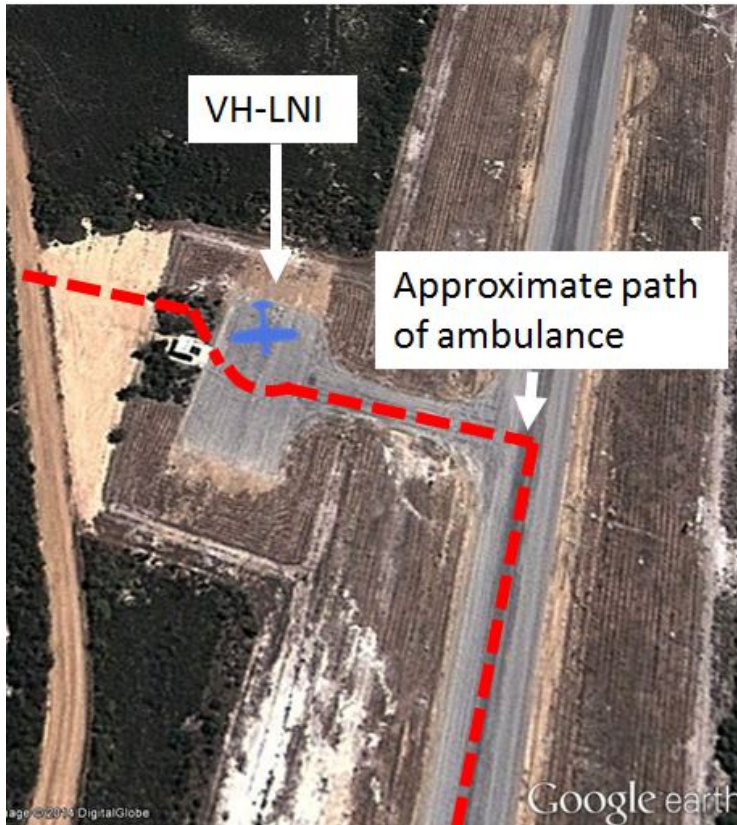
Figure 2: Jurien Bay (ALA)

The ambulance driver then proceeded to the runway and stopped prior to entering the runway. The driver reported that he and his ambulance partner conducted a thorough visual inspection for aircraft approaching and on the runway. The ambulance then entered the runway and drove towards the helipad, about 300 m south of the RFDS apron (Figure 2).

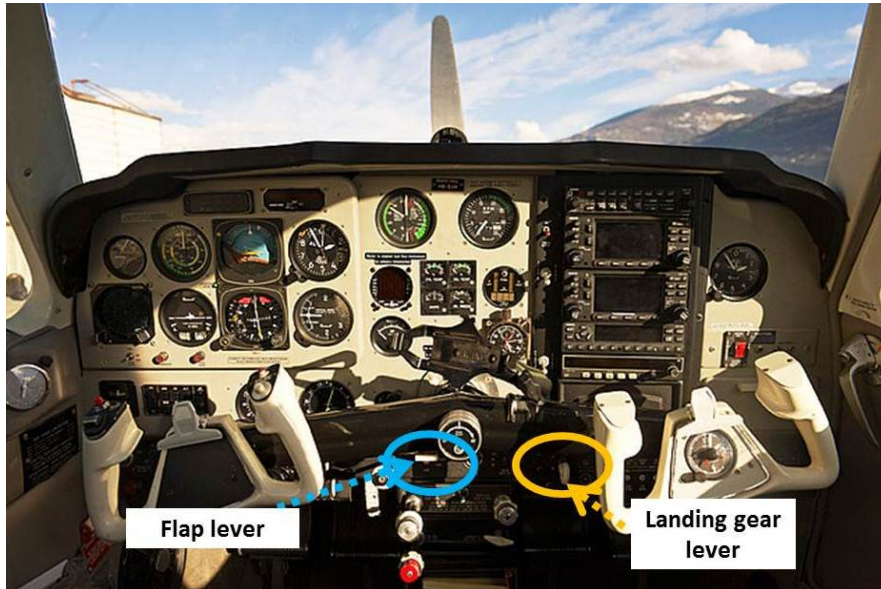
**Figure 1: Cockpit of a Beech Bonanza similar to VH-YEN**

The student had completed his recent training in a Cessna 182 aircraft, which had the flap lever located in a position similar to that of the landing gear lever in the Bonanza (Figure 1 and Figure 2).

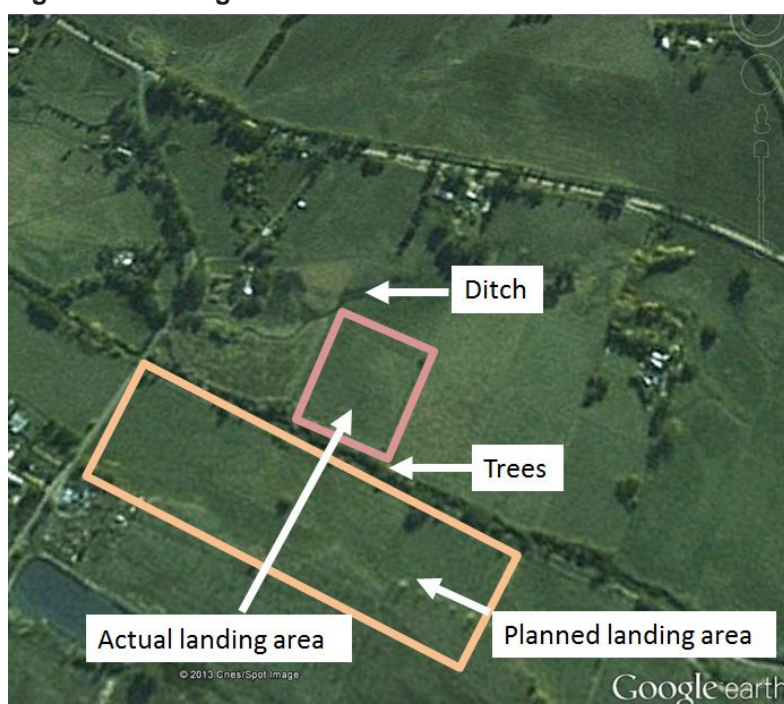
**Figure 1: Landing area**

The chief flying instructor reported that he had conducted a briefing with the pilot prior to the flight, including a discussion of the weather conditions, and a reminder regarding selection of a suitable landing area.

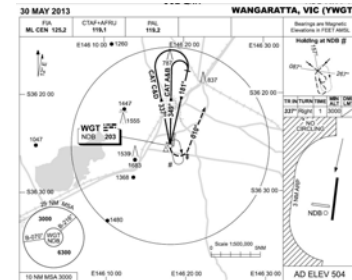
### Wangaratta NDB approach

The student of MAB continued the approach until about 1,000 ft above ground level,<sup>5</sup> overhead the NDB, he discontinued the approach and commenced a climb, maintaining runway heading.

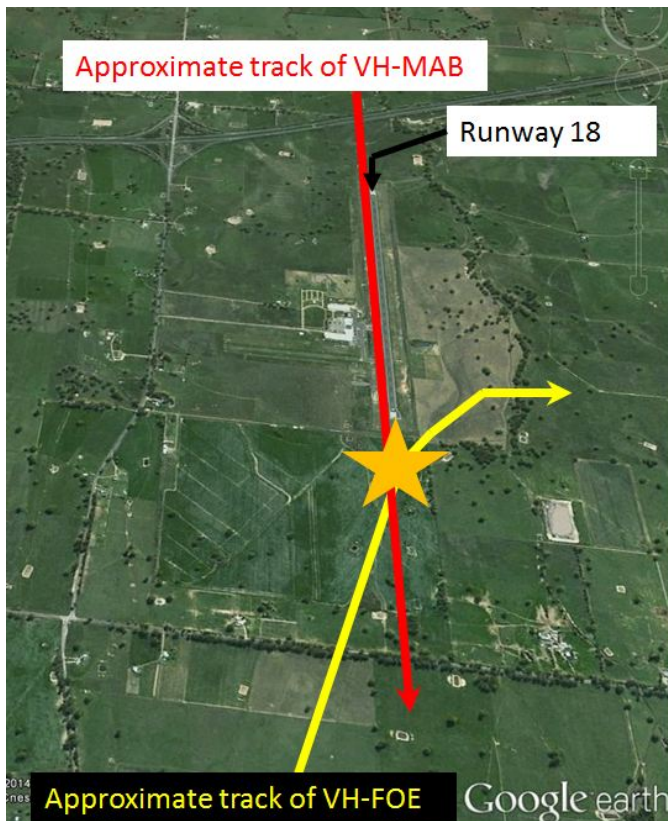
**Figure 1: Approximate aircraft tracks**

The pilot of FOE broadcast on the CTAF joining downwind, which was heard by the instructor of MAB. As MAB departed the area, the instructor also heard the pilot of FOE broadcast a base call on the CTAF and cancel SARTIME<sup>6</sup> with Melbourne Centre.
