Aviation Short Investigations Bulletin

Issue 31

ATSB Transport Safety Report
Aviation Short Investigations
AB-2014-085
Final – 17 June 2014

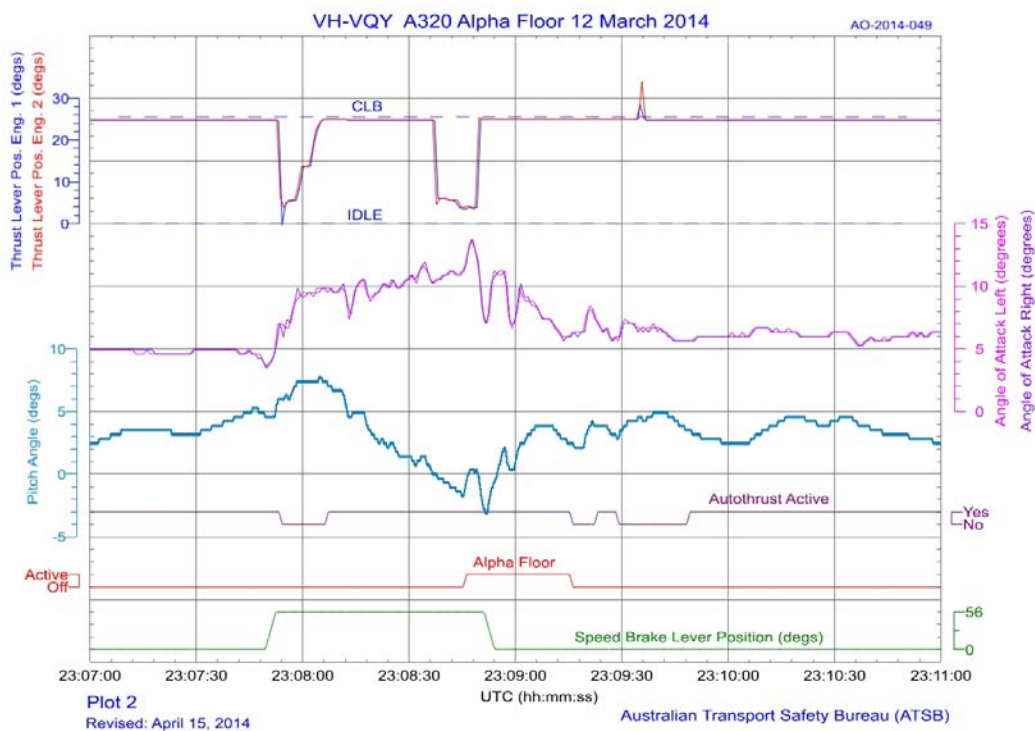
Figure 2: Thrust settings, angle of attack, pitch, speed brake and Alpha Floor

The aircraft then descended and the airspeed slowed below the V_{LS} speed: the lowest selectable speed that autothrust permits. The first officer then applied rearward pressure on the sidestick in an attempt to regain FL 380 and reduced the thrust levers towards idle, but short of the idle stop position. This limited the maximum amount of thrust available. The application of back pressure increased the aircraft's angle of attack. At the Alpha Protection speed,⁴ which corresponds with the angle of attack at which Alpha Protection becomes active, the Alpha Floor function activated. In that mode, the speed brakes retracted⁵ (Figure 2) and the take-off/go-around (TOGA) thrust lock was activated.

The first officer reported that the aircraft changed very rapidly from an overspeed to an Alpha Protection state, and this rate of change may have been due to a combination of the high altitude and the light weight of the aircraft. He observed the TOGA LOCK display on the electronic centralized aircraft monitoring (ECAM), but did not recall an ALPHA FLOOR annunciation on the Flight Mode Annunciator (FMA).

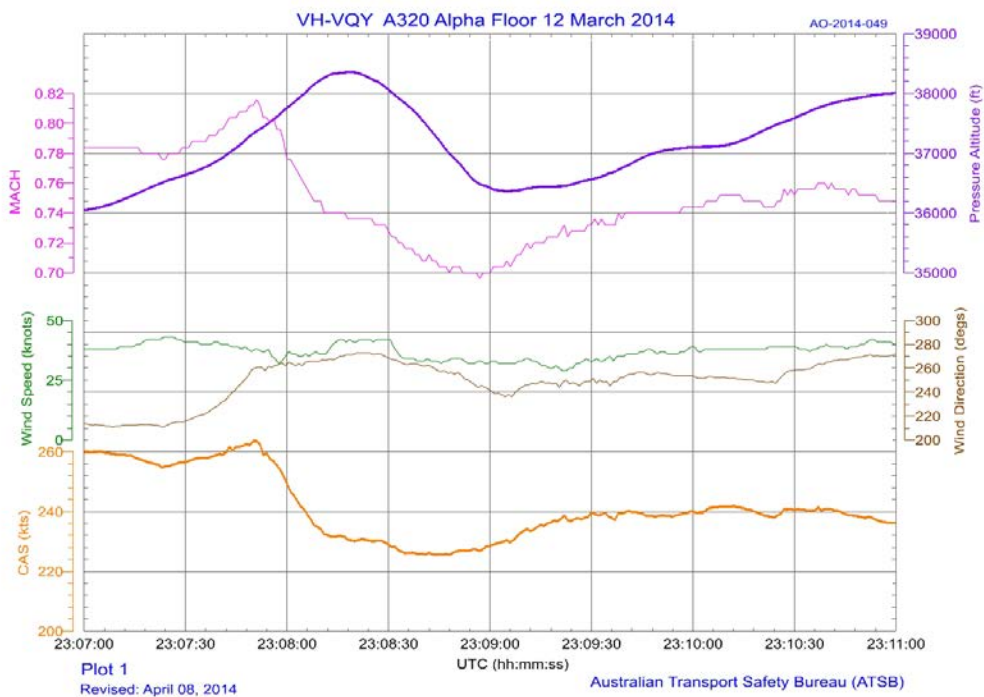
Figure 3: Altitude, Mach, Wind speed and CAS

The flight data indicated the following (Figure 3):

- During the climb, passing about FL 365, the wind shifted from a tailwind of about 20 knots to a headwind of about 15 kt, resulting in an effective 35 kt windshear on the aircraft. This resulted in a rate of climb of 3,005 fpm and a transient Mach increase.
- The computed airspeed (CAS) increased about 6 kt from 256 to 262 kt.
- The Alpha Floor activated when the aircraft was on descent passing about FL 370, at a CAS of 226 kt, thrust levers just above the idle stop with autothrust disconnected, and the aircraft descending at about 4,500 fpm.

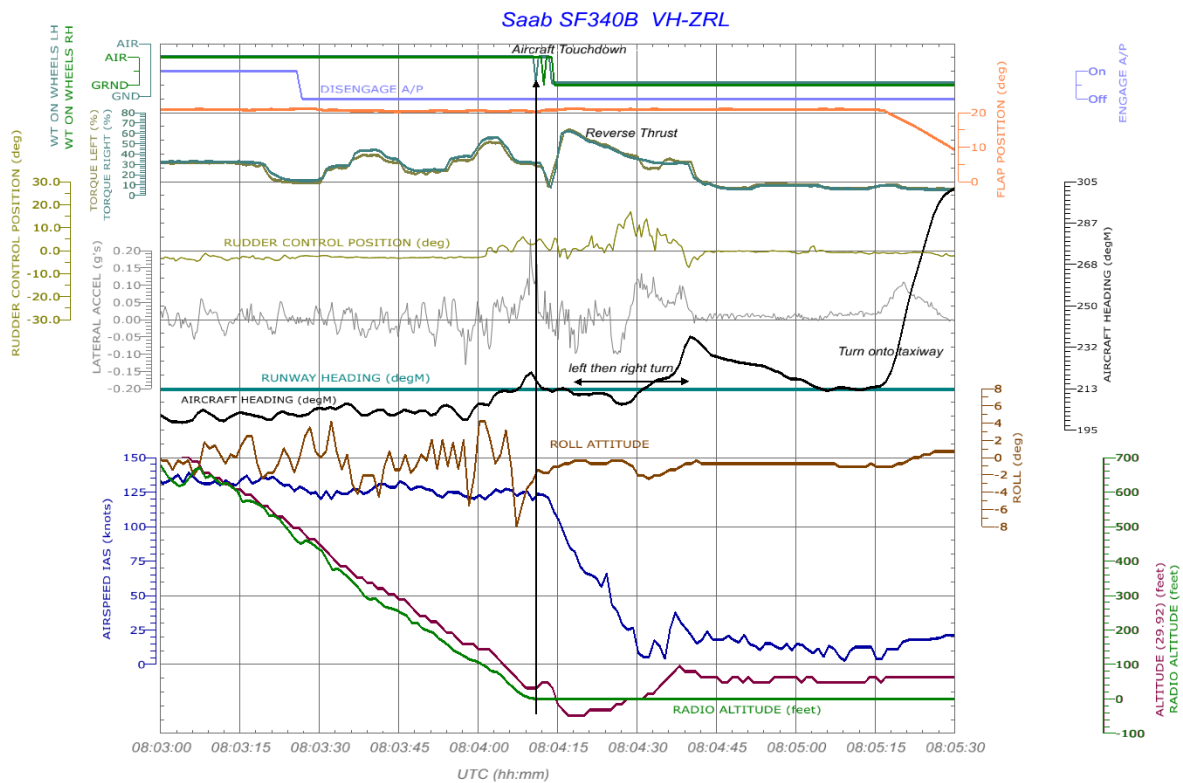
Figure 4: Summary of flight data

The aircraft was fitted with a flight data recorder (FDR) and following the incident, the data was downloaded and provided to the ATSB. The recorded data (Figure 4) showed that, during final approach, the aircraft's heading was less than the published runway heading, indicating that the aircraft was experiencing a crosswind from the left. When at about 800 ft, the calculated crosswind component was about 30 kts and decreased to about 13 kt when at about 100 ft.⁷ At 1904:08, just prior to touchdown, the aircraft rolled left by about 8° and right rudder was applied. The aircraft rolled back to the wings level position.

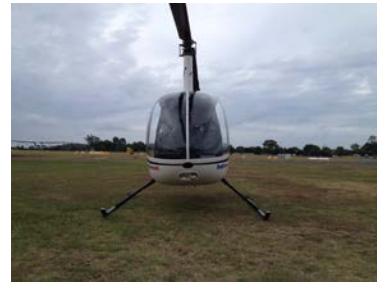
VH-YZO

The instructor again exited the helicopter and conducted a walk-around inspection with no damage observed. After a further demonstration by the instructor, the student completed the sequence twice more. The instructor and student then conducted further training exercises and subsequently concluded the flight. After landing, the instructor detected that the helicopter was leaning to the right. He exited the helicopter and observed that the landing skid was damaged (Figure 1). The instructor then taxied the helicopter to the hangar for an engineering inspection.
