Terrain awareness warning system alert involving Eurocopter BK 117C-2, VH-SYB

near Crookwell, New South Wales | 21 October 2016

ATSB Transport Safety Report
Aviation Occurrence Investigation
AO-2016-160
Final – 6 November 2018

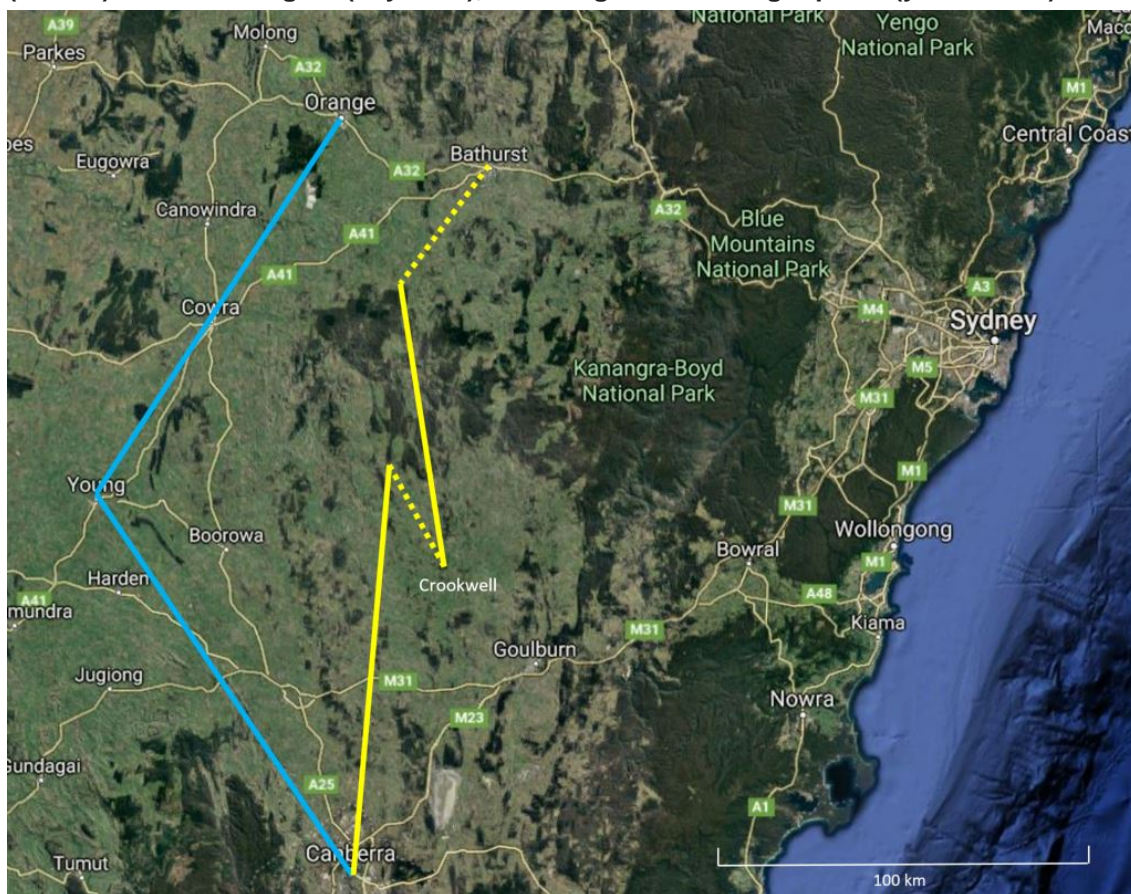
Figure 1: VH-SYB’s approximate flight path for outbound flights from Orange to Canberra (in blue) and return flights (in yellow), including diversion flight paths (yellow dots)

The flights between Orange, Young, Canberra Hospital and the operator's Canberra base (Figure 1) were planned and conducted under day visual flight rules (VFR) in visual meteorological conditions.⁸ No weather-related difficulties were reported to have occurred during those flights.

Approximately 20 NM north-west of Crookwell the pilot determined that the weather conditions were no longer suitable for continuing the flight due to closing gaps between the storms and reduced visibility ahead. After some discussion between the pilot, ACM and paramedic regarding suitable diversion sites, it was decided to divert to the Crookwell Medical helicopter landing site (HLS) (Figure 1).

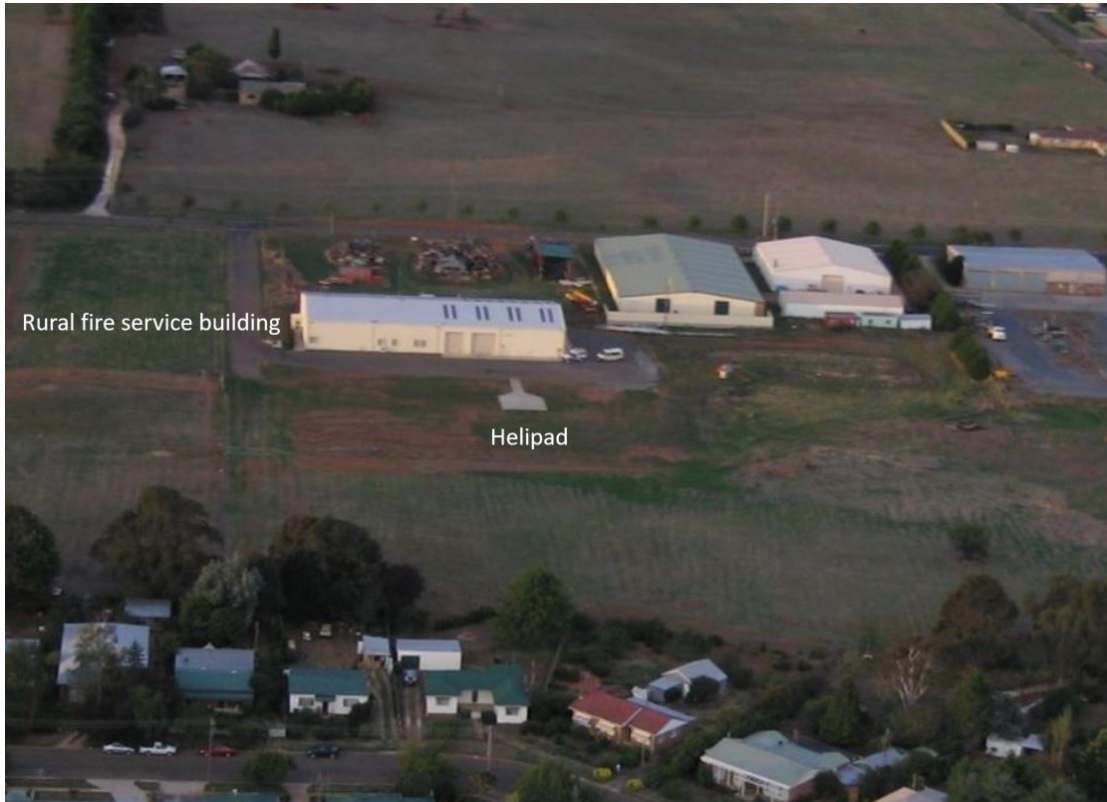
Figure 4: Crookwell Medical helicopter landing site

Crookwell Medical HLS (Figure 4), located to the northern side of the Crookwell Township, and was operated by the Crookwell Rural Fire Service (RFS). The HLS had no published IFR arrival or departure procedures. Its elevation was 2,840 ft and no weather information was available for the site. The concrete helipad was not equipped with standard pad lighting, although general floodlighting was available for night operations upon request to an RFS duty officer. Fuel and rest facilities were available, but there was no sleeping accommodation.
