FINAL REPORT
A - 051/CENIPA/2016

OCCURRENCE:	ACCIDENT
AIRCRAFT:	PP-MBN
MODEL:	AS-350B
DATE:	21MAR2016

This is the Final Report of the 21MAR2016 accident with the AS-350B aircraft, registration PP-MBN. The accident was classified as “Fuel Exhaustion”.

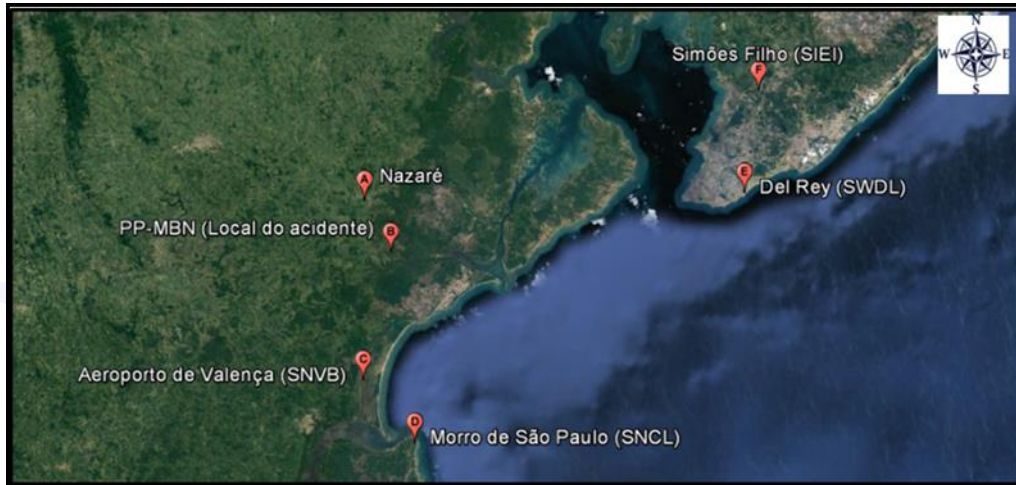
Figure 14 - Region in which the aircraft had operated in the last days.

According to information gathered through the Civil Aviation System, since the 10JAN2016, the aircraft already operated in the region among the cities of Salvador, Simões Filho, Morro de São Paulo, Nazaré and Valença (Figure 14).
