COMANDO DA AERONÁUTICA
CENTRO DE INVESTIGAÇÃO E PREVENÇÃO DE
ACIDENTES AERONÁUTICOS

FINAL REPORT
A-103/CENIPA/2013

OCCURRENCE:	ACCIDENT
AIRCRAFT:	PR-DJC
MODEL:	EC 130 B4
DATE:	30MAY2013

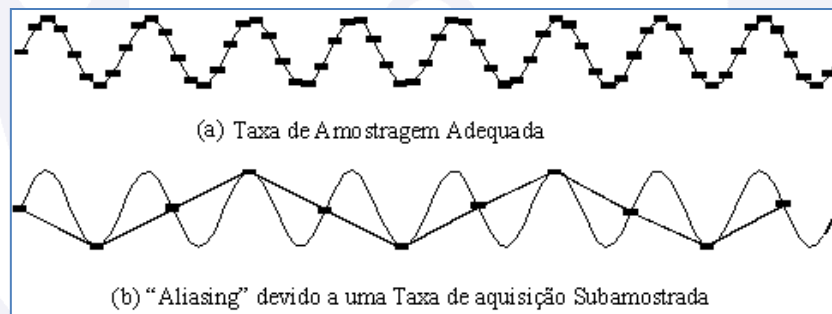
Figure 4 (a) – Appropriate acquisition rate.

Figure 4 (b) – "Aliasing" due to subsampled acquisition rate.

A very low sampling rate deforms the analog input signal (Figure 4(b)) and shows different frequency and amplitude.

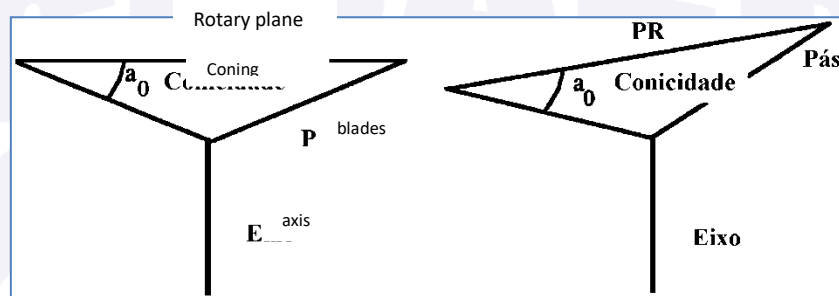
Coning is the upward bending of the blades caused by the combined forces of lift and centrifugal force. Before takeoff, centrifugal force causes the blades to rotate in a plane nearly perpendicular to the rotor hub. During a vertical liftoff, the blades assume a conical path as a result of centrifugal force acting outward, and lift acting upward. The coning angle (α_0) is the angle between a rotor blade and the rotary plane (Figure 5). It keeps constant, even if the rotary plane is not perpendicular to the axis. It just varies by changing the blades collective pitch. Such description is valid for stabilized rotation condition.

Figure 5 - Coning angle.

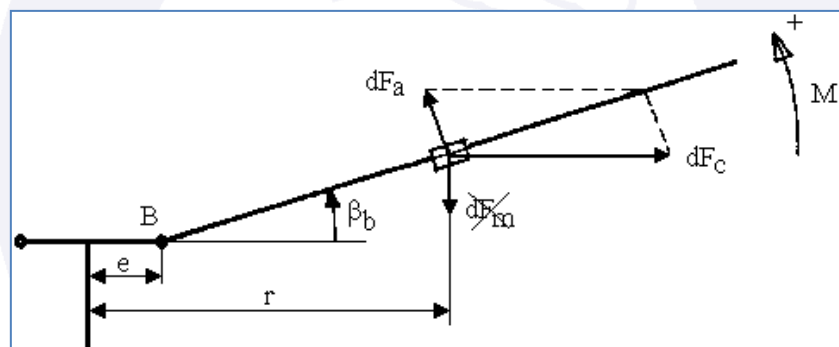
Figure 6 - Forces acting on main rotor blades.

- dF_c is the centrifugal force obtained by $\Omega^2 r dm$;
- dF_m is the weight obtained by $g dm$; and
- dF_a is the lift force, which depends on the type of flight (hovering or forward flight).

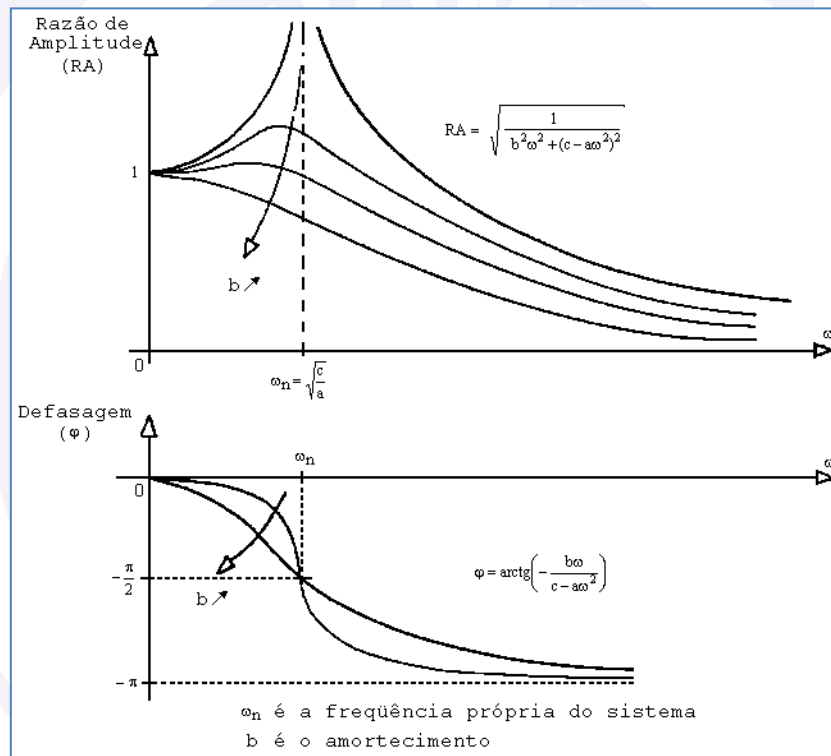
Figure 7 - Blades beat response.

By solving the β_b equation and analyzing the graph (Figure 7), the following conclusion is possible:
