**AVIATION INVESTIGATION REPORT  
A13H0002**

**COLLISION WITH WATER**

**GOVERNMENT OF CANADA, DEPARTMENT OF TRANSPORT  
MBB BO 105 S CDN-BS-4 (HELICOPTER) C-GCFU  
M'CLURE STRAIT, NORTHWEST TERRITORIES  
09 SEPTEMBER 2013**

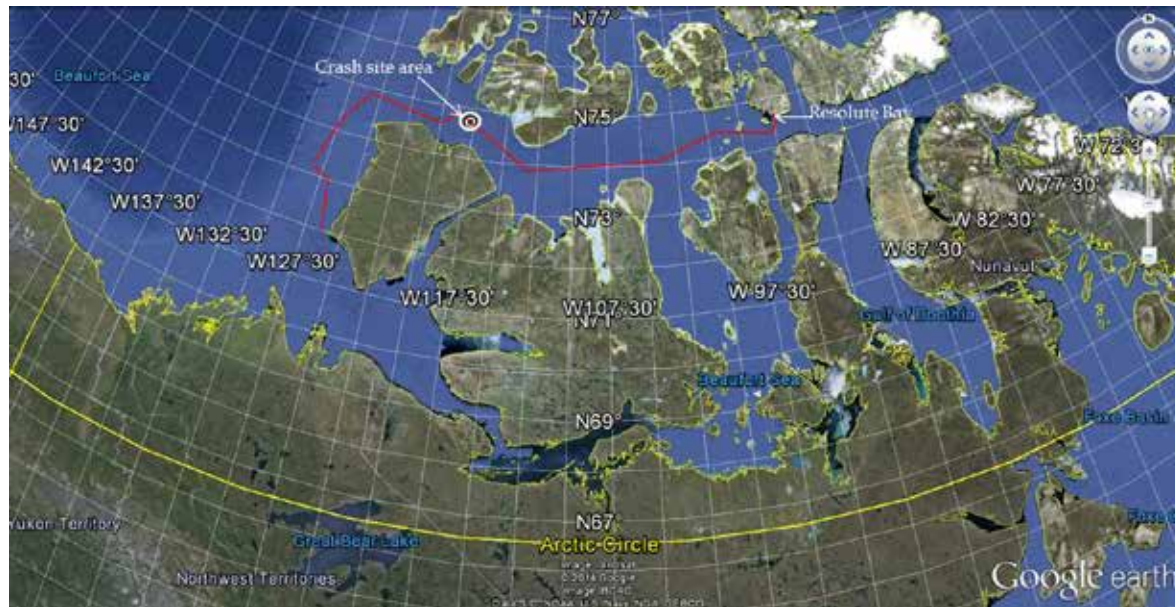
Figure 1. CCGS *Amundsen's* approximate planned route from Resolute Bay (Google Earth, with TSB annotations)

The following day, the CCGS *Amundsen* departed its anchorage at Resolute Bay with 73 people on board for the second leg of the ArcticNet Beaufort Regional Environmental Assessment (BREA) research program.<sup>2</sup> The planned route for this portion of the second leg was to continue westbound along the northern shore of Banks Island, Northwest Territories, and then descend along the western coast of the island to perform the next scientific research activities (Figure 1).

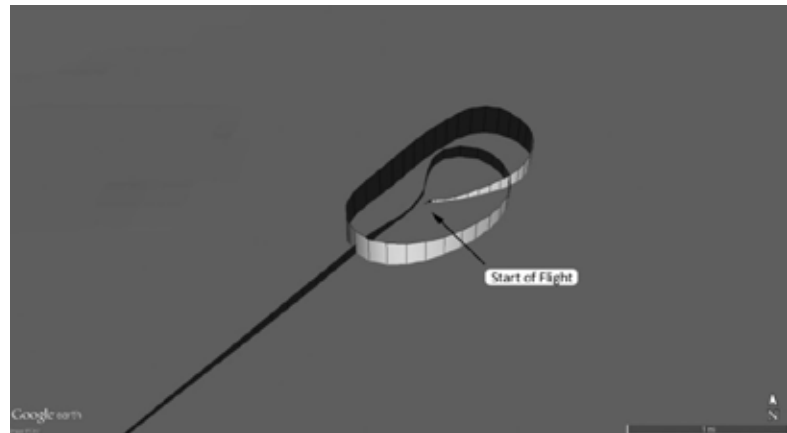
Figure 2. Plot of flight track on departure from the vessel  
(Source: Google Earth, with TSB modifications and annotations)

approximately 20 feet above the surface of the ice – as it proceeded southwest for about 24 minutes (Figure 2). Two survey runs were conducted during this first leg.

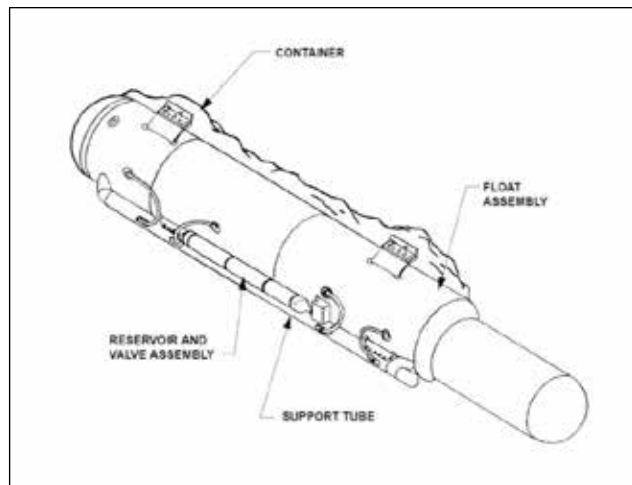
Figure 4. Float subsystem general arrangement  
(Source: Air Cruisers, BO-105 Float Subsystem, Part Numbers D24873-101, D24873-102, *Component Maintenance Manual with Illustrated Parts List*, Revision No. 11 [18 January 2010], p. 5)

The helicopter was equipped with a flotation system<sup>24</sup> designed to enable an emergency water landing and to keep the helicopter afloat. The floats can be deployed in flight at altitudes of 3000 feet or less and at airspeeds of 80 knots or less. Once deployed, the airspeed is limited to a maximum of 100 knots. The flotation system consists of a left-hand and right-hand float subsystem attached to the helicopter's skids (Figure 4).

Both float subsystems remained attached to the helicopter during the accident sequence and were found within their respective containers. Both reservoirs that store nitrogen were charged within the manufacturer's specification. With the exception of damage related to impact and water submersion, no anomalies or pre-existing defects were noted that would have prevented the flotation system from operating normally. There was no indication that the flotation system was activated prior to or at the time of the impact. A review of the maintenance records indicated that both float subsystem

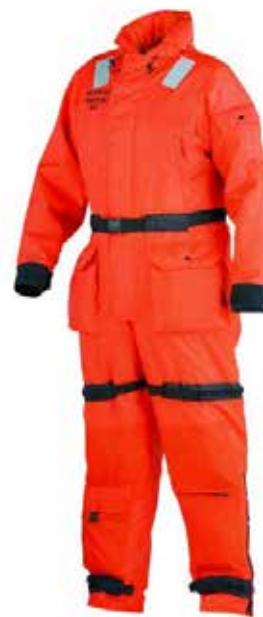
Figure 7. MS2175 TC suit  
(Source: Mustang Survival)

Both the master and the scientist were wearing a Mustang Survival model MS2175 TC helicopter transport suit (Figure 7), which is approved by ASD/CCG for use as an immersion suit. However, this model is not certified to any standard and has an insulation value of 0.4 clo in still water. This suit is based on Mustang Survival's original floater suit concept with modifications to assist the wearer in a safe egress from a ditched helicopter. Compared to the floater suit, the helicopter transport suit has less buoyancy, which allows for safe egress, and has additional anti-exposure protection that affords the wearer increased in-water survival time. Mustang Survival advises that buoyancy should be enhanced by adding a manually inflatable life preserver. According to the manufacturer, this product is intended to provide flotation and hypothermia protection in the event of cold water immersion.

The MS2175 TC suit is equipped with a neoprene hood and 3-fingered lobster-claw-style gloves, which are stored in the 2 integral calf pockets. The suit's wrist and ankle cuffs are equipped with a hook-and-loop type attachment to allow for individual adjustment. The suit design allows for water ingress at the neck and at the wrist and ankle cuff locations.

The suits are supplied in sizes ranging from extra small to triple extra-large. Both the master and the scientist were wearing a large (42-46 inch) suit. Based on the suit's sizing chart and the fact that both individuals were wearing winter clothing, the large size would have been appropriate. No donning/doffing instructions are provided with the suit.

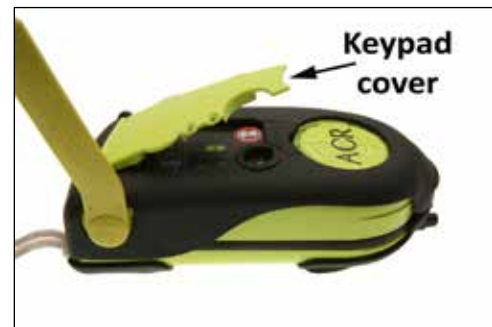
Figure 9. Aerofix 406 GPS/IO, model PLB-200

The 3 occupants' PFDs were equipped with a waterproof<sup>69</sup> PLB (Aerofix 406 GPS/IO, model PLB-200) manufactured by ACR Electronics Inc. (Figure 9).

The PLB is designed to be manually deployed and activated. To activate the PLB, the antenna must be unfastened<sup>71</sup> from the case and moved into the upright position. The operator must then lift the cover to reveal the keypad and press the self-test and GPS I/O buttons simultaneously for at least ½ second and less than 5 seconds. To ensure proper operation, the antenna needs to be unobstructed, with a clear view of the sky; therefore, it cannot be covered by anything such as clothing, survival equipment, or water. According to the manufacturer, it is important to keep the antenna dry and away from the water for best results. Water detracts from the PLB's performance and reduces its effectiveness.

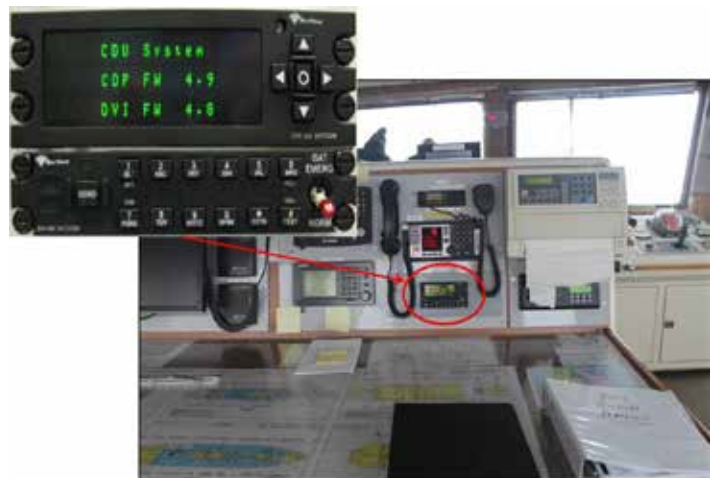
Figure 10. Location of FFS CDU user interface at chart table

Vessel officers and helicopter pilots can obtain each other's position information using the FFS through a control display unit (CDU) that combines 2 units—a CDP300 (serial number 104-300-01) and a DVI300 (serial number 105-300-01). On board the helicopter, the CDU is located at the bottom center of the instrument panel. On the CCGS *Amundsen*, the CDU is located at the chart table on the aft, starboard side of the wheelhouse (Figure 10).
