Endelig rapport HCLJ510-000387

Rapport over hændelsen med Diamond DA 40D OY-RBB ved Roskilde den 7. juni 2007.

FINAL REPORT

HCLJ510-000387	Incident		
Aircraft type:	Diamond DA 40D	A/C Registration:	OY-RBB
Engine:	Thielert TAE 125-01	Type of flight:	Test flight, VFR
Crew:	1- no injuries	Passengers:	1 - no injuries
Place:	1 nm west of Copenhagen Airport, Roskilde (EKRK)	Date and time:	07.06.2007 1330 UTC

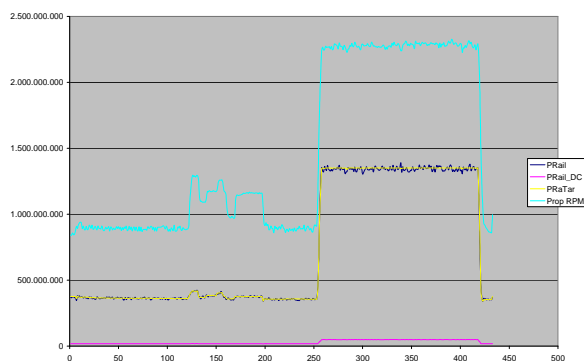
The full power test with new pumps installed showed one drop in fuel rail pressure, see graph below right.

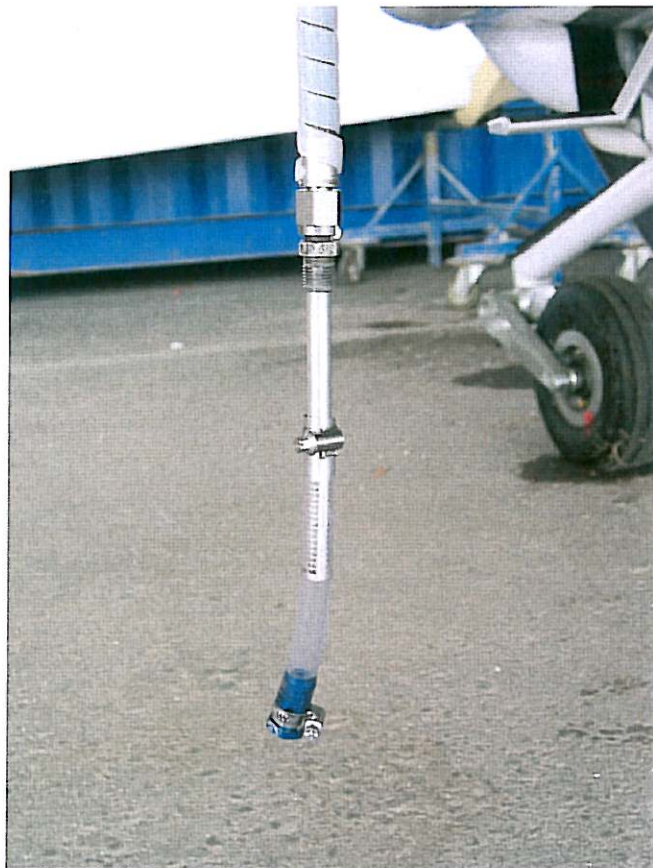
Picture 1 sealed finger filter of the main tank

The finger filter was taken out of the main tank and connected to the fuel system connector of the fuselage, see **Picture 1**. The finger filter was covered with a plastic tube with its end sealed.

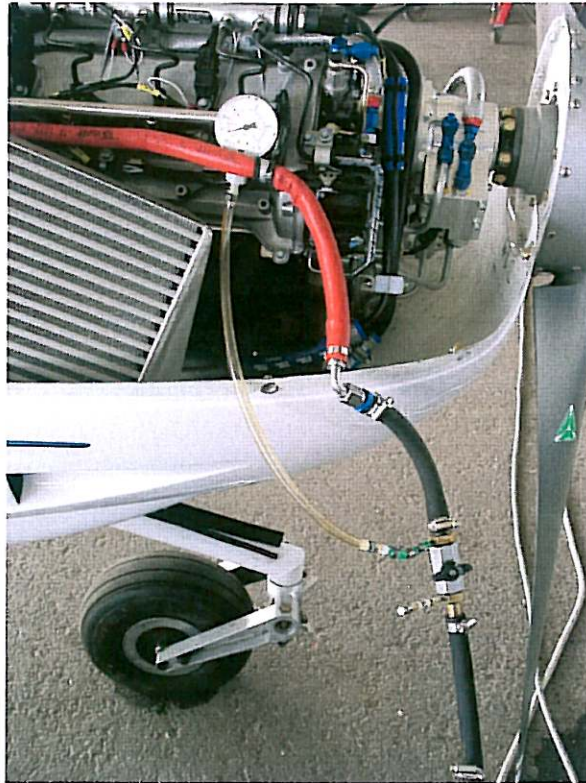
Picture 2 connection to the low pressure pump

Picture 2 shows the connection to the low pressure pump. A shut off valve was connected to the fuel hose which also had a connection to a pressure gauge. A low pressure of -0,8 bar has been applied. The shut off valve was closed and the increase of the pressure has been observed (**Picture 3**). Two hours after the beginning of the test the pressure increased about 50 mbar.

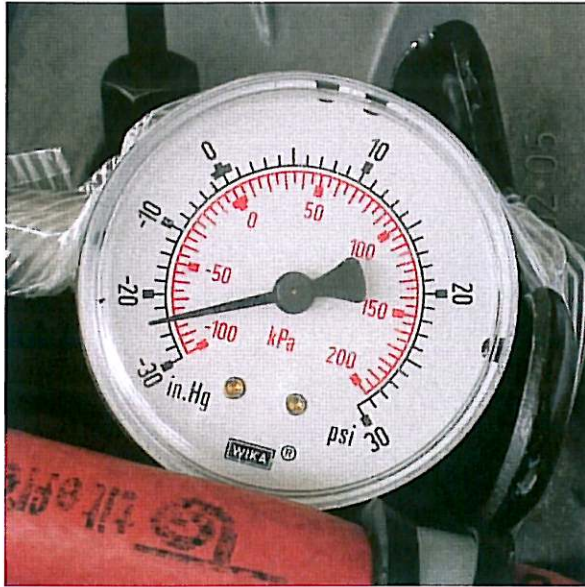
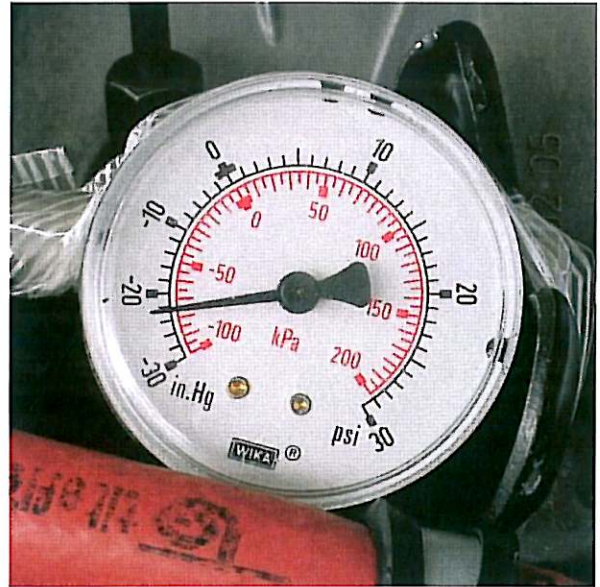
Picture 3 low pressure gauge at the beginning of the test (left) and 2 hours later (right).

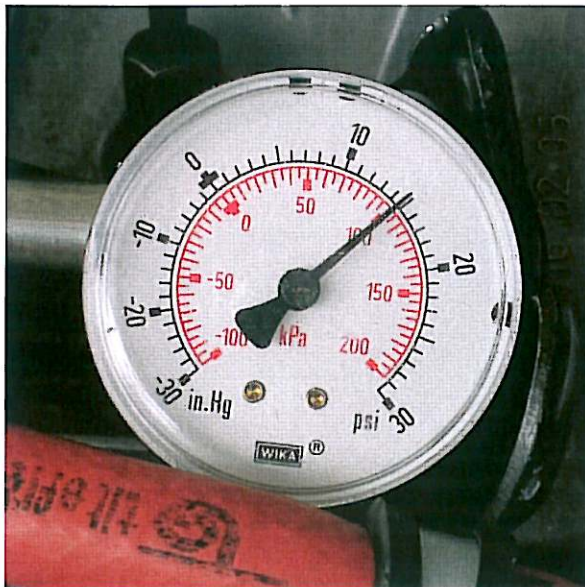
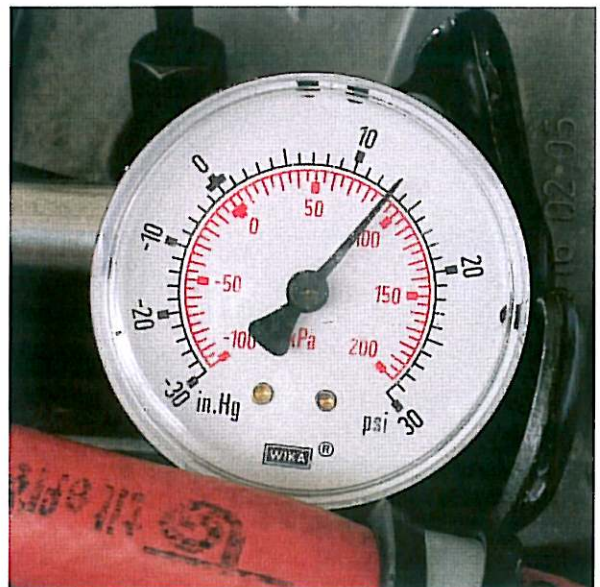
The test was made without the vibrations of the engine. When low pressure is applied to a system, loose and leaky parts can be leak tight because the over pressure of the surrounding atmosphere presses them together. These leakages can be identified by applying positive pressure, because loose parts are pushed away from each other. Therefore a second test of the fuel system with a positive pressure of 1 bar was conducted (**Picture 4**). 5,5 hours after the beginning of the test the pressure decreased about 0,1 bar.

Picture 4 overpressure gauge at the beginning of the test (left) and 5,5 hours later (right).

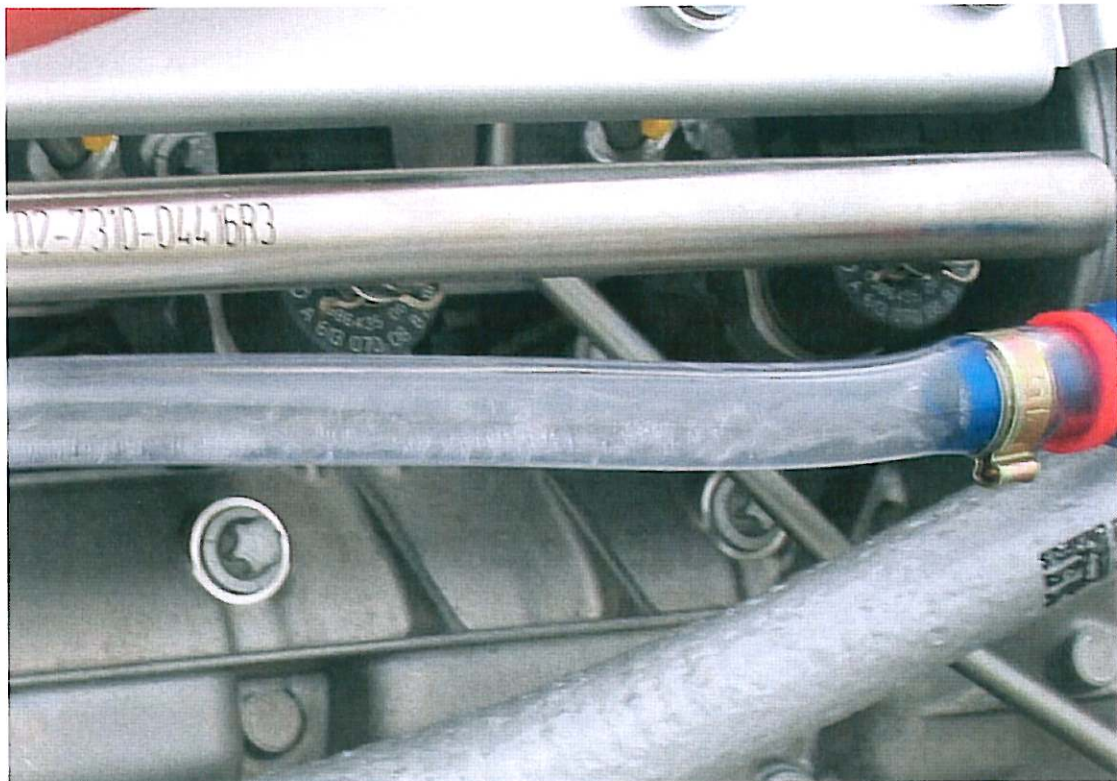
During the test the air quantity has been increased continuously up to the last mark of the measuring scale (814 ml/min). When opening the regulating valve totally the levitation ball of the rotameter could be lifted a little bit higher up to the end of the rotameter tube. Interpolating the additional measuring range it can be assumed that the maximum airflow was about 870 ml/min. **Picture 2** shows that the air forms a thick air tube in the center of the transparent tube.

Picture 2 Air contamination in the fuel at 80% power setting and 2,55 l/min fuel flow

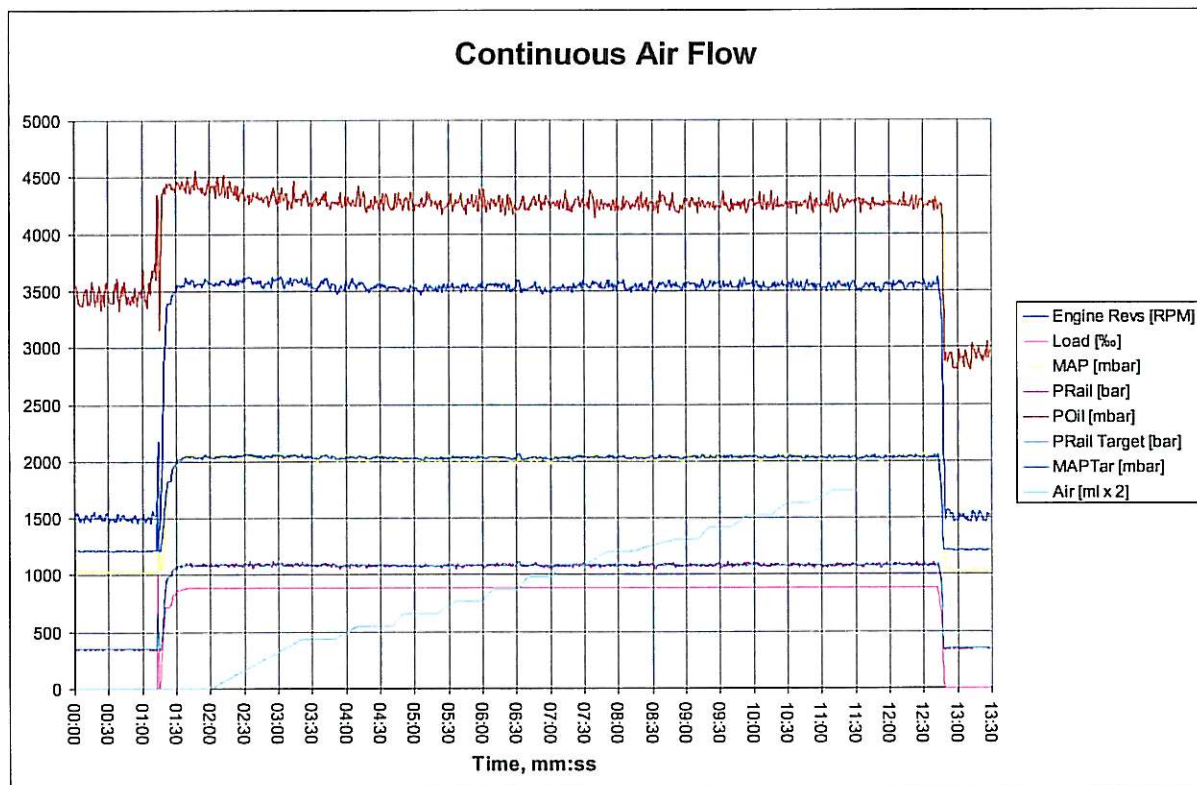
Picture 3 shows a diagram with the most relevant parameters of a test run performed at 80% power setting. It can be seen that no fluctuations or other conspicuities occurred.

Within these 13 minutes the air flow has been increased from 0 to about 870 ml/min in steps of about 56 ml/min. The fuel flow was 2,55 l/min.

The engine did not show any response to the introduction of air. The engine kept on running smoothly. No rough running or shuddering occurred. No ECU A or B warning came up. There are no entries of a low p-Rail warning in the event log.

Picture 3 Continuous introduction of air starting with 0 l/min at 01:30 up to about 870 ml/min at 11:30

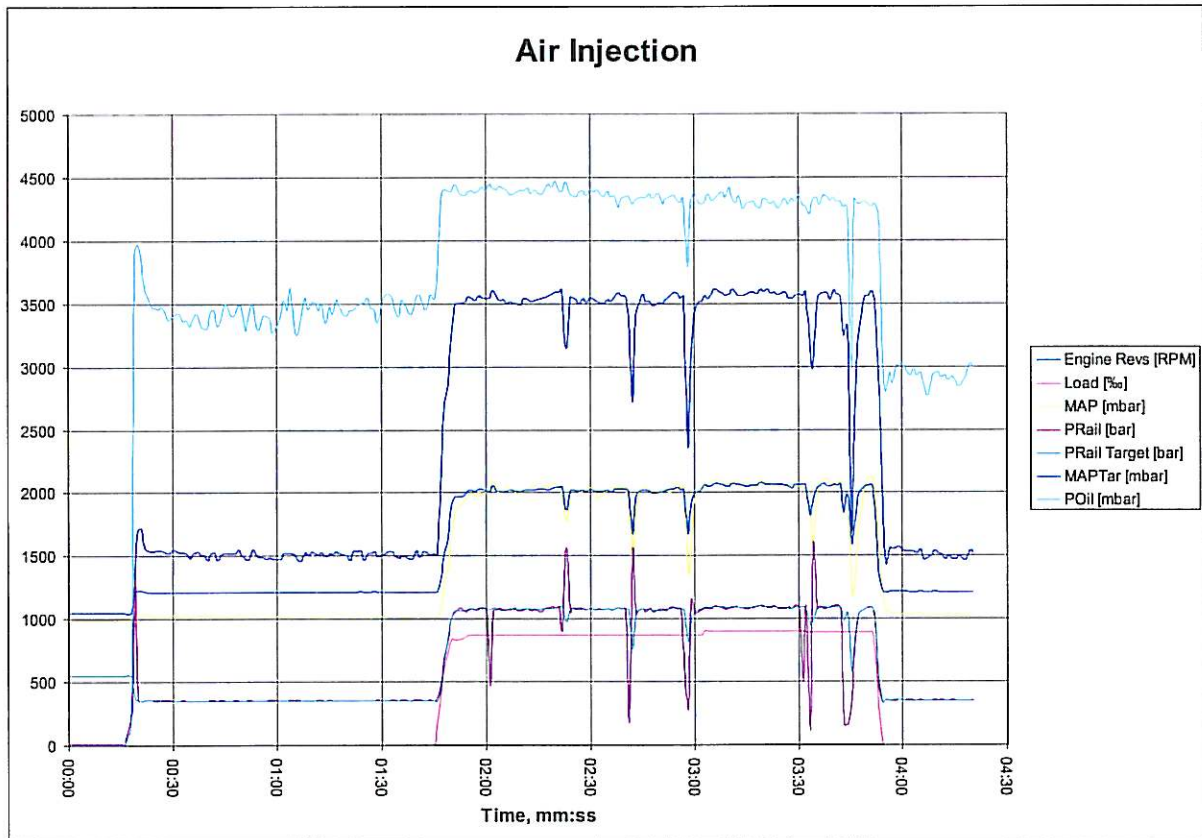
Picture 5 Injection of 50ml at 02:00, 70ml at 02:23, 100ml at 02:40 and 03:00

The first test run which is shown in **Picture 5** was performed with a single injector of 100 ml. It was started with an injection of 50 ml at 02:00 without a decrease of the RPM. But it can be seen that the rail pressure dropped. This was followed by an injection of 70ml at 02:23 with a slight decrease of the RPM and a slight drop of the rail pressure. Two injections of 90 ml each at 02:40 and 03:00 caused the RPM and the rail pressure to drop significantly. But the engine was able to recover every time. A remarkable detail is that in the majority of cases the drop of the rail pressure is followed by a compensating positive peak.

The **Pictures 5 and 6** (air injection during ground run) show very clearly that the drop of the rail pressure is followed by a sudden increase of the rail pressure above the actual level.

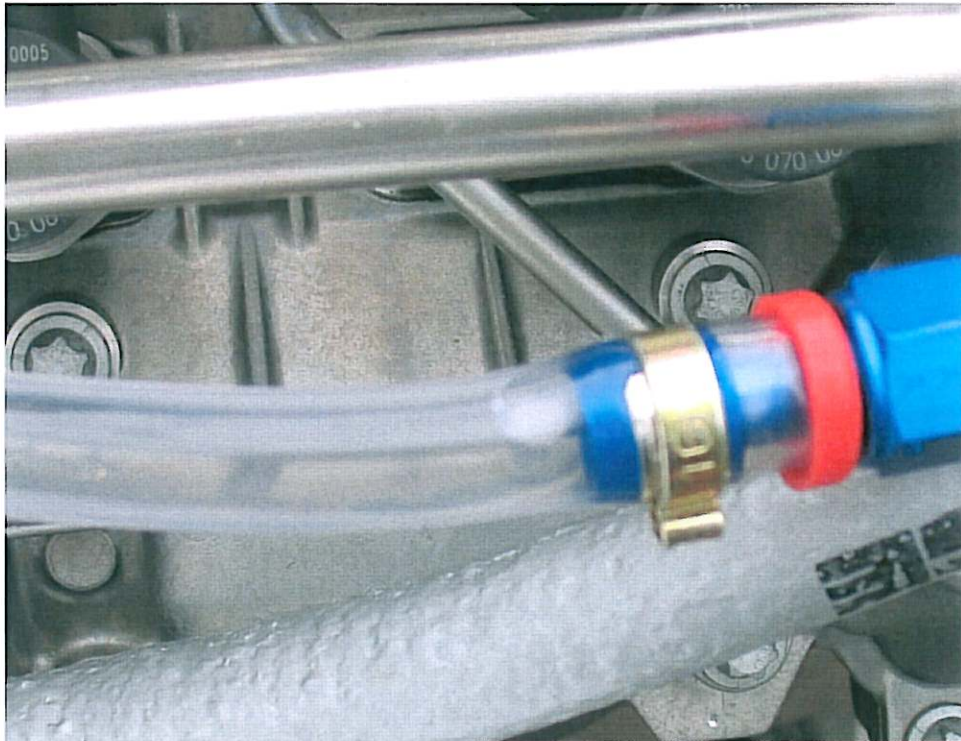
Again the negative peak of the rail pressure is followed by a positive peak. **Picture 7** shows the end of a long air bubble of 120 ml. Behind the air bubble the transparent tube was completely filled with fuel again.

Picture 7 The end of a long air bubble of 120ml

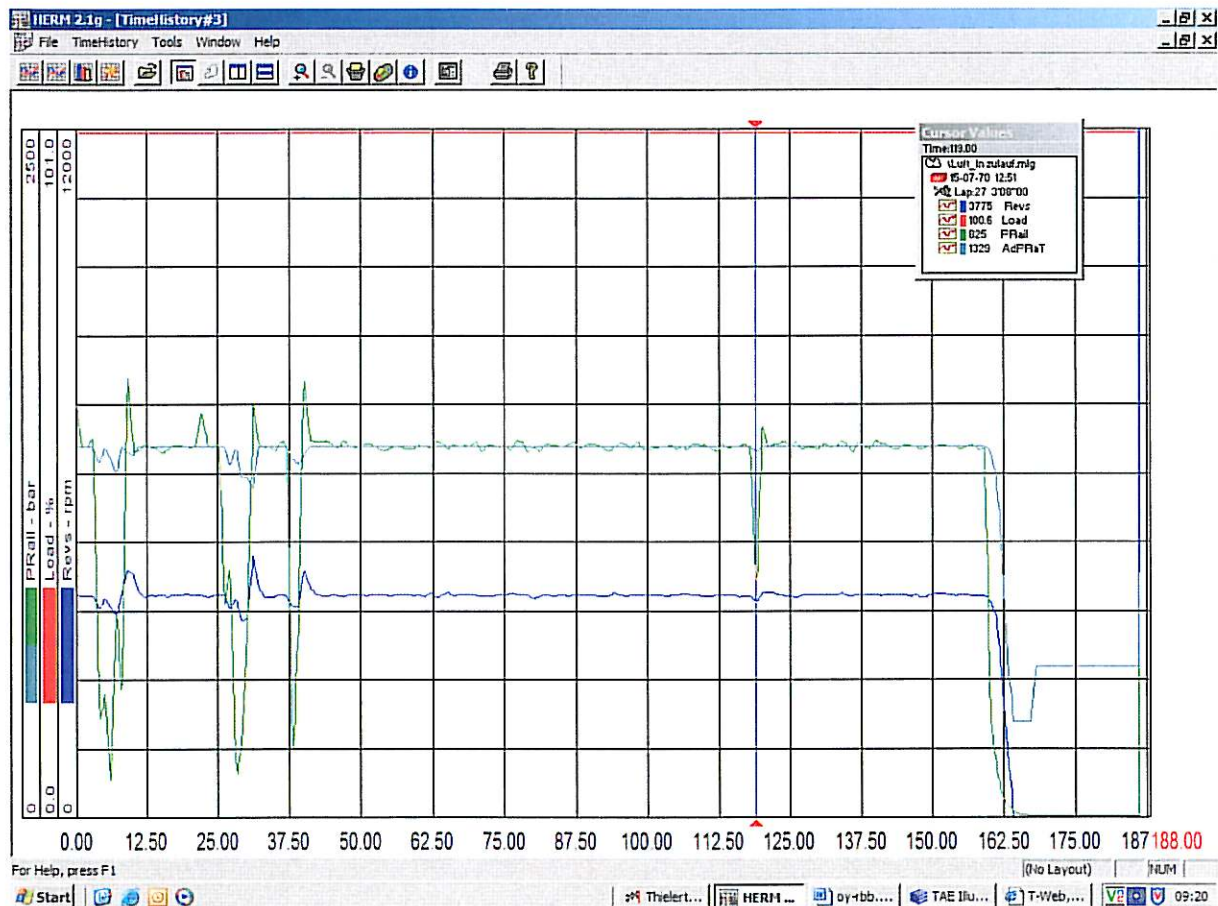
The same characteristics of the rail pressure can be found in **Picture 8**, the chart of a TAE bench test with air in the fuel system. Again negative peaks are followed by positive peaks.

Picture 8 TAE engine test with air in the fuel, taken from TAE Occurrence Investigation Report OY-RBB

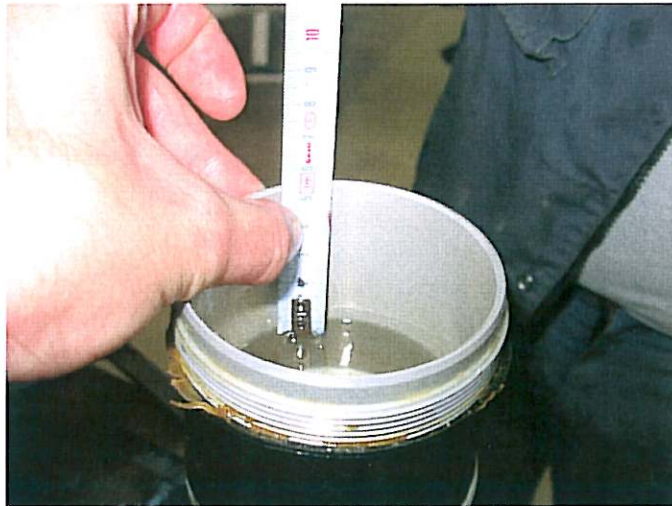
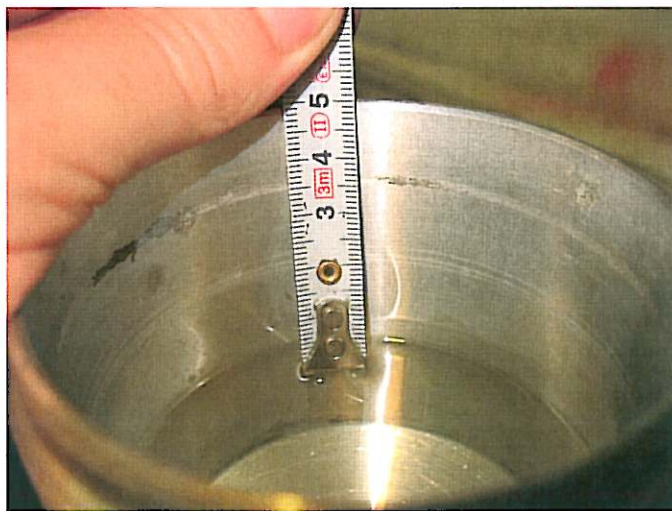
Picture 10 shows this situation. These are fuel filter housings of two DA 40 D´ s which were maintained at DAI-M at the time when the ground and flight tests have been conducted. Both show a normal fuel filter level, as it is calculated above.

Picture 10 Fuel filter housings after removing the fuel filter

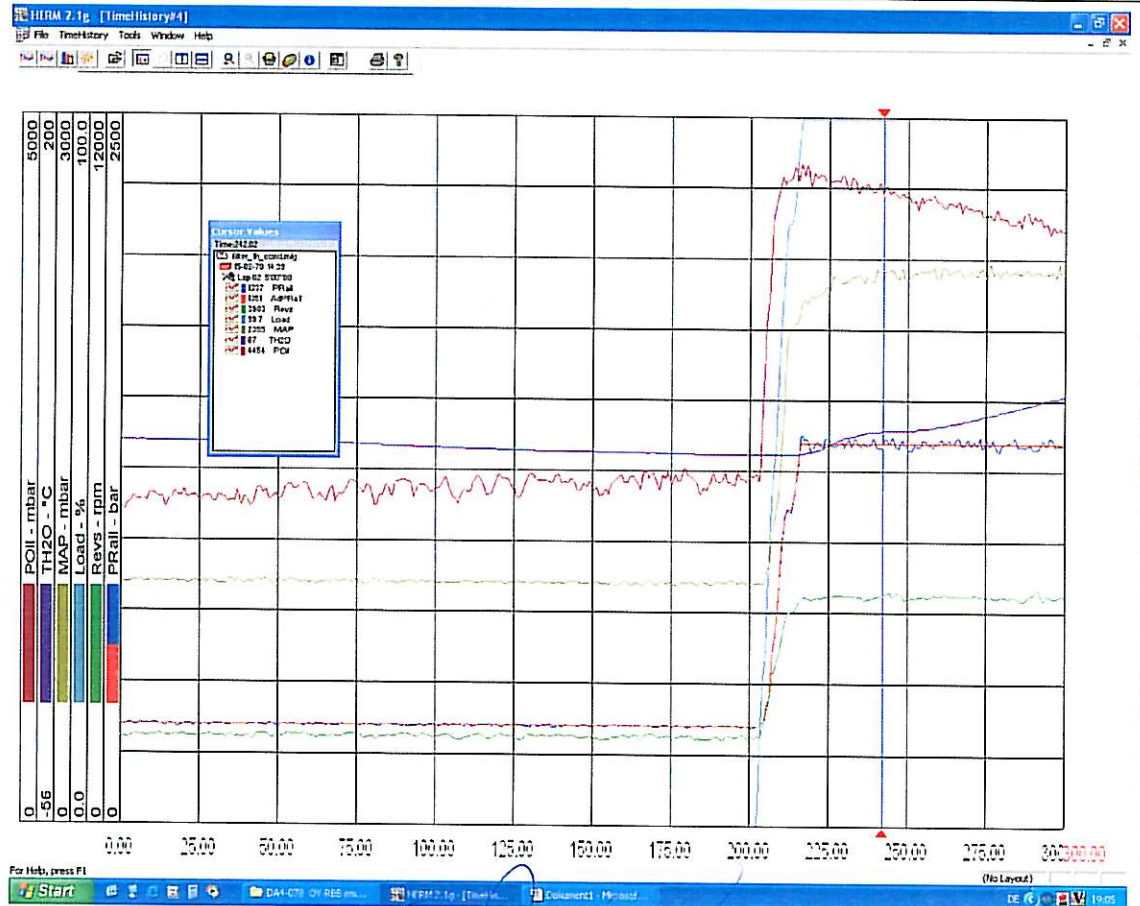
This chart shows a continuous introduction of air during a ground test. The airflow was started with 600 ml/min at about second 250 and was raised continuously. The coolant temperature rose quickly due to the lack of cooling air during the ground test. This chart is continued on the next page.

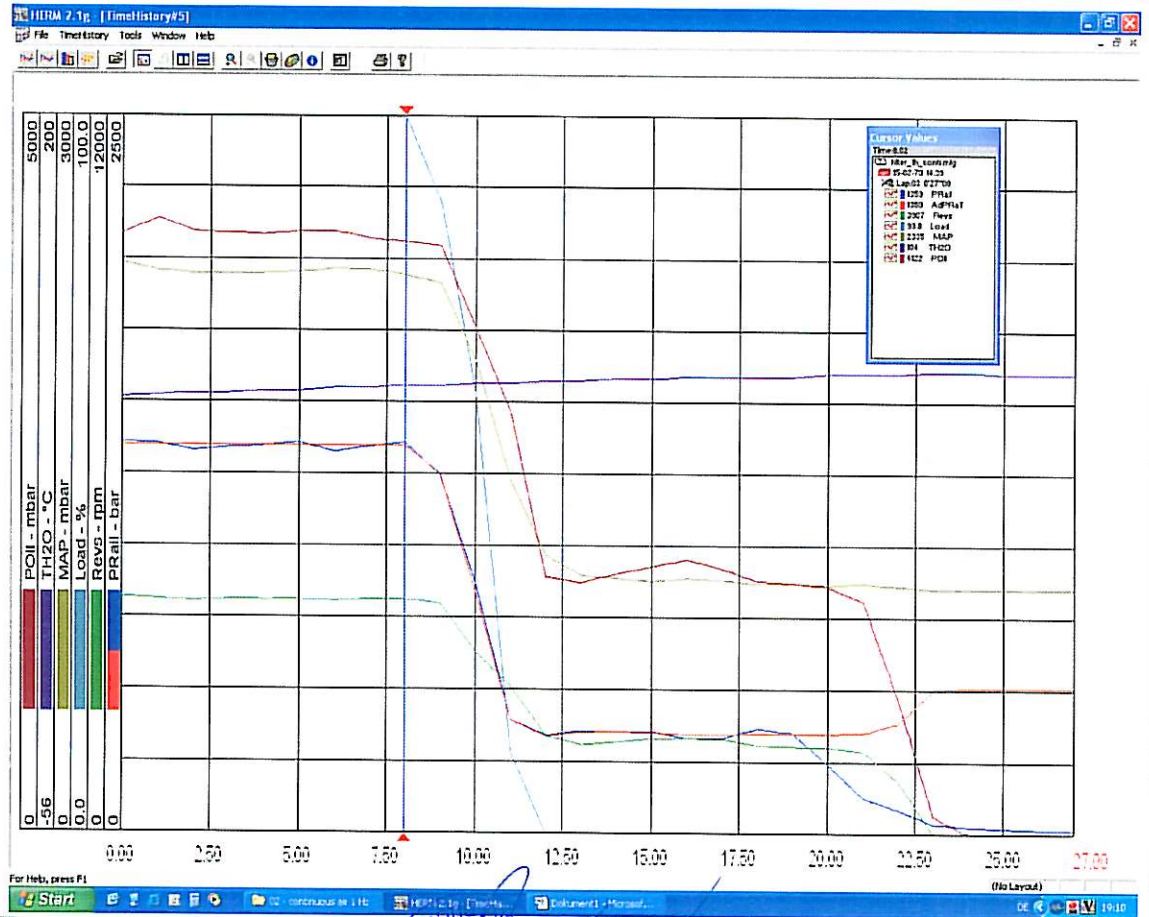
Due to overheat the power had to be reduced after 60 sec. By then the air flow has been raised continuously up to about 2000 ml/min. The air did not show any noticeable influence on the engine. The rail pressure was recorded with a sample rate of 1Hz.

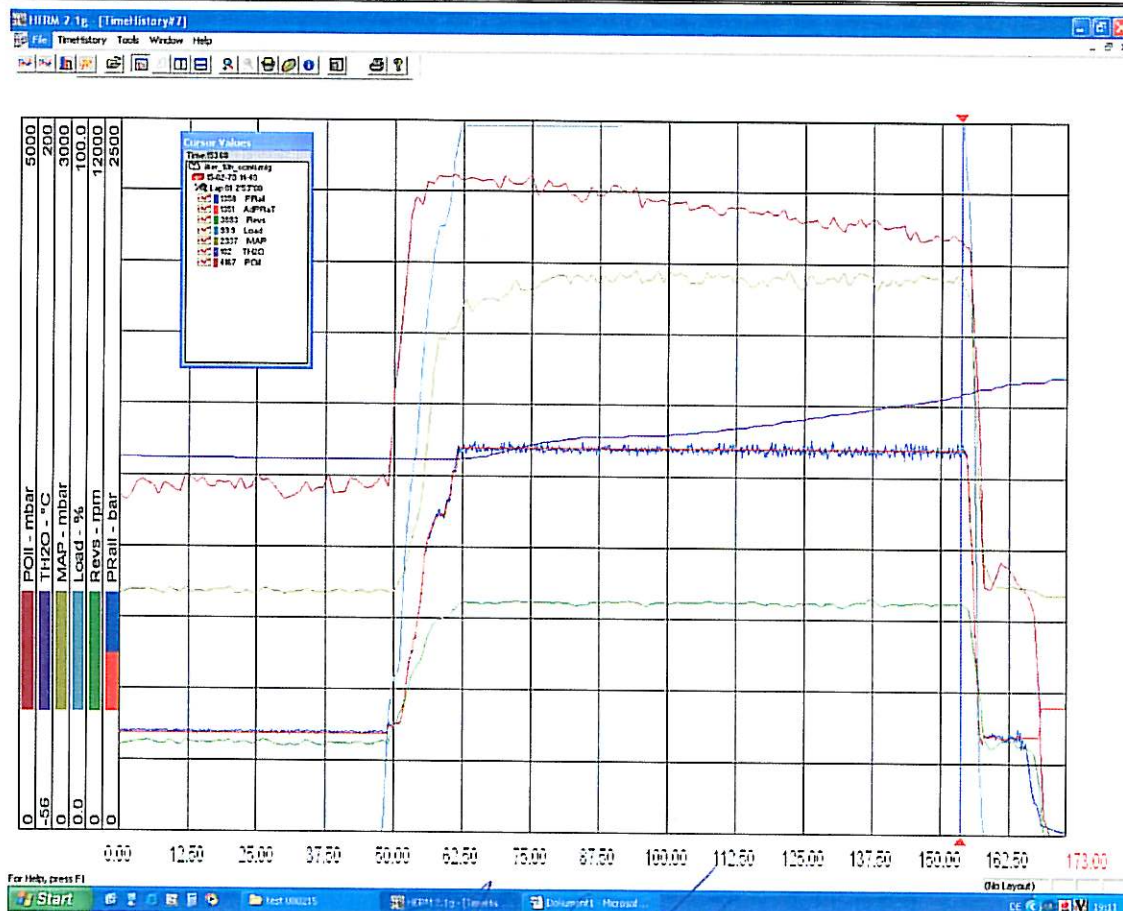
This ground test was repeated with a recording sample rate of 10 Hz. The airflow was started at about second 75 again with 600 ml/min air and was raised continuously up to 2000 ml/min air at about second 150 when the power had to be reduced due to high temperature. The engine did not show any influence.

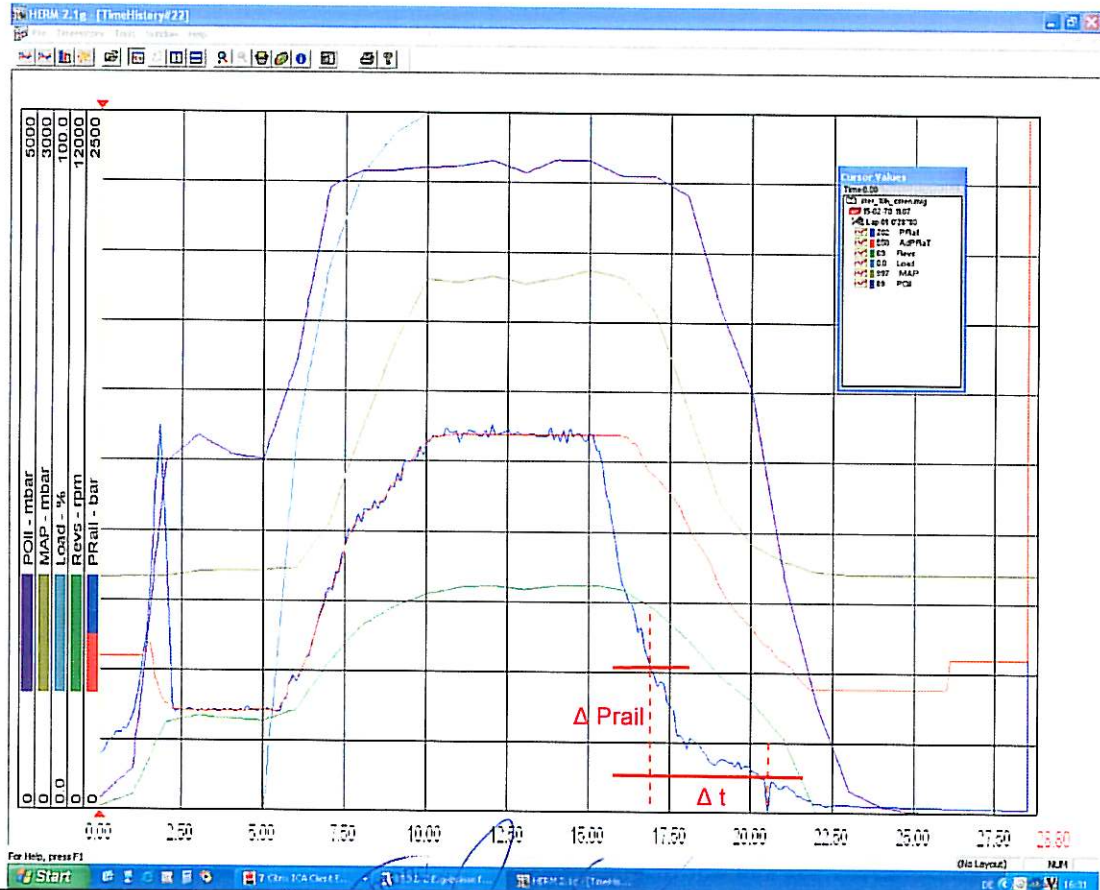
For the next ground test the tube (1) on the picture on page 3 was taken off. At full power the shut off valve (2) was opened to simulate the behaviour of the engine when the fuel fitting on the inlet side of the fuel filter bowl gets loose and falls off.

The rail pressure was recorded with a sample rate of 10 Hz.

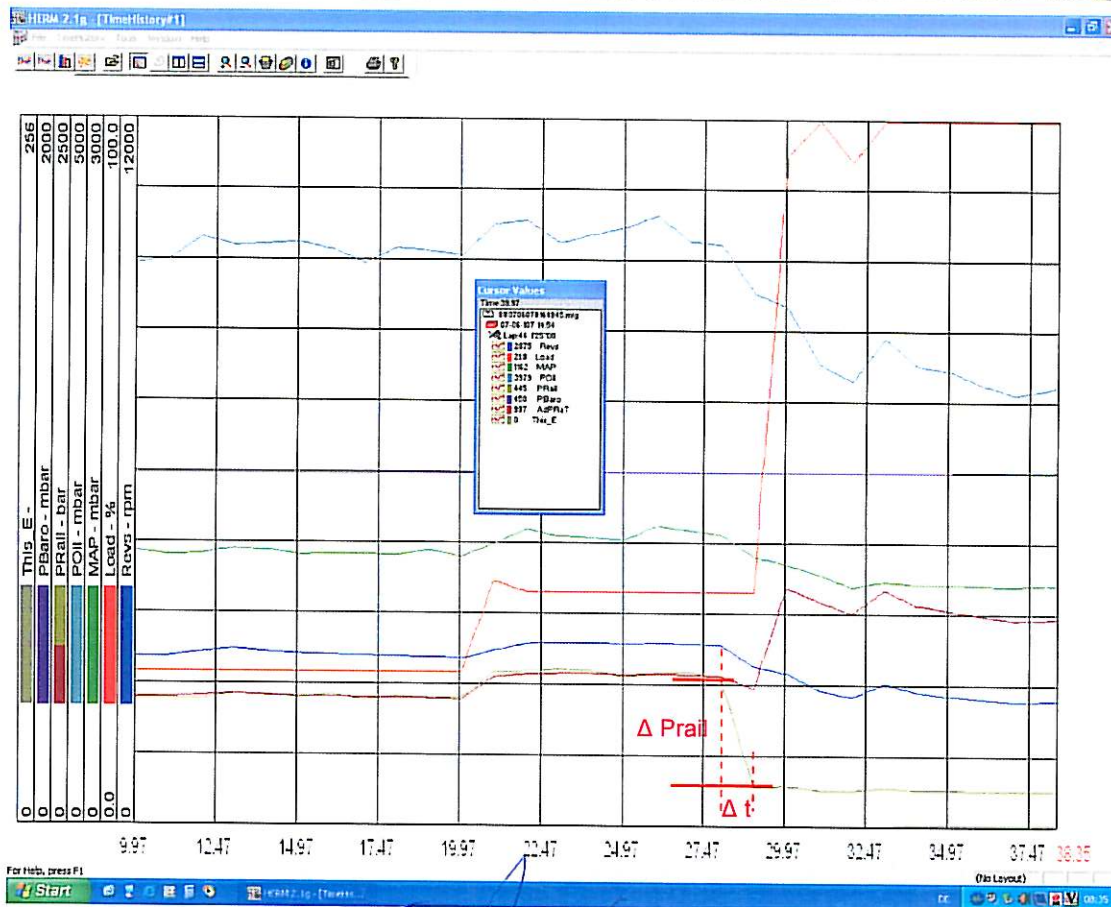
The time period Δt of the drop of the rail pressure at the moment of the engine shut down of the OY-RBB is much shorter than the Δt that results from an open fuel filter inlet fitting.

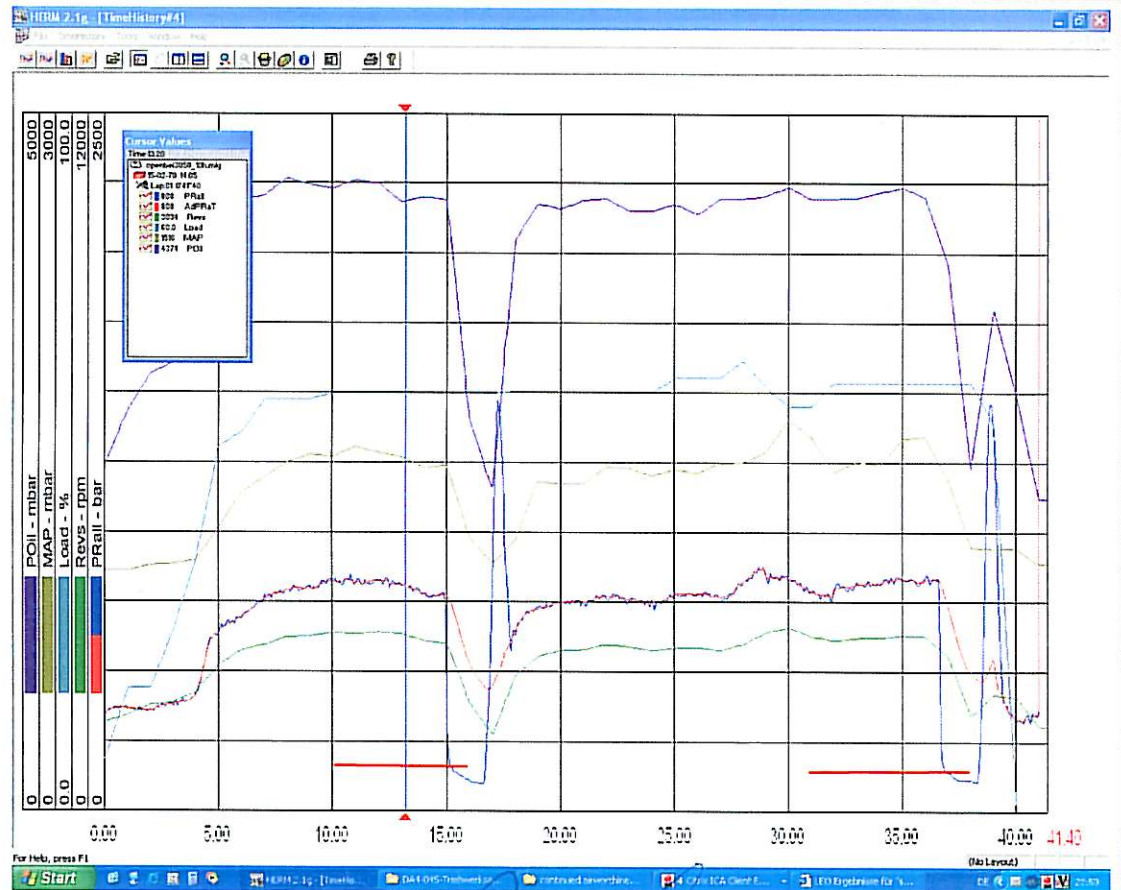
In case of wind milling the 140 bar would have been maintained. The recording sample rate was 10Hz.

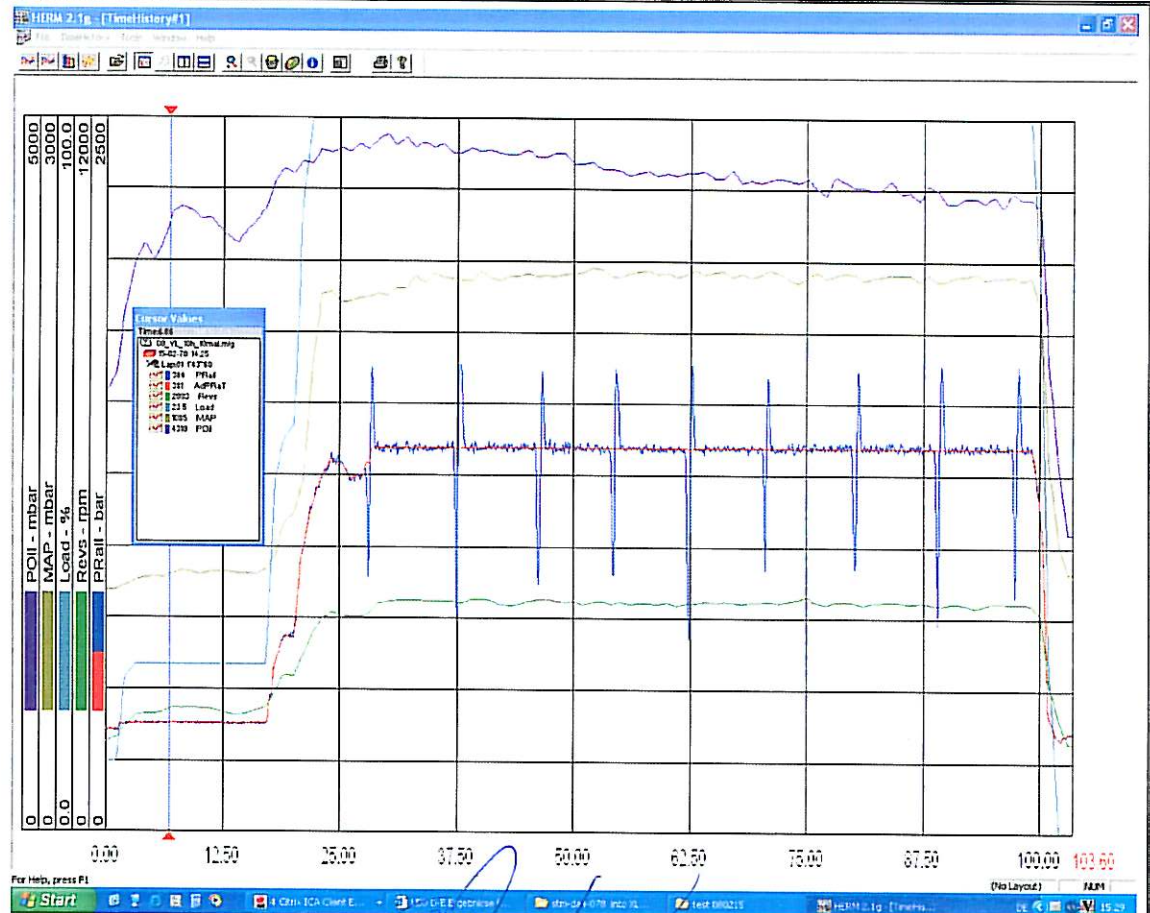
This ECU chart shows several air injections of 50 ml at once during a ground test. The rail pressure was recorded with a sample rate of 10 Hz. The air bubble causes a decrease in the rail pressure. The FADEC tries to balance the drop of the rail pressure which results in a positive peak. For each of the nine injections the charts look equal.

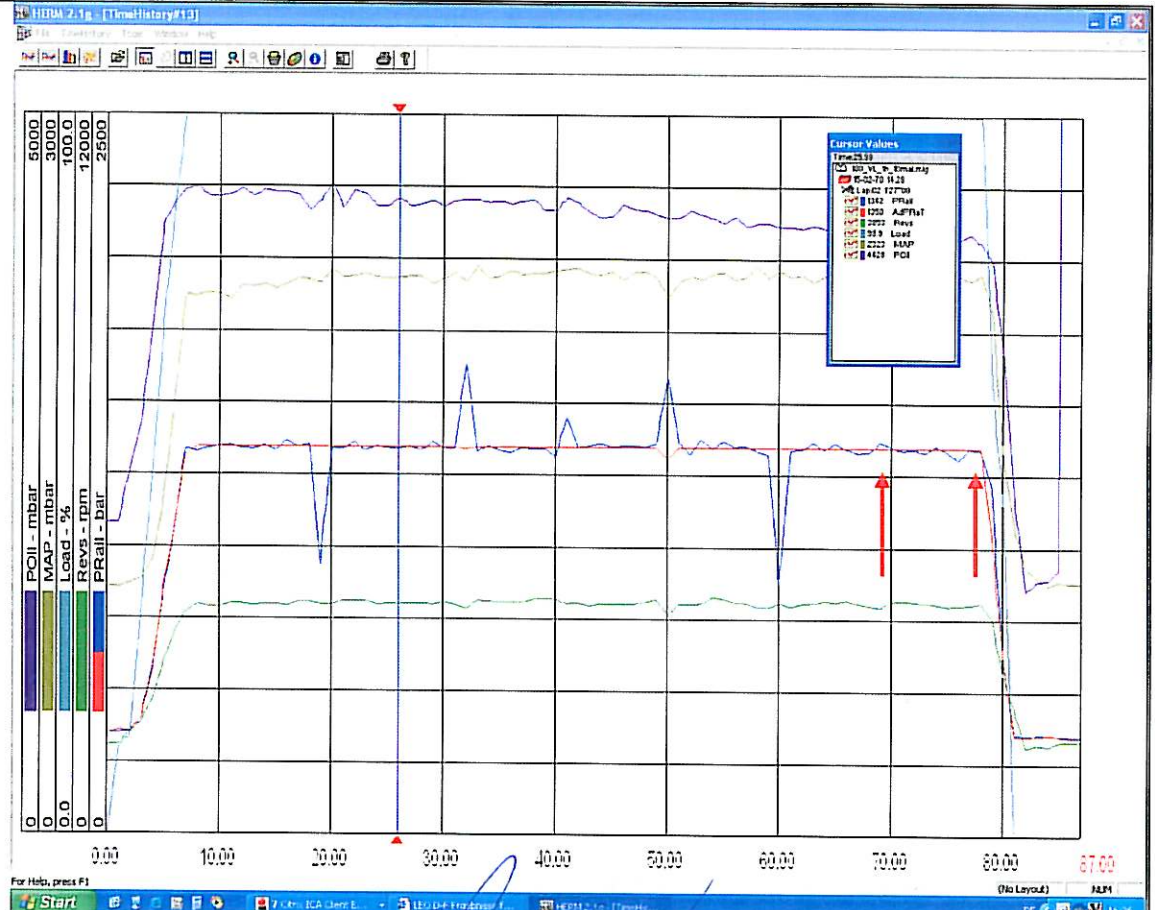
The same injections of air look differently when the recording sample rate of the rail pressure is changed to 1 Hz. In this case either the drop in the rail pressure is recorded or the balancing positive peak is recorded. Sometimes the recording points miss the negative and following positive peak at all, as it is marked by the two red arrows.

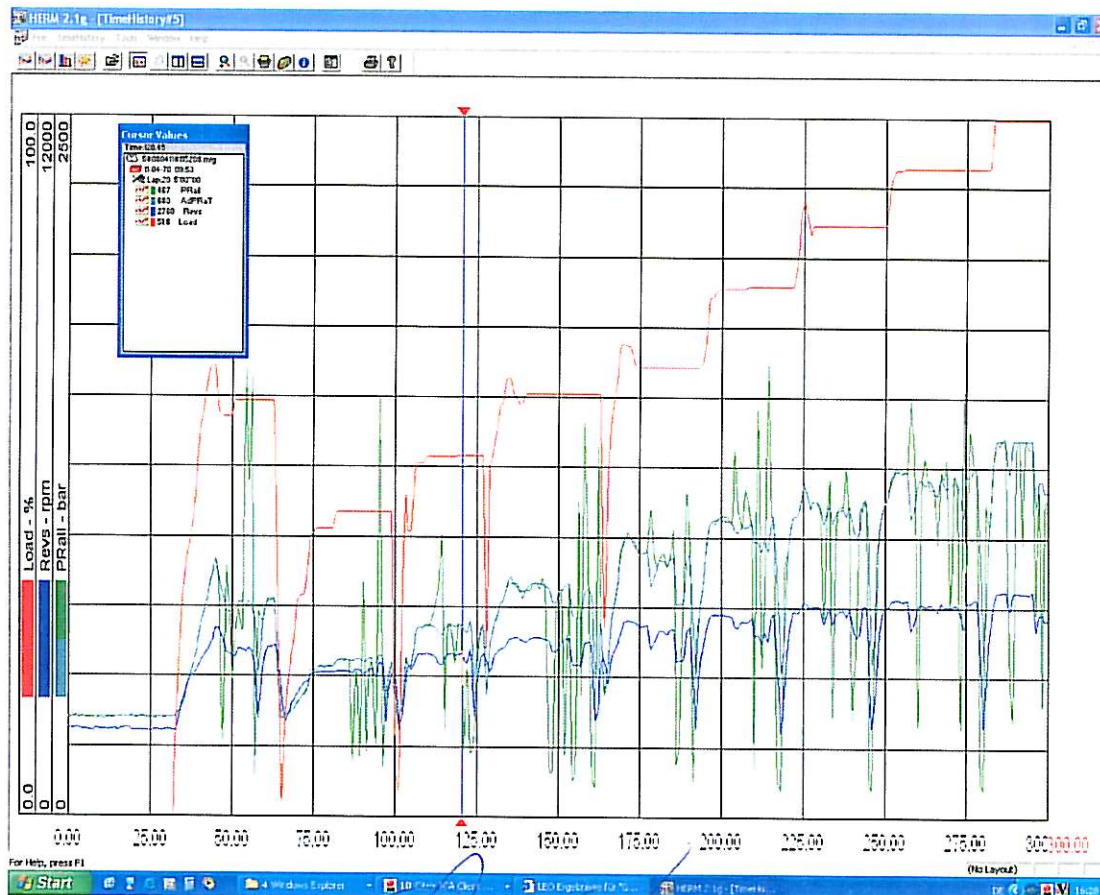
This picture shows the behaviour of the rail pressure at different power settings. After having adjusted a certain power setting the electrical circuit of the rail pressure valve was interrupted every 2 - 3 seconds for a few tenth of a second. Each peak or rather each combination of a positive and a negative peak represents an interruption of the electrical circuit.

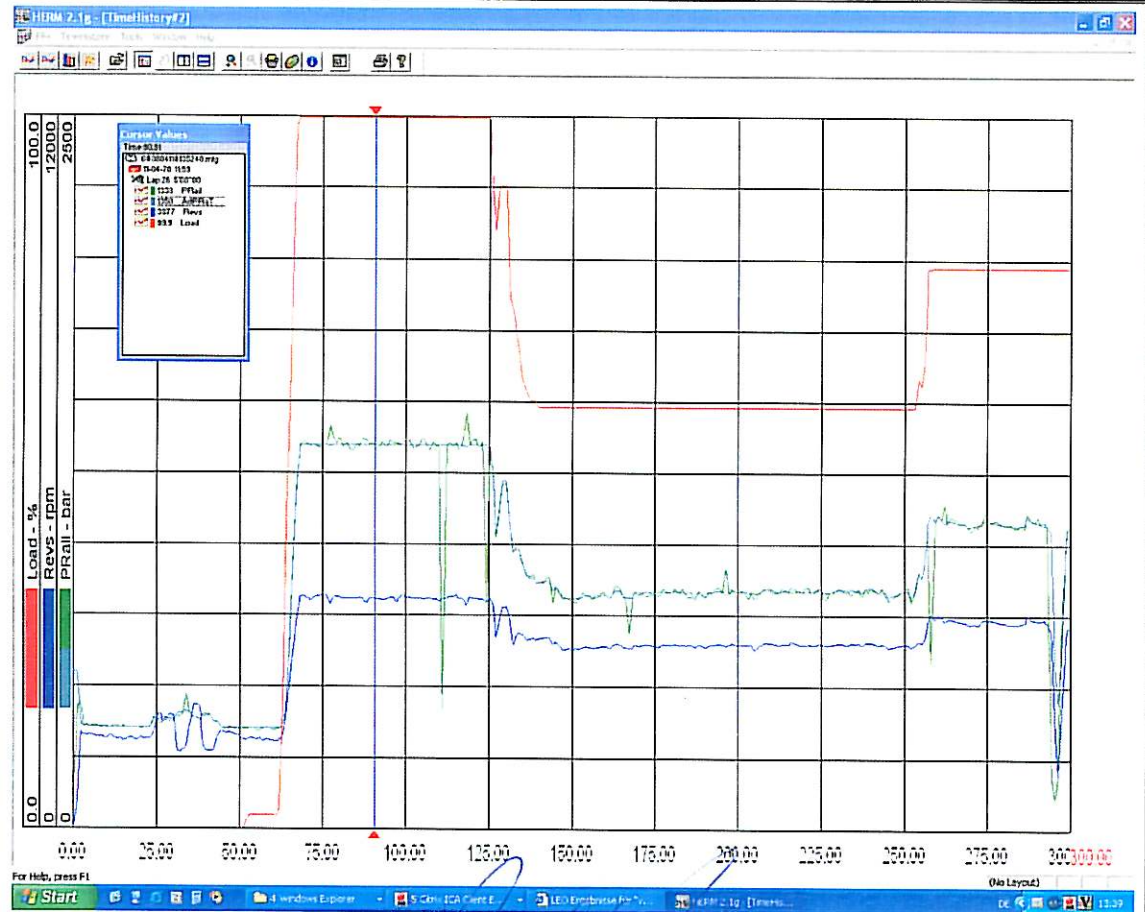
This ground test was repeated choosing a power setting that was similar to the one which is shown on the next page, which is about 10 minutes prior to the engine shut down of the OY-RBB. The additionally installed cable was used to produce electrical interruptions approximately every 10 seconds. It could be noticed that each interruption of the electrical circuit was followed by a shudder of the engine. The intensity of the shudders was dependent on the duration of the electrical interruption. Very short interruptions resulted in shudders which were hardly noticeable. The ECU chart shows negative and positive peak in the rail pressure.

As it was described above it is not possible to record each electrical interruption due to the low recording sample rate of 1 Hz.

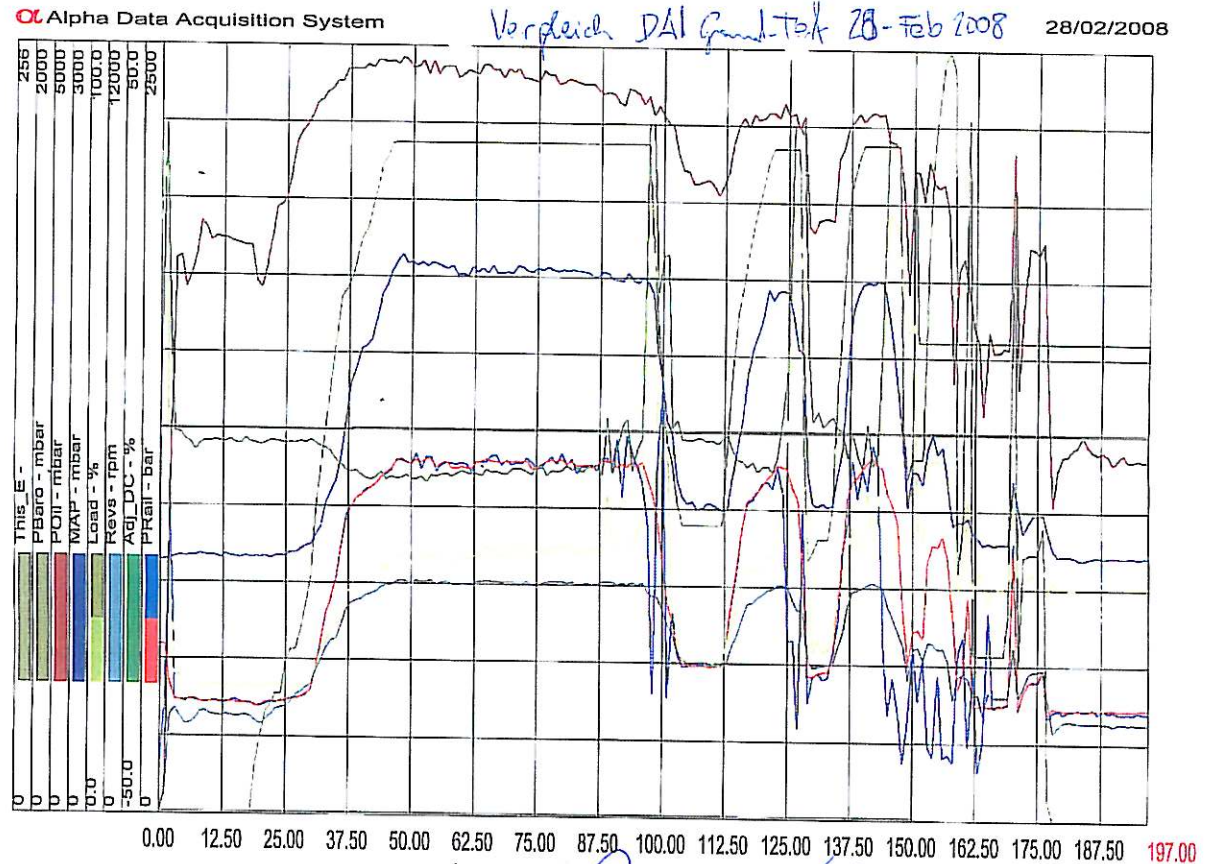
The ECU chart on this page was recorded during a separate ground run conducted on the 28-Feb-2008 and was added to this report for comparison reasons. It shows the behaviour of the engine when the fuel fitting at the fuel filter outlet fitting is opened very slowly. Air is sucked by the feed pump and the rail pressure starts fluctuating. Secondary it can be seen that when reducing the load (at second 112 and 187) the engine parameters return to standard conditions. With higher load the rail pressure starts fluctuating again.

- The ECU chart on page 17 shows the consequences of a slightly opened fuel fitting on the engine which is a wildly fluctuating rail pressure. This behaviour could not be observed in the ECU charts of the G-ZANY and the OY-RBB. Therefore it can be assumed that a slightly opened fuel fitting was not the cause of the two occurrences.
