Endelig rapport HCLJ510-000387

Rapport over hændelsen med Diamond DA 40D OY-RBB ved Roskilde den 7. juni 2007.

FINAL REPORT

HCLJ510-000387	Incident		
Aircraft type:	Diamond DA 40D	A/C Registration:	OY-RBB
Engine:	Thielert TAE 125-01	Type of flight:	Test flight, VFR
Crew:	1- no injuries	Passengers:	1 - no injuries
Place:	1 nm west of Copenhagen Airport, Roskilde (EKRK)	Date and time:	07.06.2007 1330 UTC

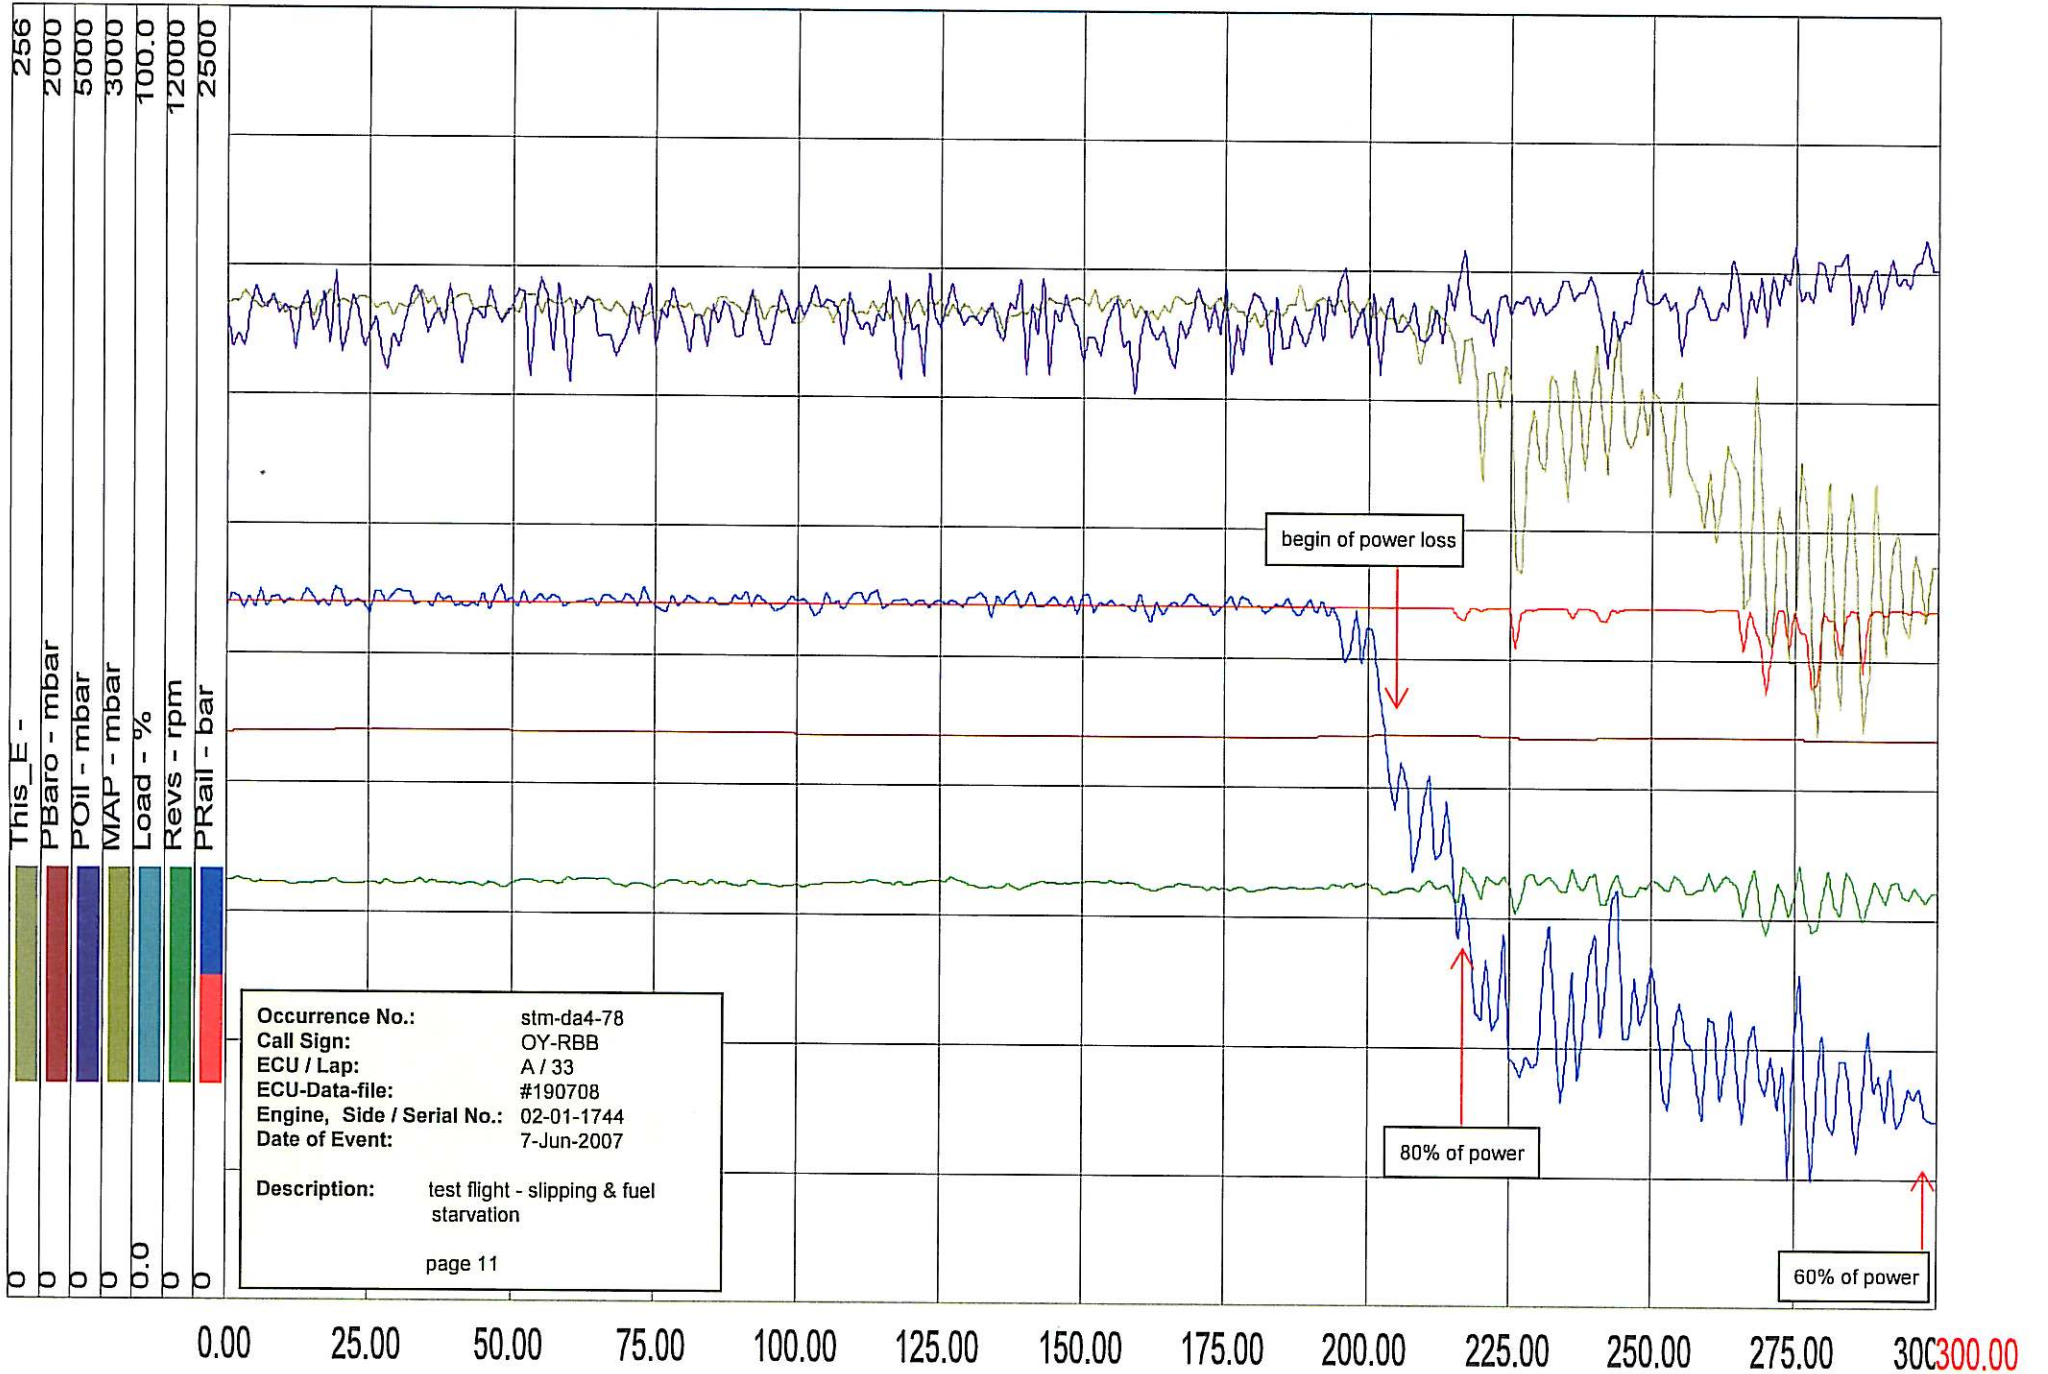
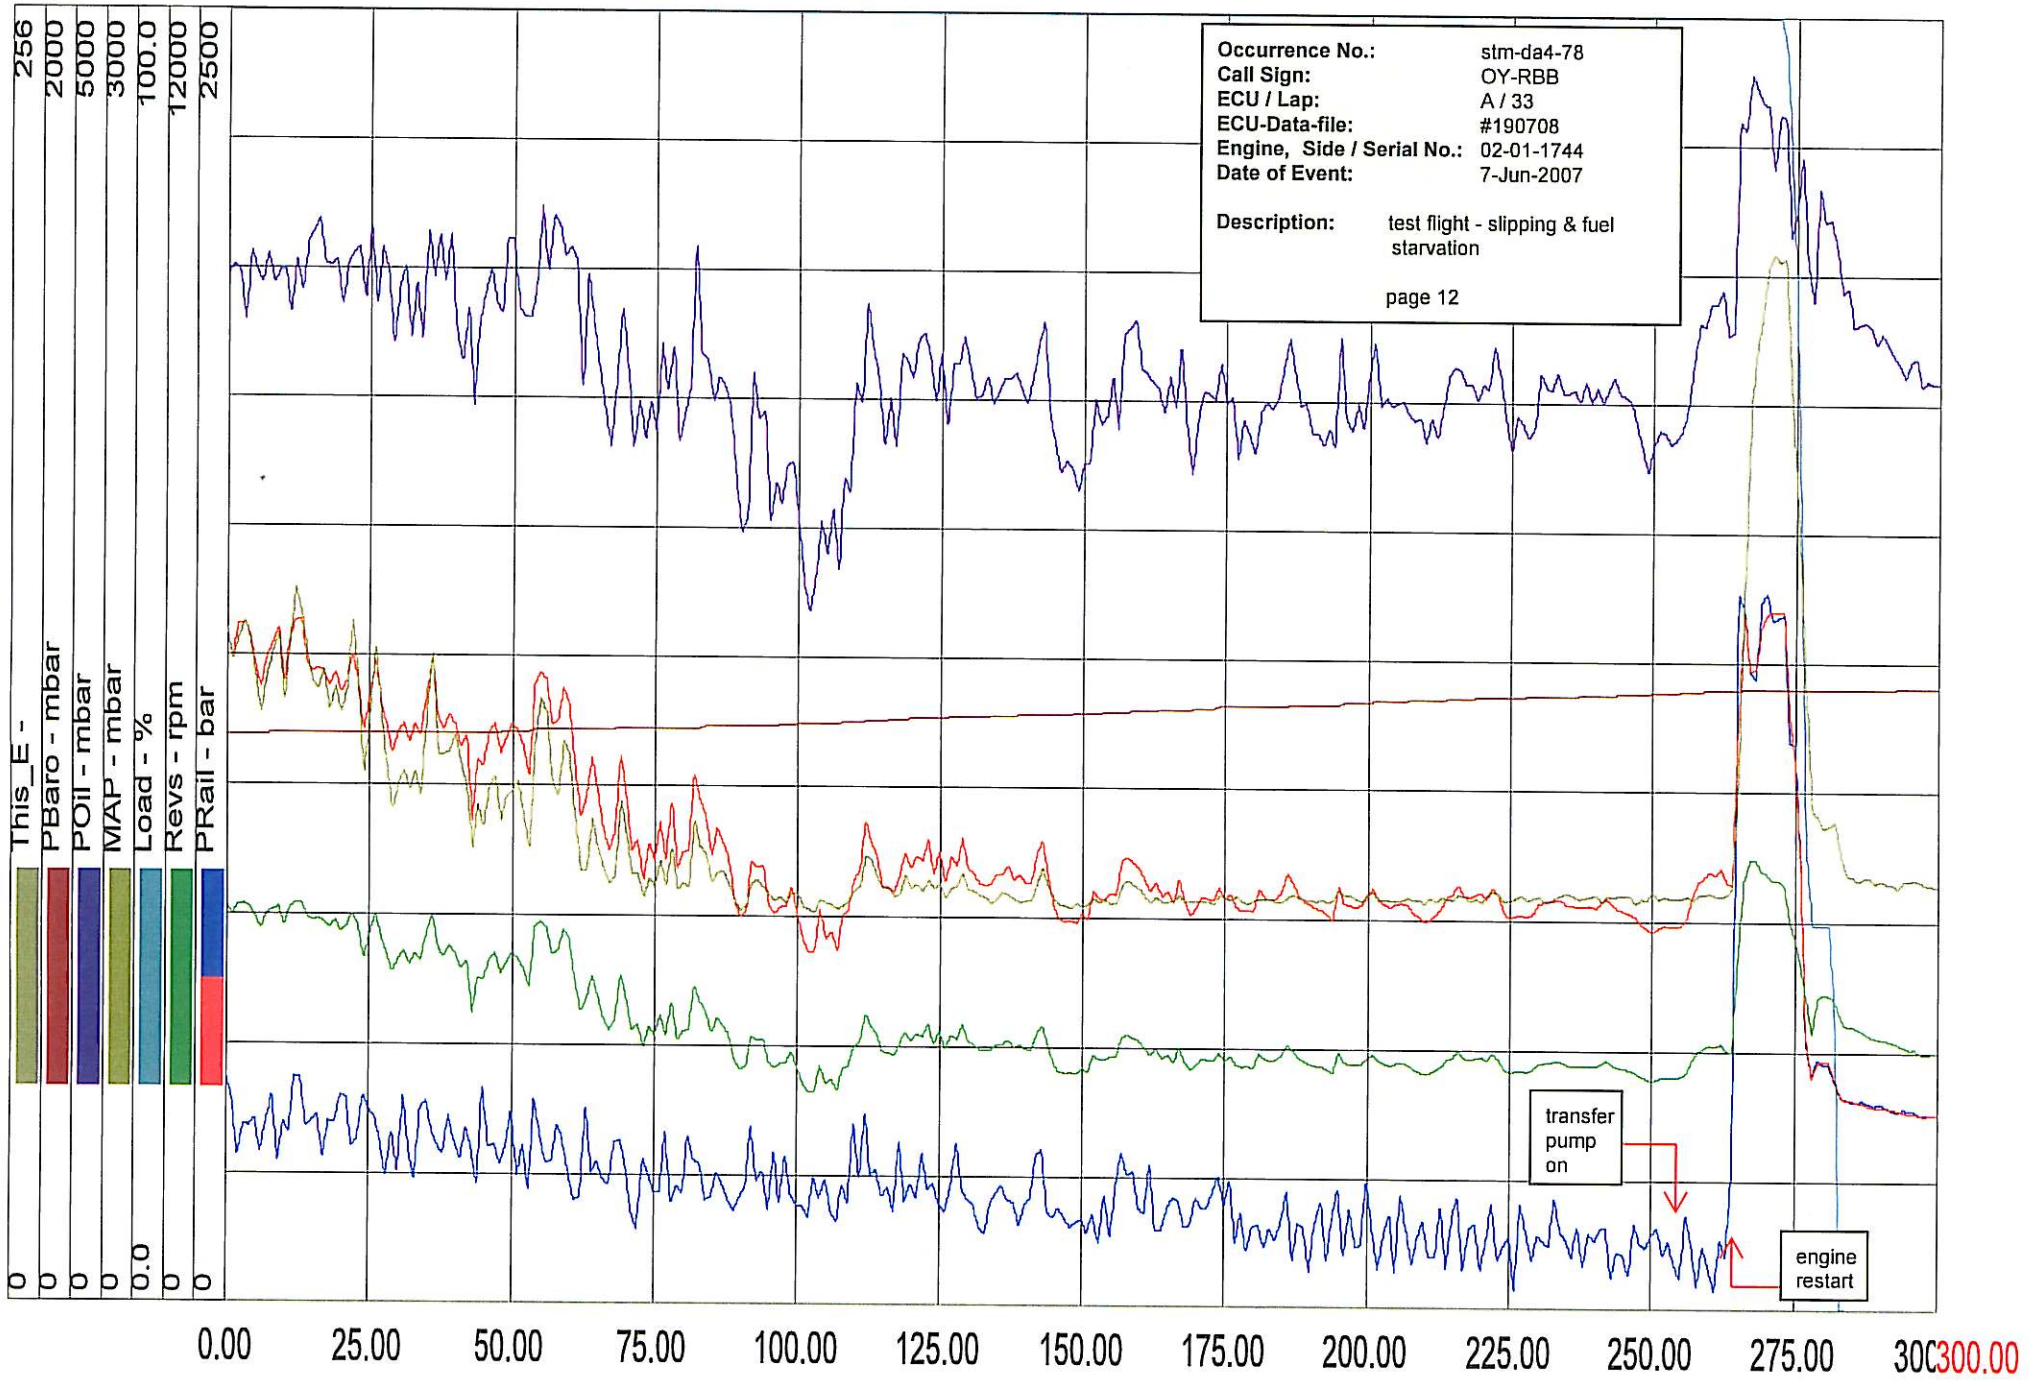
4:39 minutes after the engine started to lose power the load indication remained permanently below 5 % and was considered to have quit. In order to find out if a wind milling engine due to lack of fuel damages the High Pressure Pump so that a restart is not possible anymore the crew continued descending down to 2000 ft. 1:16 minutes after the engine was considered to have quit the fuel transfer pump was switched on. The engine restarted by itself 10 seconds later.

Therefore it could be shown that air in the fuel system due to slipping or depletion of the main tank does not cause the engine to fail permanently.

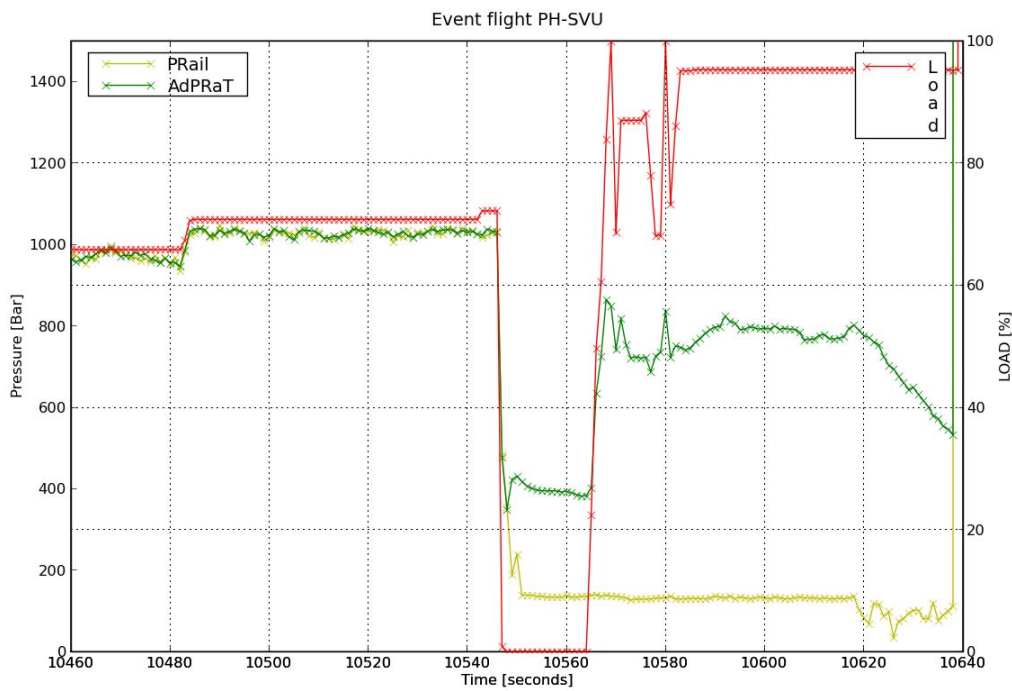
Event: Engine rundown during training flight.
Dutch registration PH-SVU
Aircraft Robin DR 400

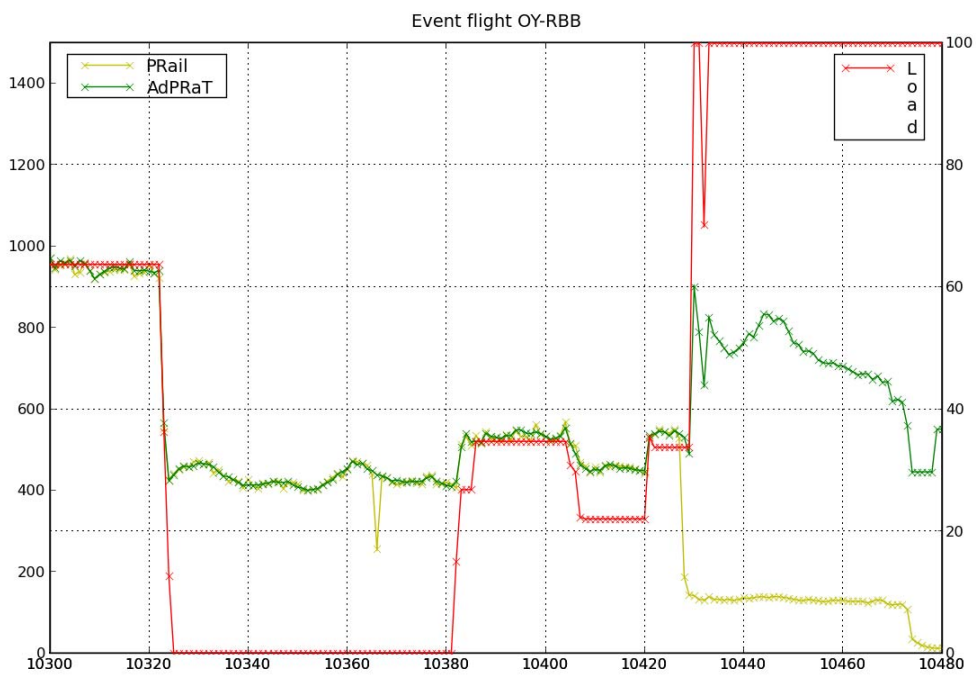
Event: Engine rundown during test flight.
Danish registration OY-RBB
Aircraft Diamond DA 40D
