AIR ACCIDENT INVESTIGATION SECTOR

SERIOUS INCIDENT INVESTIGATION REPORT

LANDING WITHOUT GEAR EXTENSION

Diamond DA-42
A6-FTZ
Horizon International Flight Academy
Al Ain International Airport
United Arab Emirates
23rd February 2010

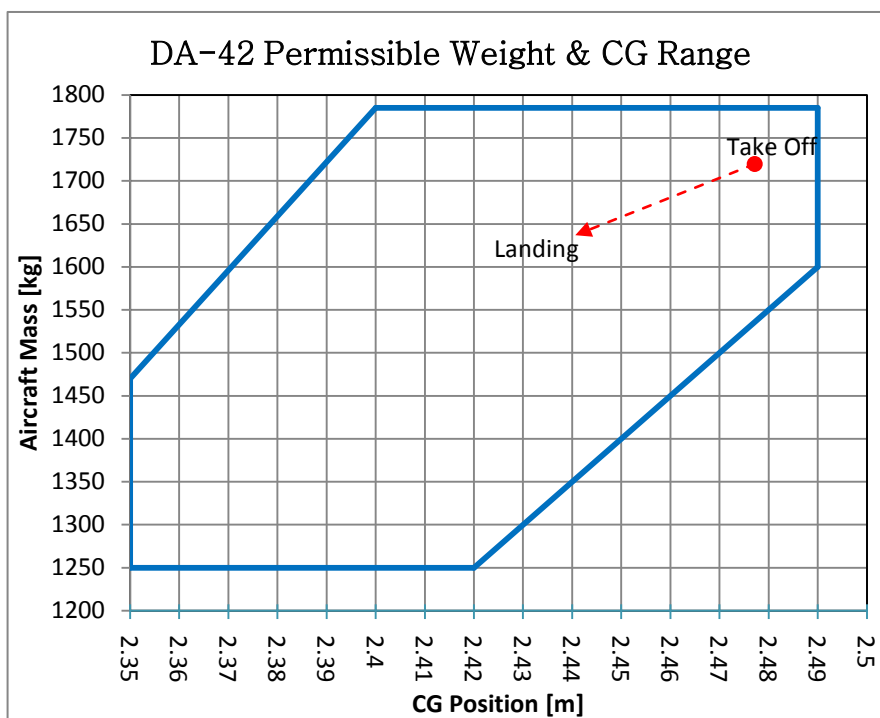
Figure 1- Aircraft Weight and Balance on the Day of the Serious Incident

During the occurrence, the aircraft landing weight was about 1,637 kg and centre of gravity was at 2.441 m from the datum, which were within the permissible limitation (refer to AFM chapter 6.4.4, and as plotted in figure 1). The mass and balance of the Aircraft had no influence on the occurrence.

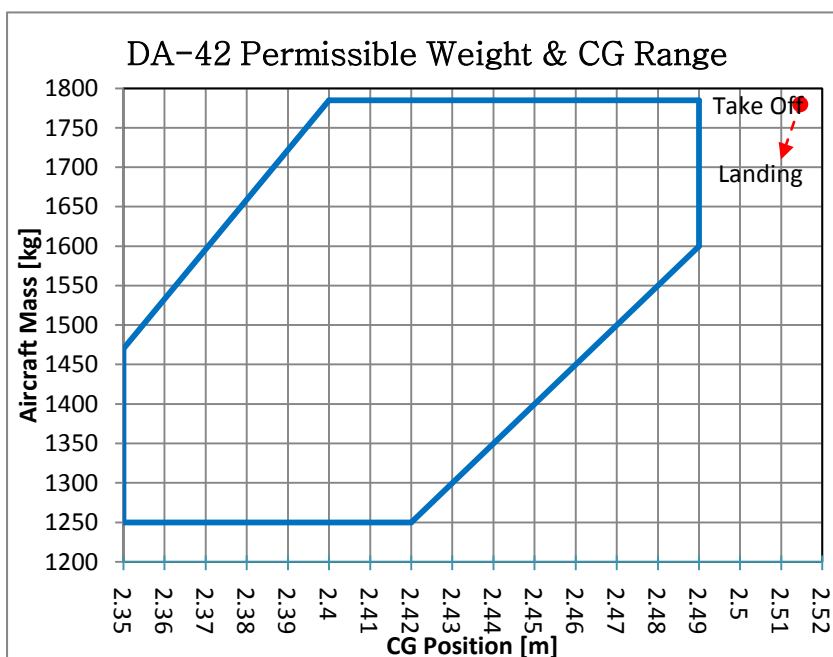
Figure 3 An example of Aircraft Weight and Balance of four occupied seats and 42 US Gal of takeoff fuel configuration

As stated in Paragraph 1.6.3, the mass and balance of the Aircraft during the occurrence was within the weight and balance envelope limitation, and it had no influence on the occurrence. However, there was no specific aircraft loading and takeoff mass and balance calculation (load sheet) form used by the Operator for each flight. Since the Aircraft had 4 seats configuration, it is considered that mass and balance calculation or load sheet should be available before takeoff of each flight.

As an example, figure 3 below shows the Aircraft mass and balance when all four (4) seats are occupied, fuel is 42 US Gallons (fuel only in the main tanks) before takeoff, and fuel remains 22 US Gallons at landing. The takeoff weight calculation gives 1,780 kg which is below the MTOW, while the CG is 2.515 m from the datum which is beyond the centre of gravity limitation. From this example it is considered that the weight and balance could be possibly overlooked before takeoff when there is no load sheet available.

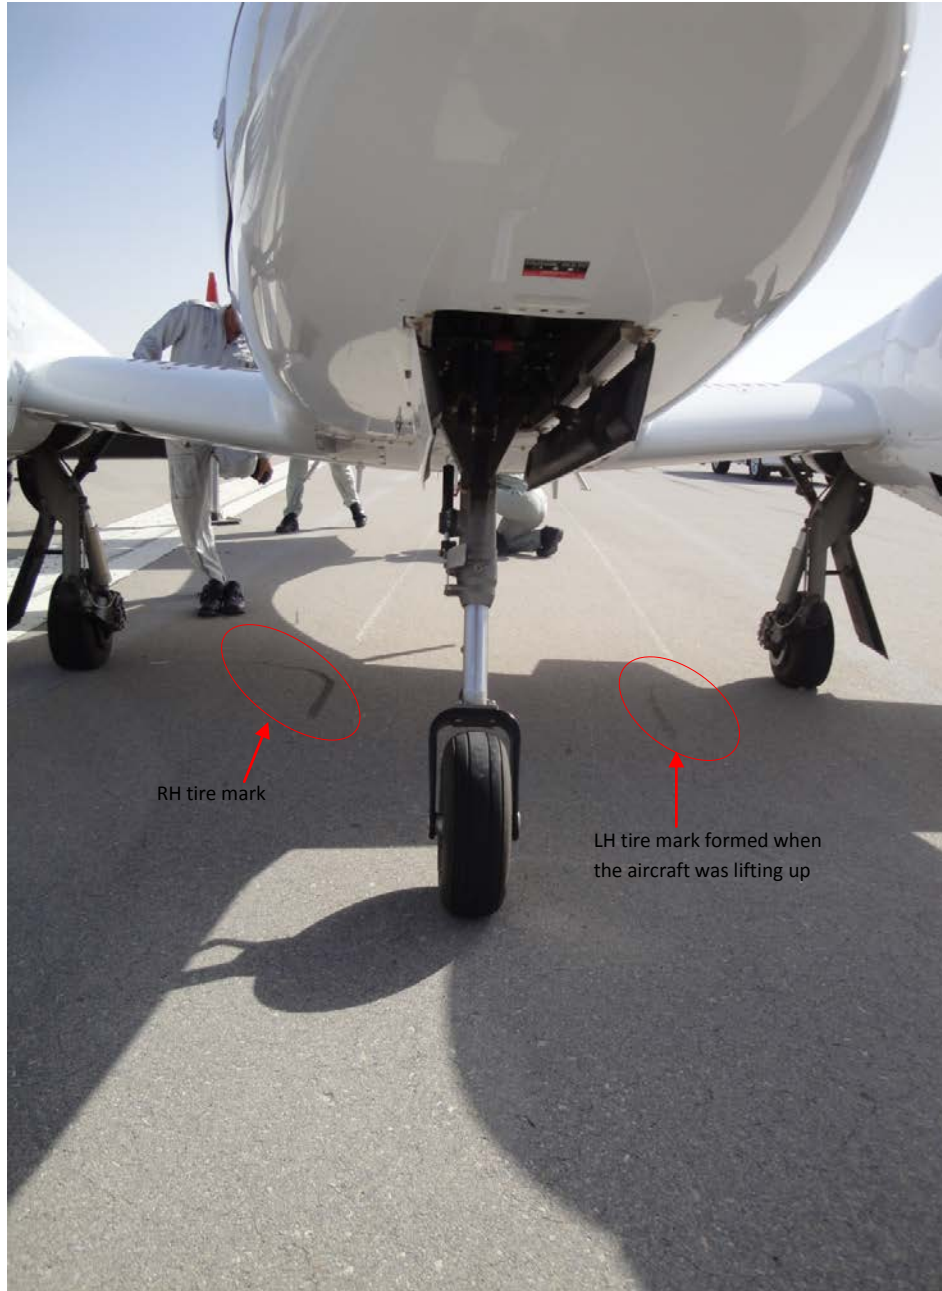
Figure A1-24

The Aircraft in stand up condition after lifting up the Aircraft

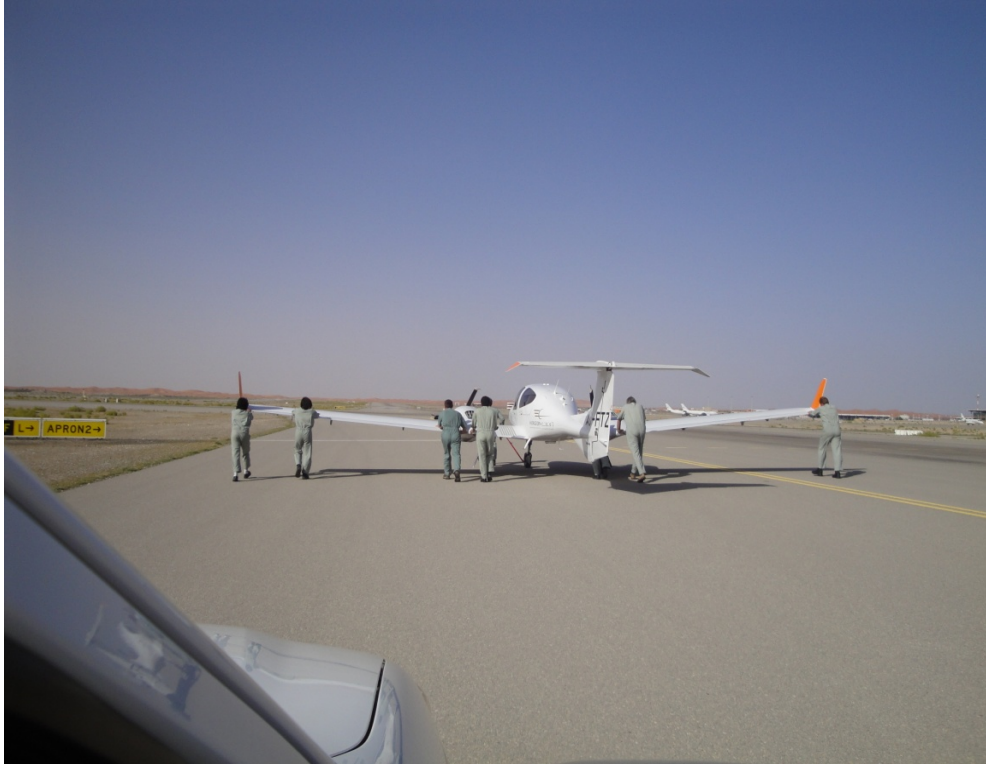
Figure A1-25

The Aircraft was pushing away from the runway
