Serious Incident - Final Report -

AAIS Case No. 08/2011

Failure of Undercarriage AFT Crosstube

Type: Bell 412EP

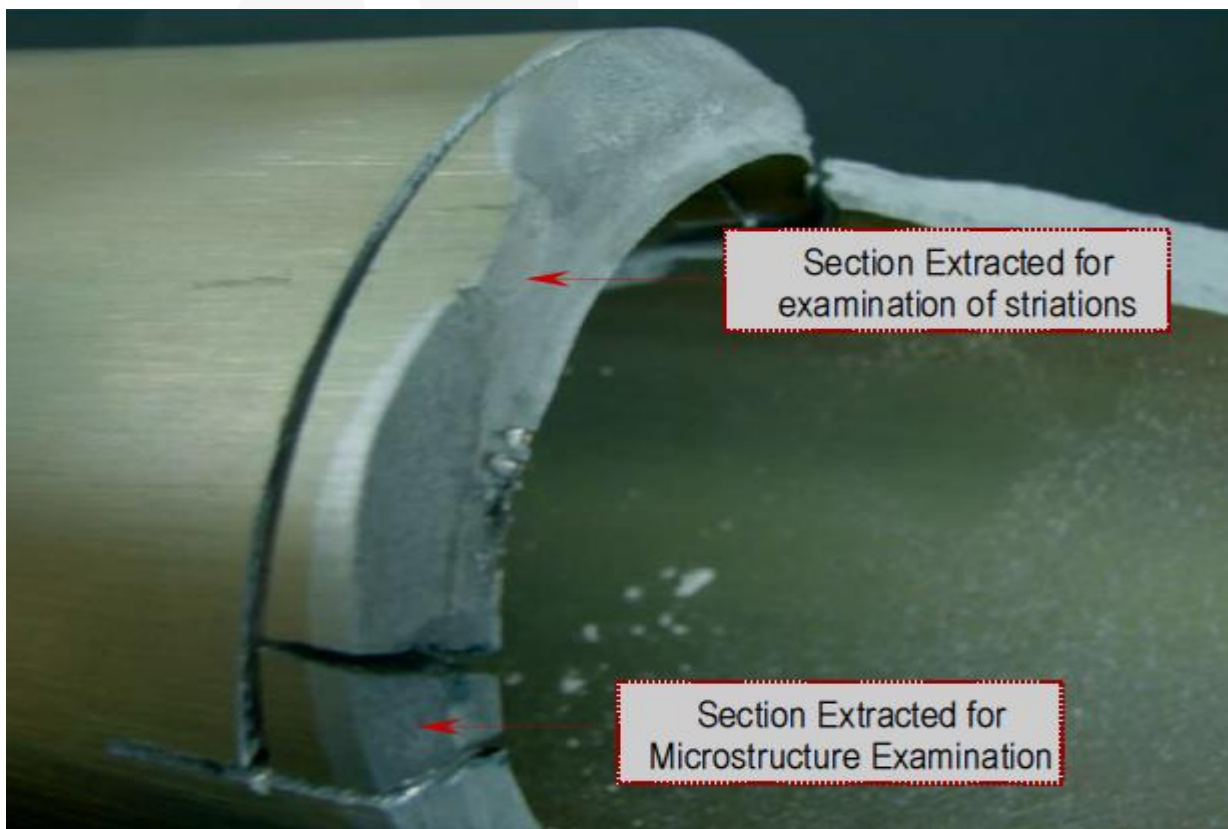
No external damages, scorings marks or impact were noticed on the crosstube surface. The fractured surfaces of the crosstube exhibited beach marks/ striations originating from the inner radius surface of the bend as shown in photo 8. As it is evident the photo below clearly indicates that there was no external damage close to the originating crack area on the paint surface of the tube.

Photo 8. Location of the section cut examined for fracture surface and micro examination from A6-FLZ.

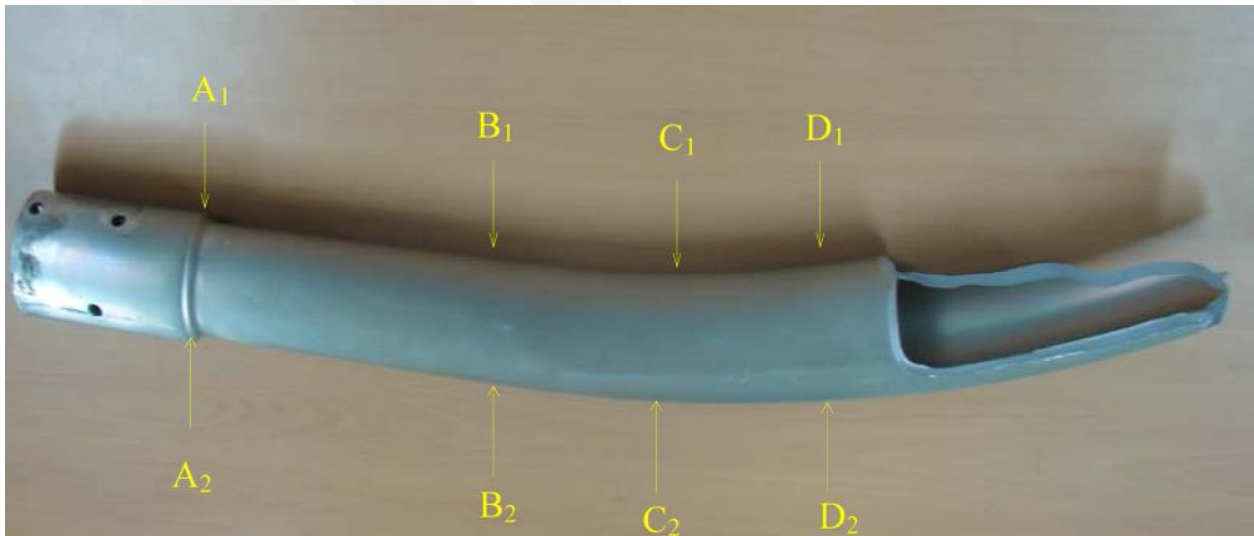
The Hardness survey revealed values ranging between 89-91 HRB. This hardness value confirms the material to be Aluminium Alloy 7075 T6. In addition, the hardness values observed were uniform across the inner and outer radius of the crosstube bend areas (see Table 10 for the results). The results in table 10 have to be read in association with photo 14 below, where the hardness survey location identifications are shown.

Photo 14. A6-FLZ paint stripped crosstube hardness survey location identifications

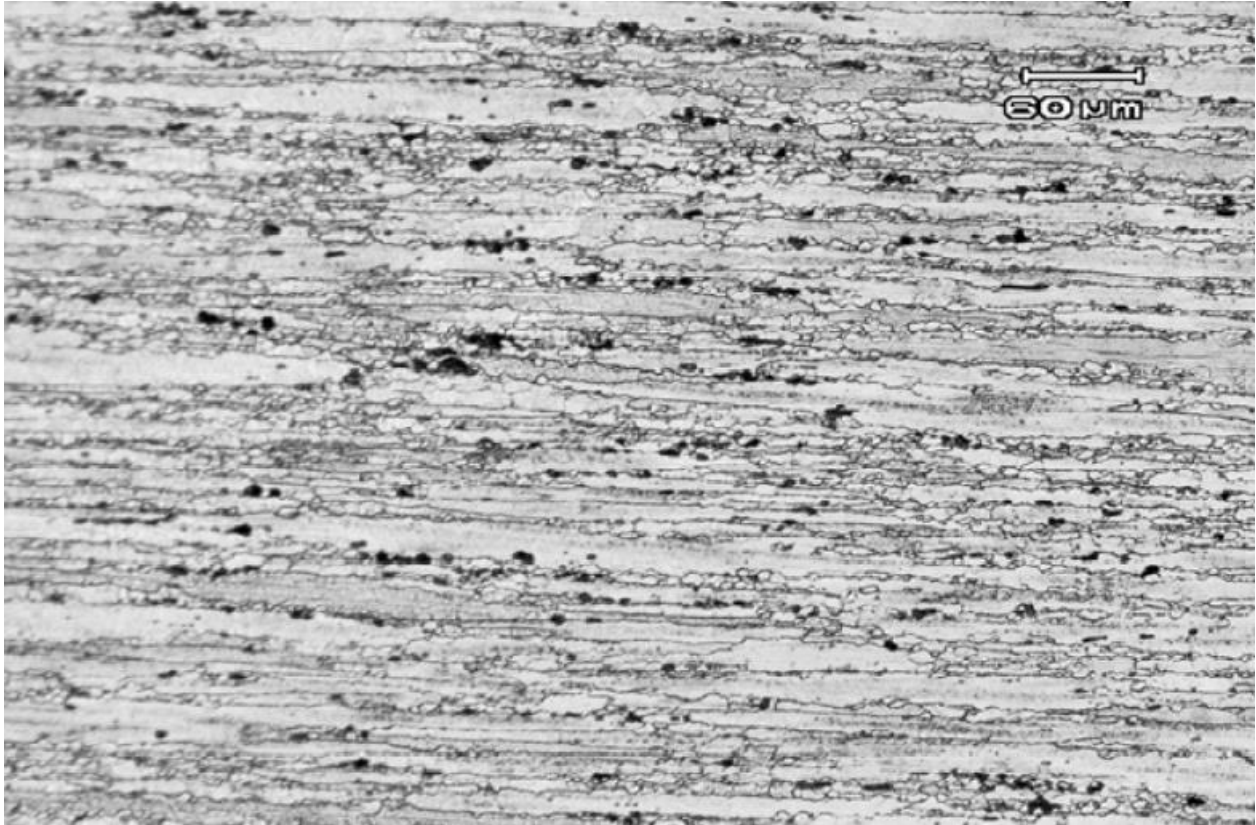
Figure 9. Microstructure of the fractured section examined at 100X.

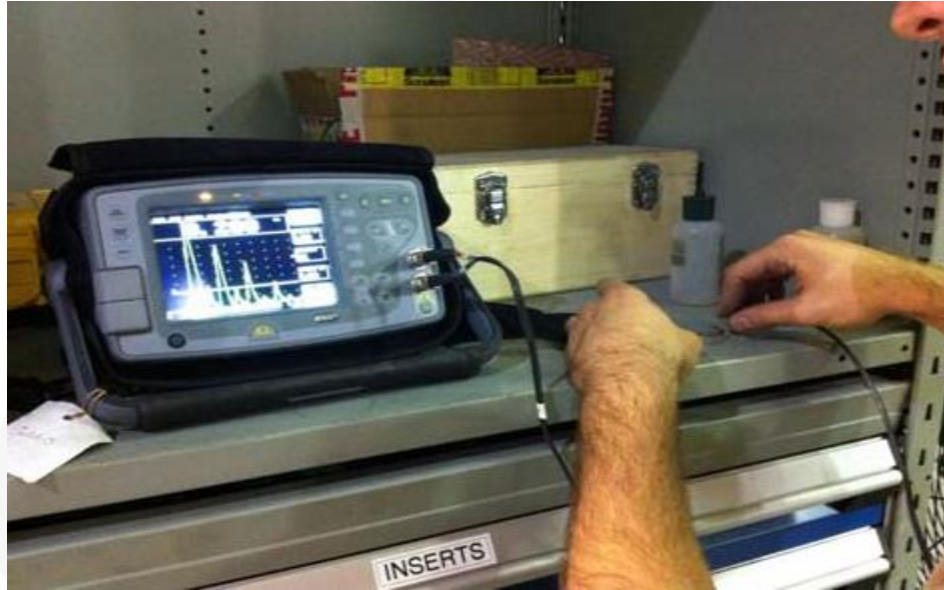
determined to be a contributing cause. The subject sample from A6-FLZ was found to have an unusual amount of eccentricity in the crosstube at the point of failure...”.

Photo 15. The ultrasonic equipment used to measure the failed crosstube.

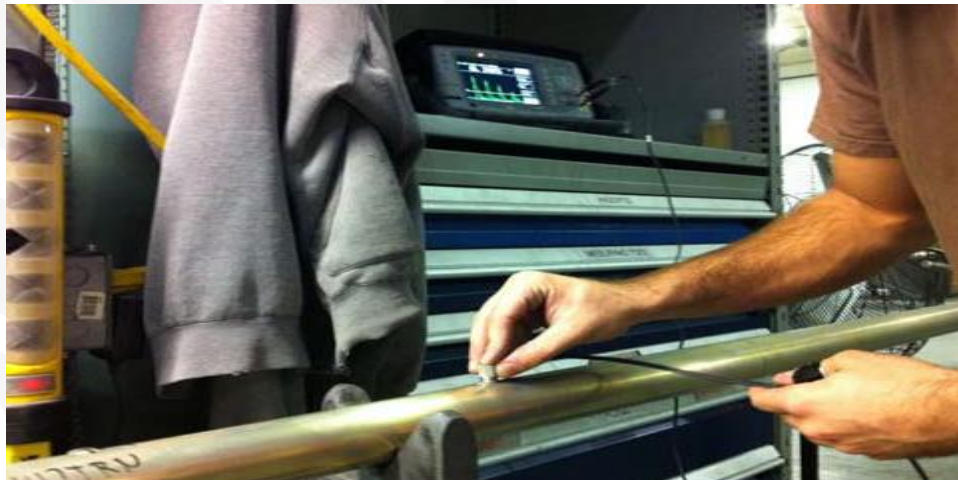
Photo 16. The crosstube thickness measurement utilising ultrasonic equipment.

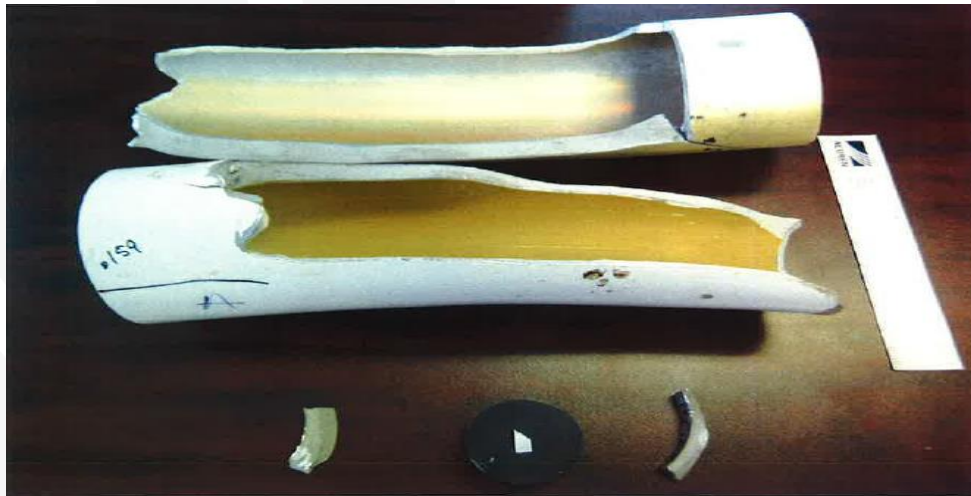
Photo 18. Pieces of the broken component and mount as received by the second laboratory.

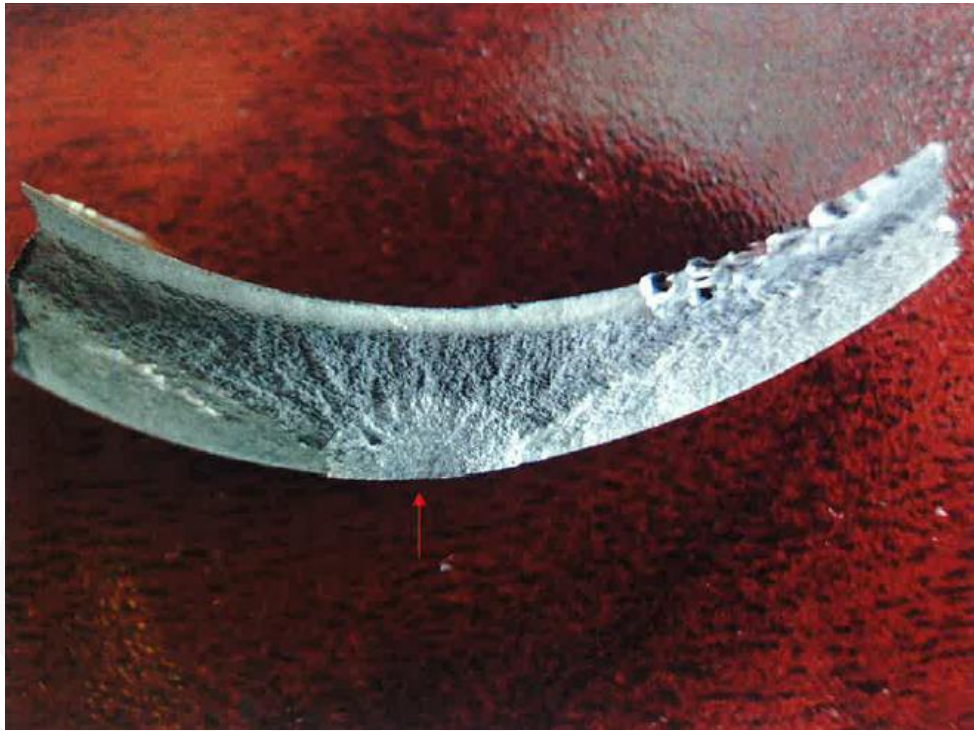
Photo 19. The fractured surface

The laboratory photographed the crack initiation area and took measurements of the thumbnail region under a stereo microscope. Image analysis was also verified prior to making the measurements (see photos 19 & 20 above).

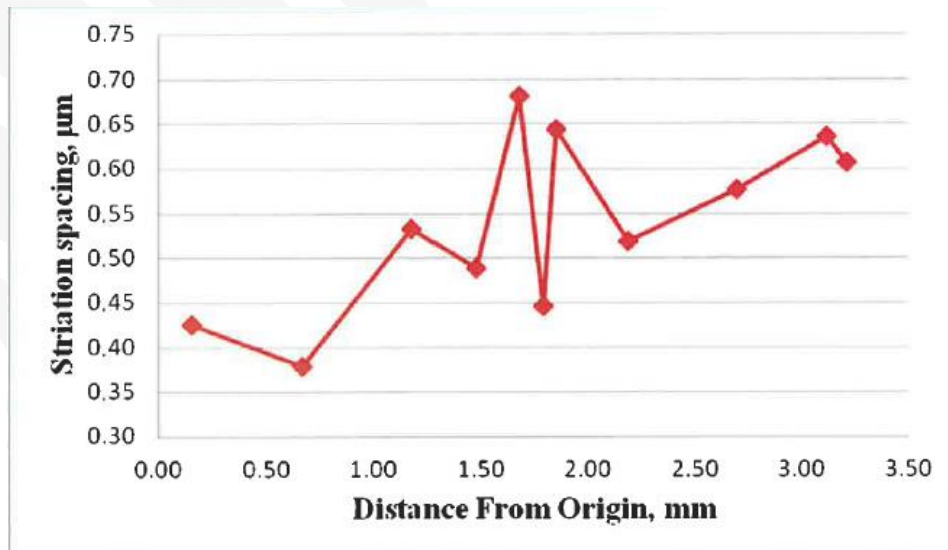
Figure 19. Variation in striation spacing.

Taking into account the total length of the thumbnail, the average striation spacing calculated ($0.5398025\mu\text{m}/\text{striation}$), the report calculates the total number of striations to 6021.

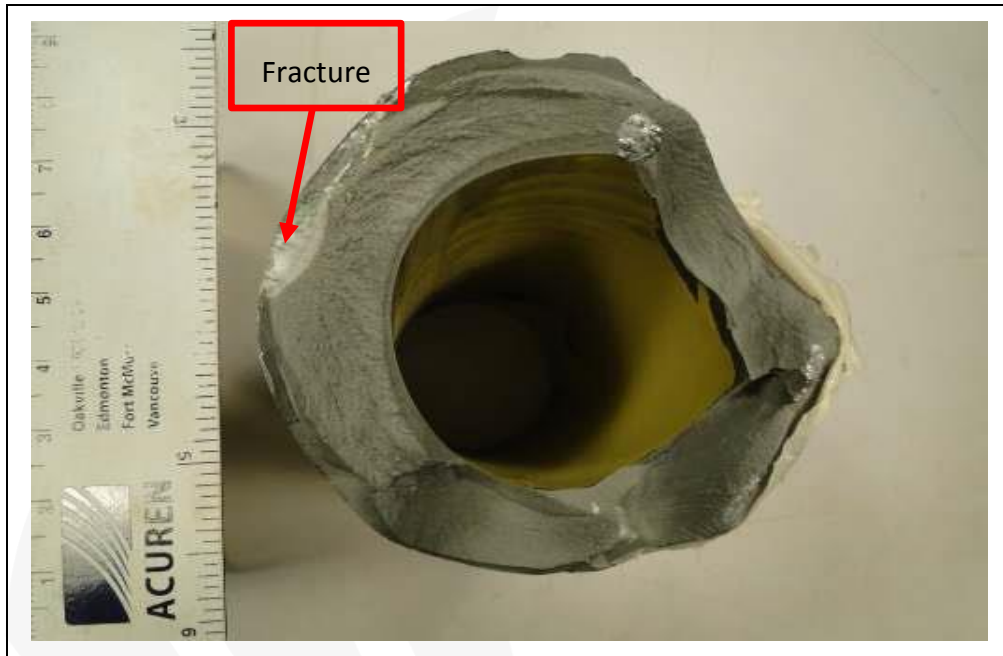
Photo 21. Fractured surface

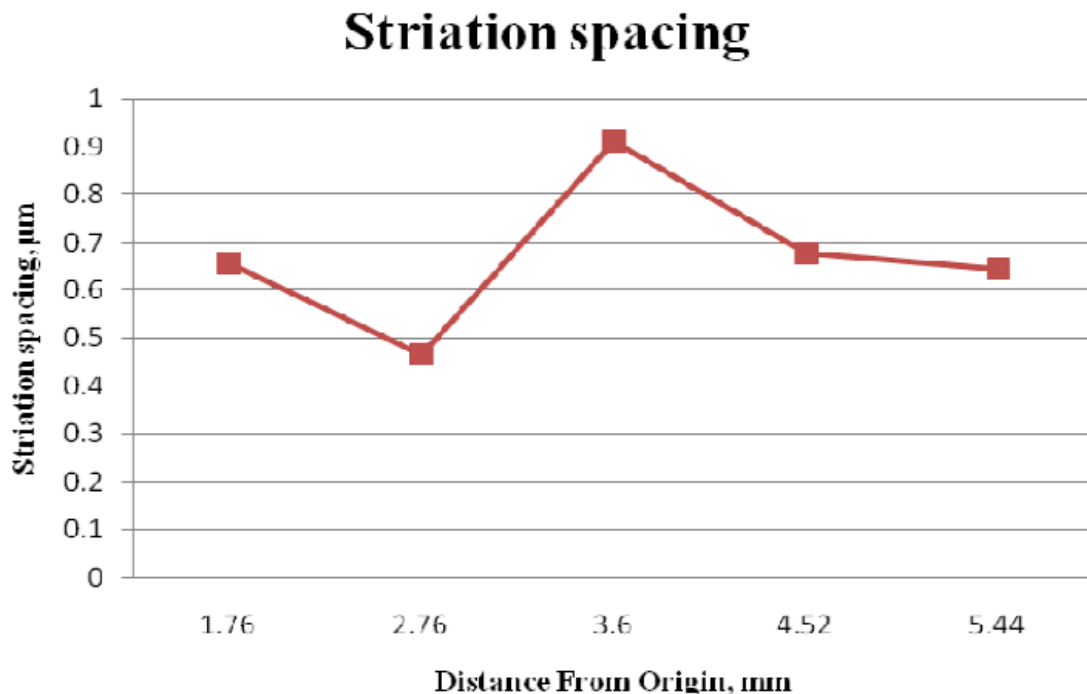
Distance From Origin, mm	Striation spacing, µm
1.76	0.65677966
2.76	0.46610169
3.6	0.91101695
4.52	0.67796610
5.44	0.64406780
Average	0.67118644

Figure 21 Variation in Striation spacing.
