# Air Accident Investigation Sector

### - Final Report –

AAIS Case N°. AIFN/0002/2012

## Attempted Takeoff from Runway Edge

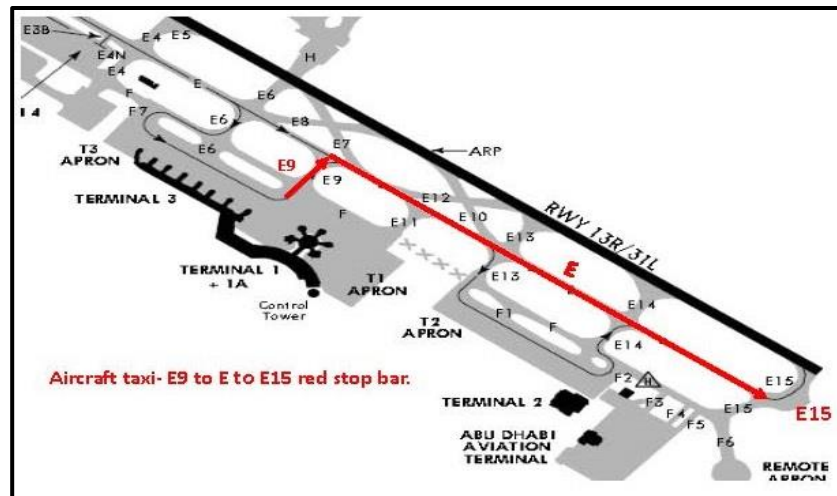
Figure 1. Taxi route E9 to E15

0331 - Taxi clearance was given to follow taxiways Echo 9 (E9) to Echo (E) and to the Echo 15 (E15) CAT III holding point stop bar (figure 1). The flight crew followed their company airport charts for taxiing, which were up-to-date. The ground ATCO did not offer follow-me vehicle (FMV) assistance to the crew. The crew did not request any follow-me assistance to the E15 CAT III taxi holding point.

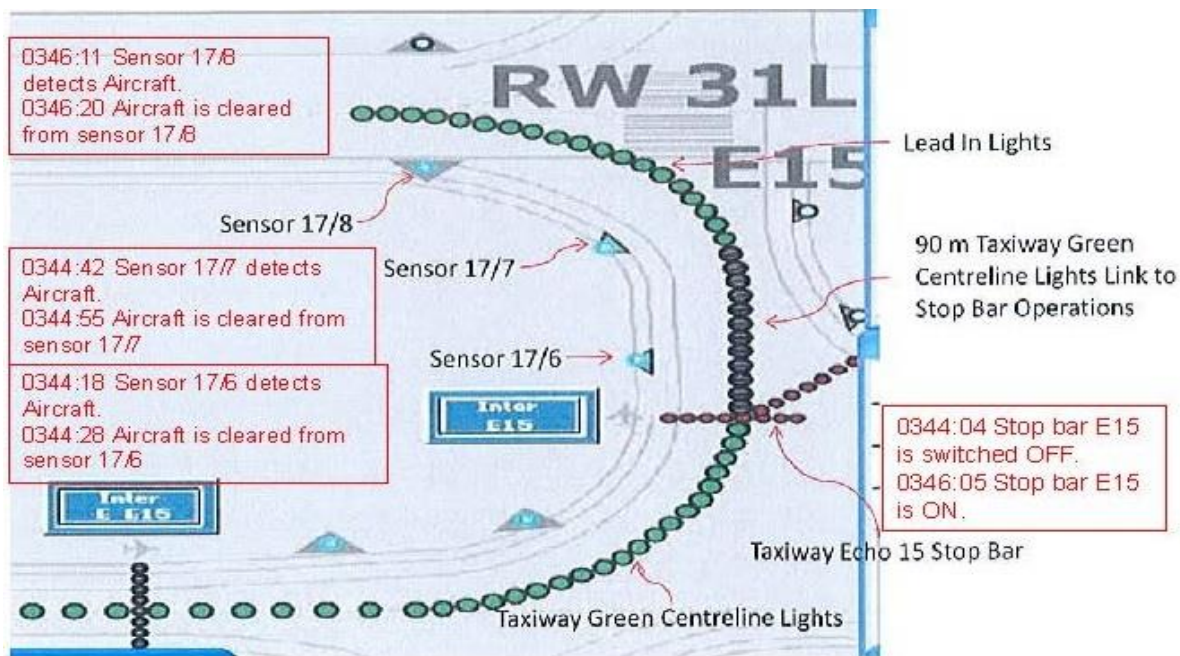
Figure 2. E15 Sensors and taxiway lead-in lights

0345:03 - The Commander stated: “I see only two lights.” The Aircraft was now on a heading of 311 degrees, which is the heading of runway 31L.

0345:07 - The Aircraft came to a stop

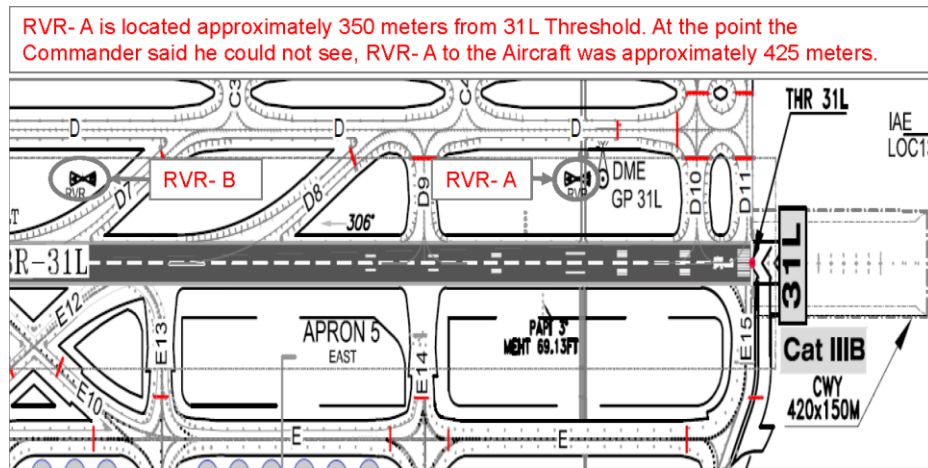
Figure 9. RVR A location

Runway 31L is equipped with RVR sensors, A, B and C. The RVR reading is continuously updated and at the time that take-off clearance was issued for the Incident flight, RVR A for the first one third was 175m, RVR B for the second third was 200m and RVR C for the last third of the runway was 175m.

The location of RVR A is approximately 350m away from the 31L threshold, as shown in figure 9. When the Commander said that he could not see during the taxi after stop bar E15, the Aircraft was approximately 425m from RVR A.

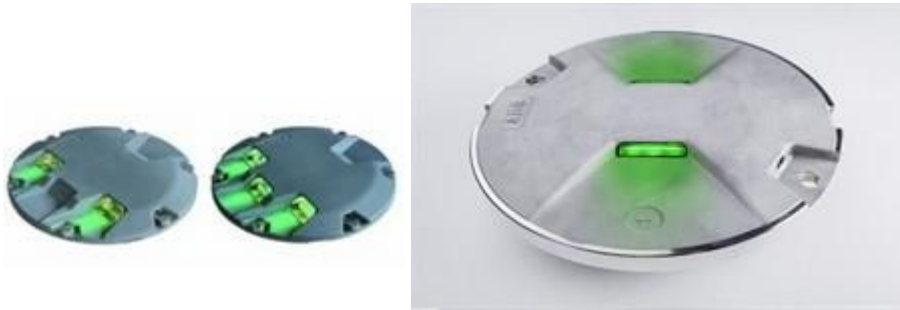
**Figure 10.** Typical taxiway low protrusion runway lead-in lights

The taxiway centerline lights are green and are spaced 7.5m apart and lead to the runway centerline.

The E15 red stop bar is linked to 90m of green taxiway centerline lights forward of the stop bar. When the stop bar is ON, the 90m green taxiway centerline lights will be OFF.

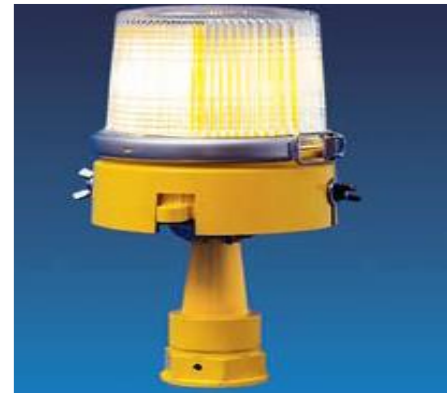
**Figure 11.** Runway edge lamp

The runway edge lamps, spaced at 60m, feature an omnidirectional component for circling guidance. They are 30mm in height and are mounted above the runway surface. It is designed to withstand the heaviest jet blast with a minimum number of parts. There is an inner lens and the outer dome remains clamped to the upper body for fast re-lamping as it is only necessary to undo two wingnut-screws. The light inside the lamp is a precision quartz halogen bulb which is pre-focused and accurately positioned in the lower body. Stability of the lamp is normally ensured through attachment to heavy material such as concrete. Levelling and aiming in azimuth of the lamp are performed using a specialized aiming device. The lamp is designed to be frangible in case of impact.

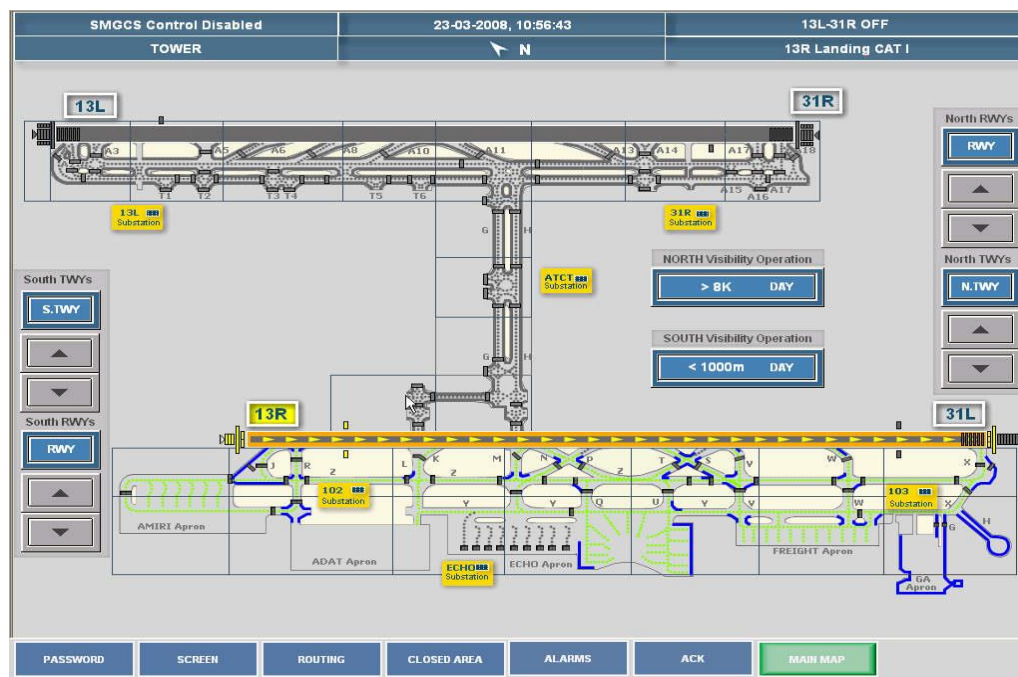
Figure 12. Control of the Airfield lighting system, ATCO interface

As per the Airport's *ATC Instruction Manual*<sup>2</sup> the Abu Dhabi aerodrome lighting control and monitoring system operation is performed on 24-inch liquid-crystal display (LCD) touch screen monitors at the ATCT, and on other LCD monitors throughout the rest of the system (figure 12). The monitors provide real time information to the ATCOs and to the maintenance personnel on the status of the runway and taxiway lighting as well as information on failures at the time of their occurrence.

ATCOs could control the system, called Human Machine Interface (HMI)<sup>3</sup>, using the screen shown in figure 12, as well as enabling maintenance personnel to remotely operate the system, or part of the system.

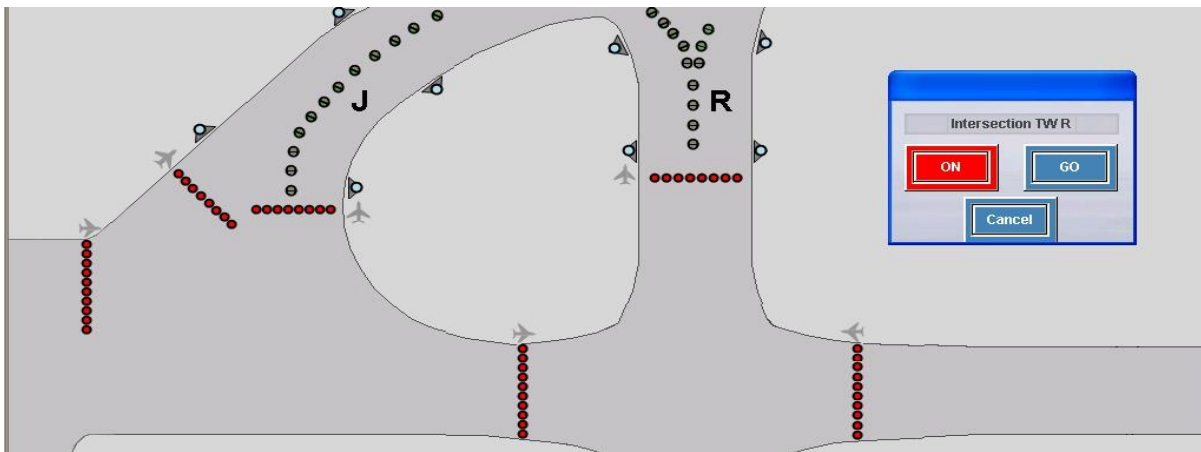
Figure 13. Viewing an intersection stop bar

For the Incident flight, when the ATCO wanted to operate the E15 stop bar, he had to touch the stop bar indicator in the screen which would have popped up the page shown in figure 13 indicating that the stop bar is ON and the green lead-in lights are OFF. Initially the ON button was red indicating that the stop bar was ON. Additional selectable options are ON, GO and CANCEL.

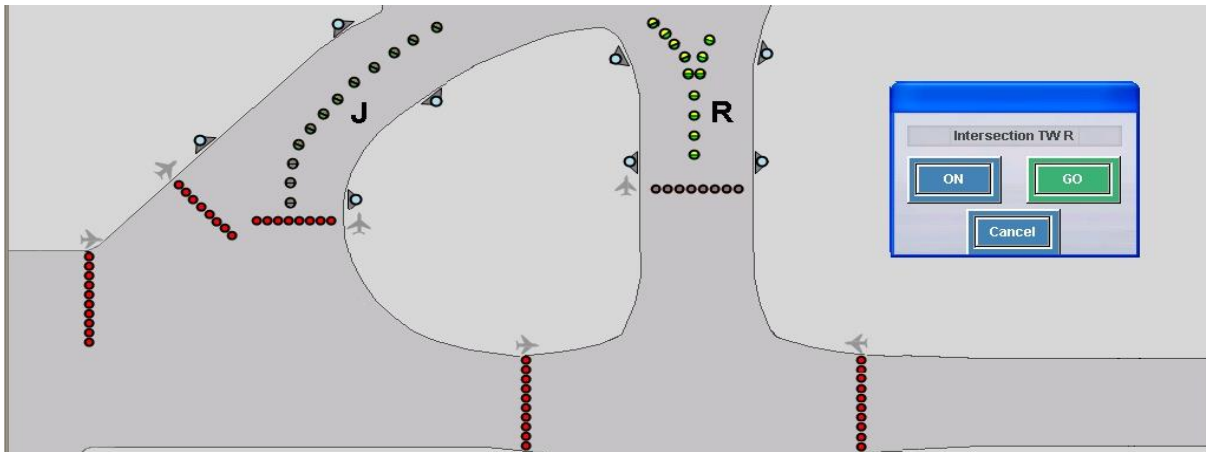
**Figure 14.** Activating an intersection stop bar

When the GO button was pressed, the colour changed to green (figure 14). The green lead-in lights came ON and the E15 stop bar lights went out. Then the ATCO instructed the Aircraft to proceed onto the active runway.

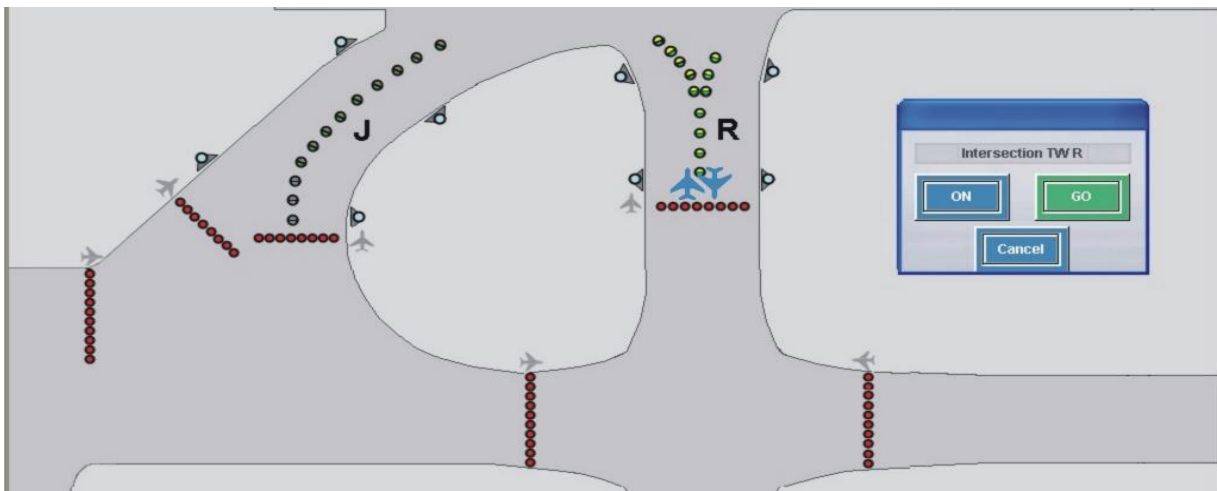
**Figure 15.** Aircraft passes the first sensor

When the Aircraft passed through the first sensor, a blue aircraft symbol appeared (figure 15) which indicated to the ATCO that the Aircraft had passed the stop bar. As per the ALCMS historical report provided to the Investigation, the E15 stop bar was switched ON two minutes and one second after it was OFF by the ATCO. The operation of the stop bar was done by manual selection as automatic selection was not available to the ATCO.

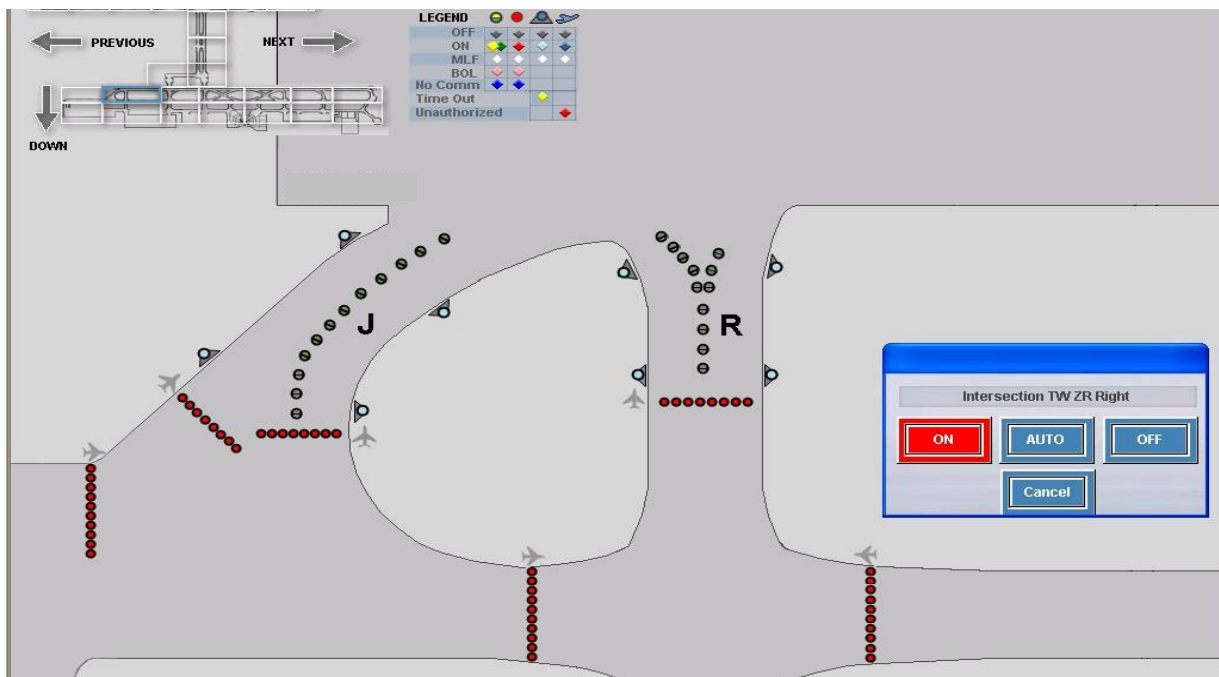
Figure 16. Activating a timed intersection

If the system was set to automatic, figure 16, the difference was that the stop bar would have turned back ON when either the Aircraft passed the second sensor 17/7, or a period of 45 seconds had elapsed since the command to GO was issued.
