Air Accident Investigation Sector

- Final Report -

AAIS Case File N° AIFN/0009/2015

Cabin Crew Serious Injury Due to Turbulence

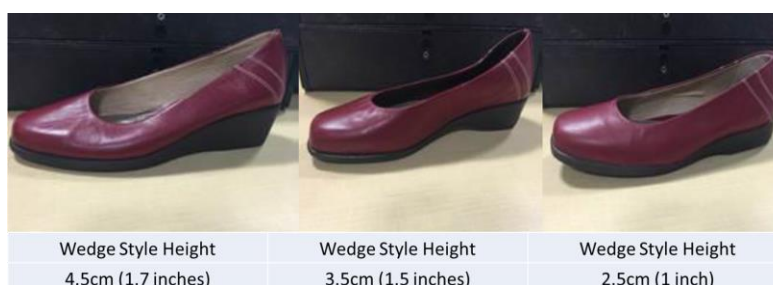
Figure 2. Cabin crew shoes

There are three different types. Wedge style – 1.7 inches (4.5cm), Flat style 1 – 1.5 inches (3.5cm), Flat style 2 – 1 inch (2.5cm) for the inflight service.

Female cabin shoe options (flatter heeled shoes)

At the time of the event the cabin crewmember was wearing the heel high shoes below, 7.5cm, 3 inches high.

The injured cabin crewmember was wearing high heel shoes during the approach phase of the flight which did not provide stable support in turbulent conditions.

The injured cabin crewmember was standing at the time of the turbulence encounter completing pre-landing tasks and fell over sustaining a fracture to her ankle.
