الهيئة العامة للطيران المدني
GENERAL CIVIL AVIATION AUTHORITY

- Final Report -

AAIS Case N°: AIFN/0001/2016

Balloon Hard Landing

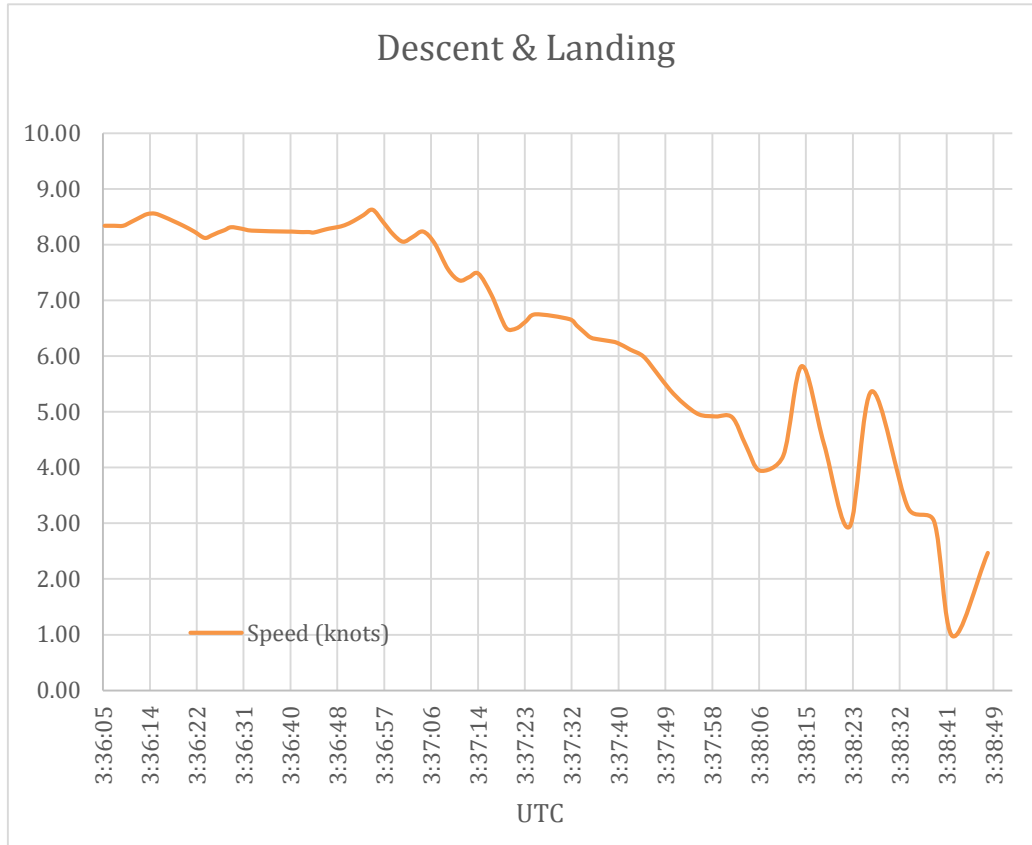
Figure 7b. Balloon speed during descent and landing

The downloaded height, rate of climb, and Balloon speed data are given in Figures 7a and 7b. The figures represent the time period from the start of descent, to landing.

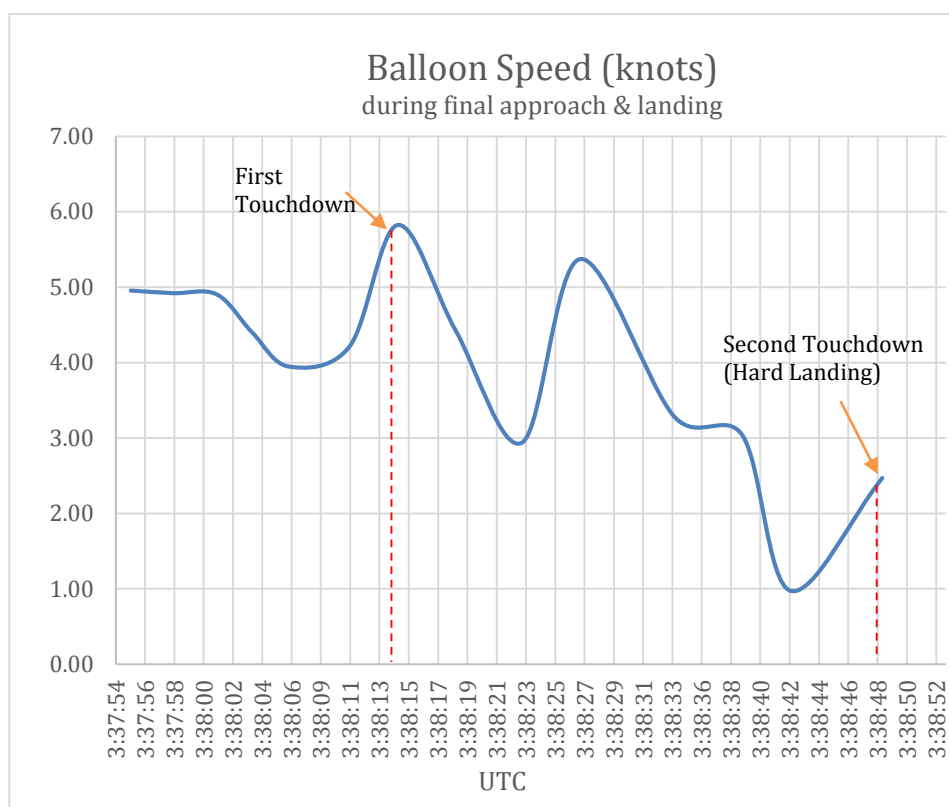
Figure 8c. Balloon speed on final approach and landing

Figures 8a to 8c show the last part of the final approach of the Balloon. The events shown in this figure are based on the information obtained from the Pilot, which includes the final application of the burners, FDS deployed, first touchdown, turning off the cylinder valves (shutdown of the burners), and the second touchdown.

The final burner application was estimated to have been between 10 and 12 seconds before the first touchdown, and it was continuously used for a relatively longer period.
