AAIS Case N° AIFN/0004/2017

Helicopter Controlled Ditching due to High Main Gearbox Oil Temperature and Associated Noise

Make and Model: AgustaWestland AW139

Nationality and Registration: The United Arab Emirates, A6-AWN

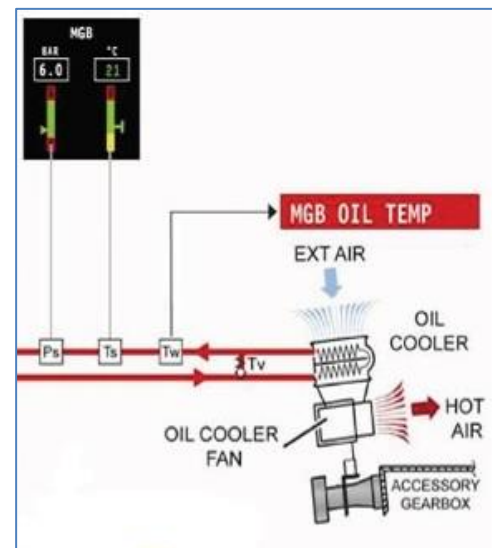
Figure 2. MGB cooling fan [Source: Leonardo Helicopters]

The Aircraft MGB oil cooling fan assembly was manufactured in April 2006 by Technofan in Italy. It was initially installed on another aircraft of the Operator's fleet in 2008, and was transferred to another aircraft for operational reasons having accumulated 258 hours in service. After reaching 2,398 hours, it was removed for overhaul in June 2013. It was then fitted to the Aircraft in January 2016, where it remained until the Accident. The oil cooling fan had reached 1,016 hours since overhaul (TSO) and 3,414 hours since new (TSN).

The fan assembly is a line-replaceable unit (LRU) with a 2,400 hour overhaul life. A visual inspection of the fan assembly is scheduled every 1,200 hours as task 39-A-63-20-03-00A-310A-A in the *aircraft maintenance manual (AMM)*. The task description is "Do a GVI [general visual inspection] to check freedom of rotation of the fan impeller (bearing roughness)."

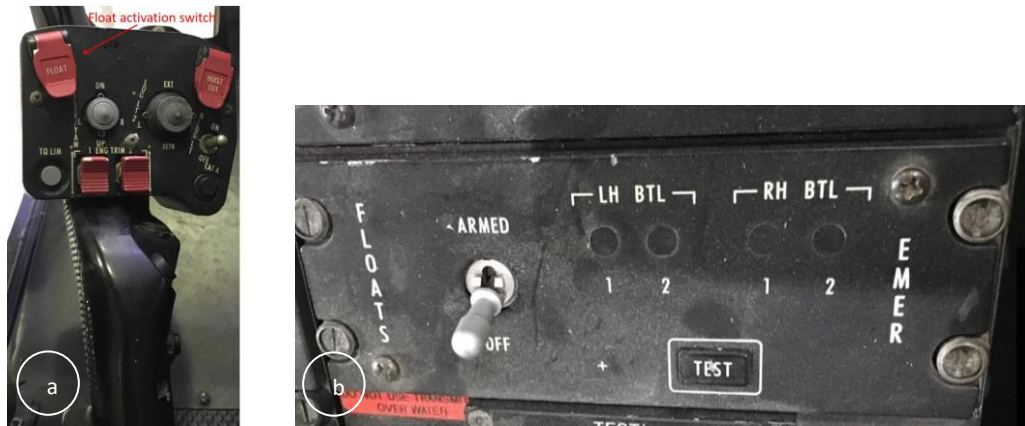
Figure 6. Floatation activation system

The flight crew deployed the emergency floats during the controlled descend at 150 ft prior to contact with the water. All four floatation devices inflated fully and provided sufficient buoyancy to keep the Aircraft upright and afloat. During the evacuation, the Commander noticed that the Aircraft tended to tilt towards the aft left float.

It was identified that part of the aft pillow chamber had delaminated, releasing air from the aft floatation chamber through the pillow inflation valve. A second area of delamination was found at a main chamber seam which was slowly releasing air.
