FINAL REPORT

97-75/A-26

PH-TKC

Final report of the investigation into the probable cause of the accident with Transavia Boeing 757, registration PH-TKC, on December 24th, 1997 at Amsterdam Airport Schiphol.

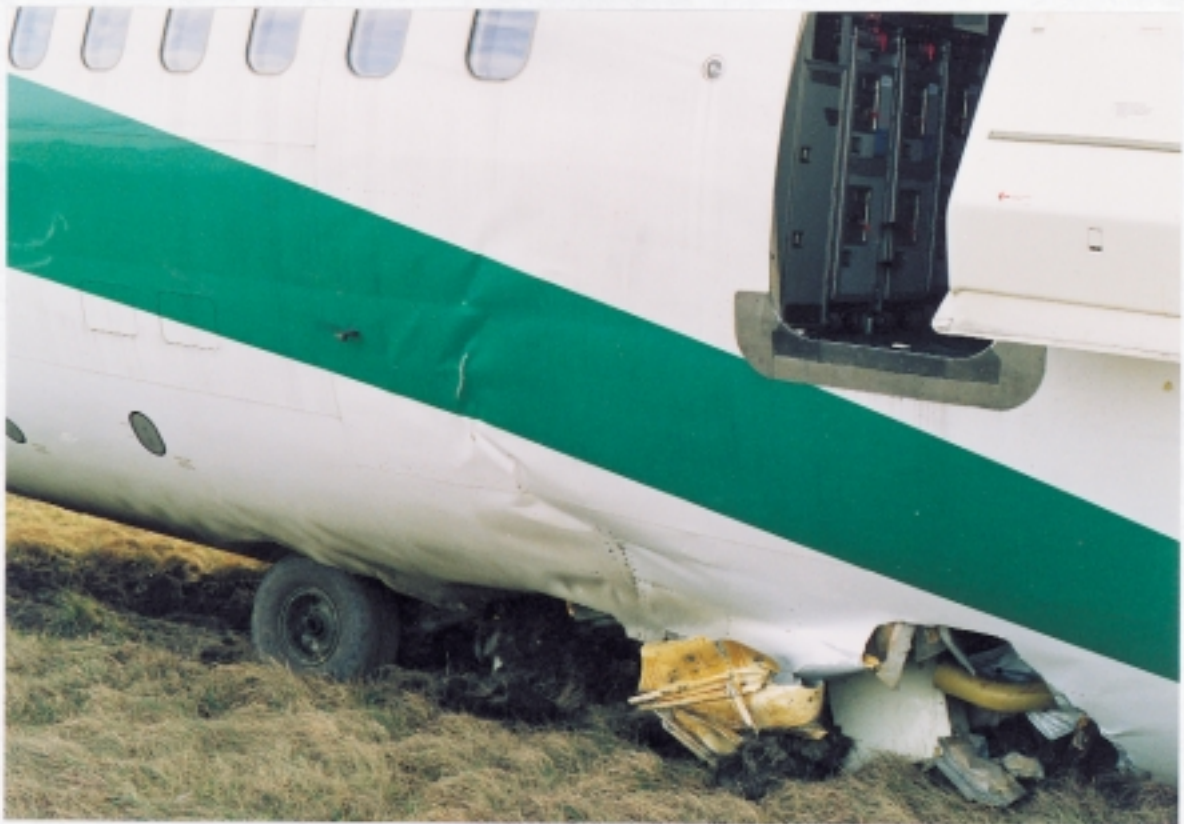
DAMAGE TO ELECTRONIC COMPARTMENT

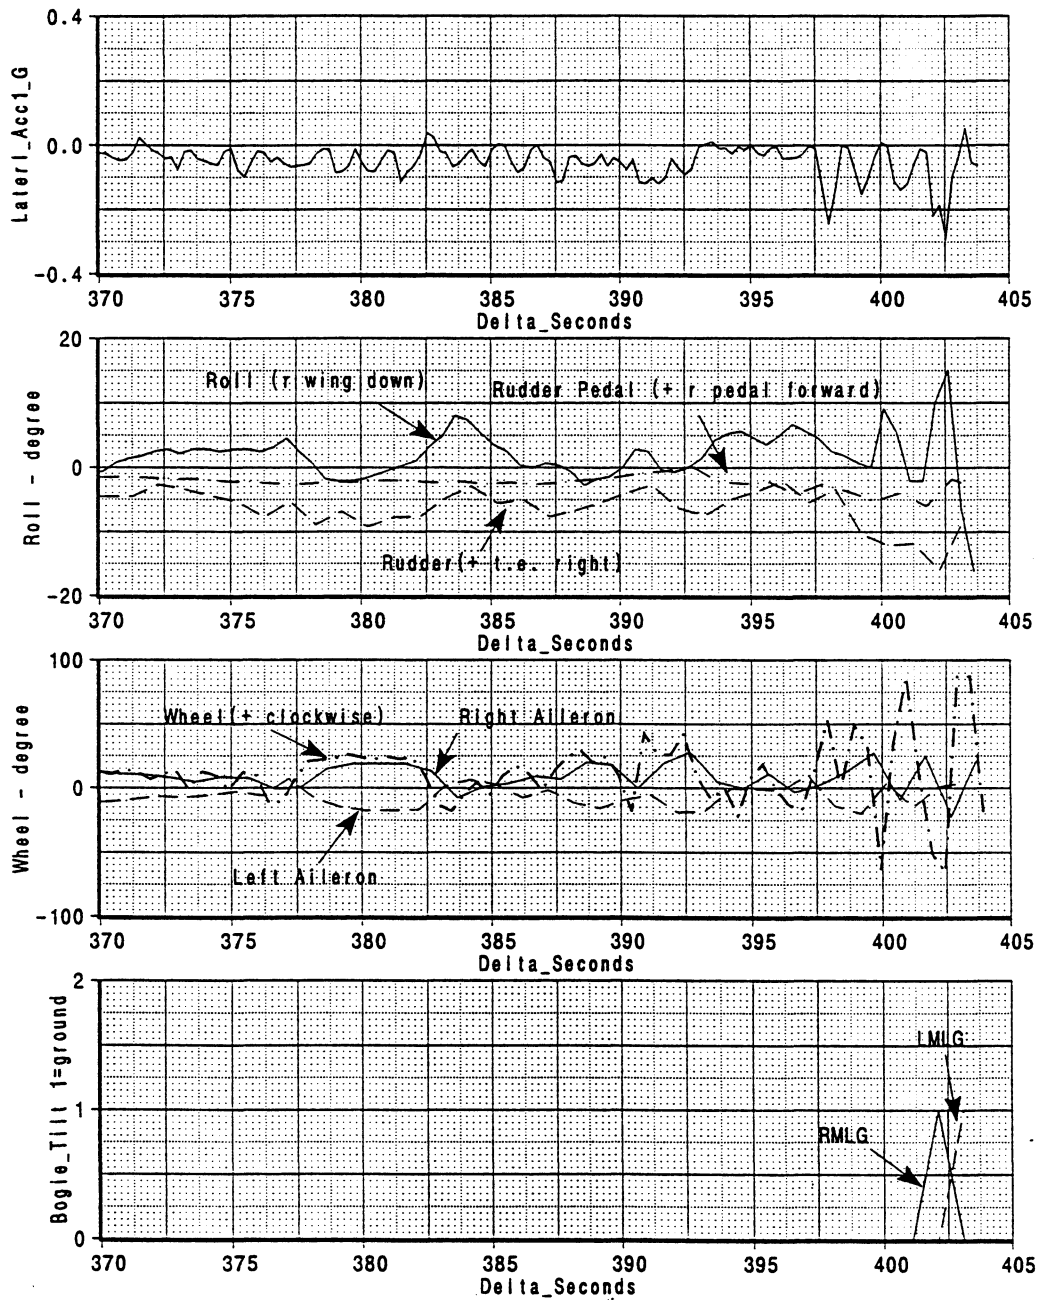
CALC	C. C. Ma	7Aug98	REVISED	DATE	TAV 757-200 PK-TKC/NB453 Landing Accident DFRD, Roll parameters	757-200
CHECK						
APPD.					BOEING	PAGE
APPD.						Figure 3

From Figures 3 and 4, the pilot was very busy responding to the cross wind to keep the airplane level. During the flare, beginning about time 398, the pilot had a few rapid maximum wheel cycle commands to fight the progressively bigger roll response of the airplane.

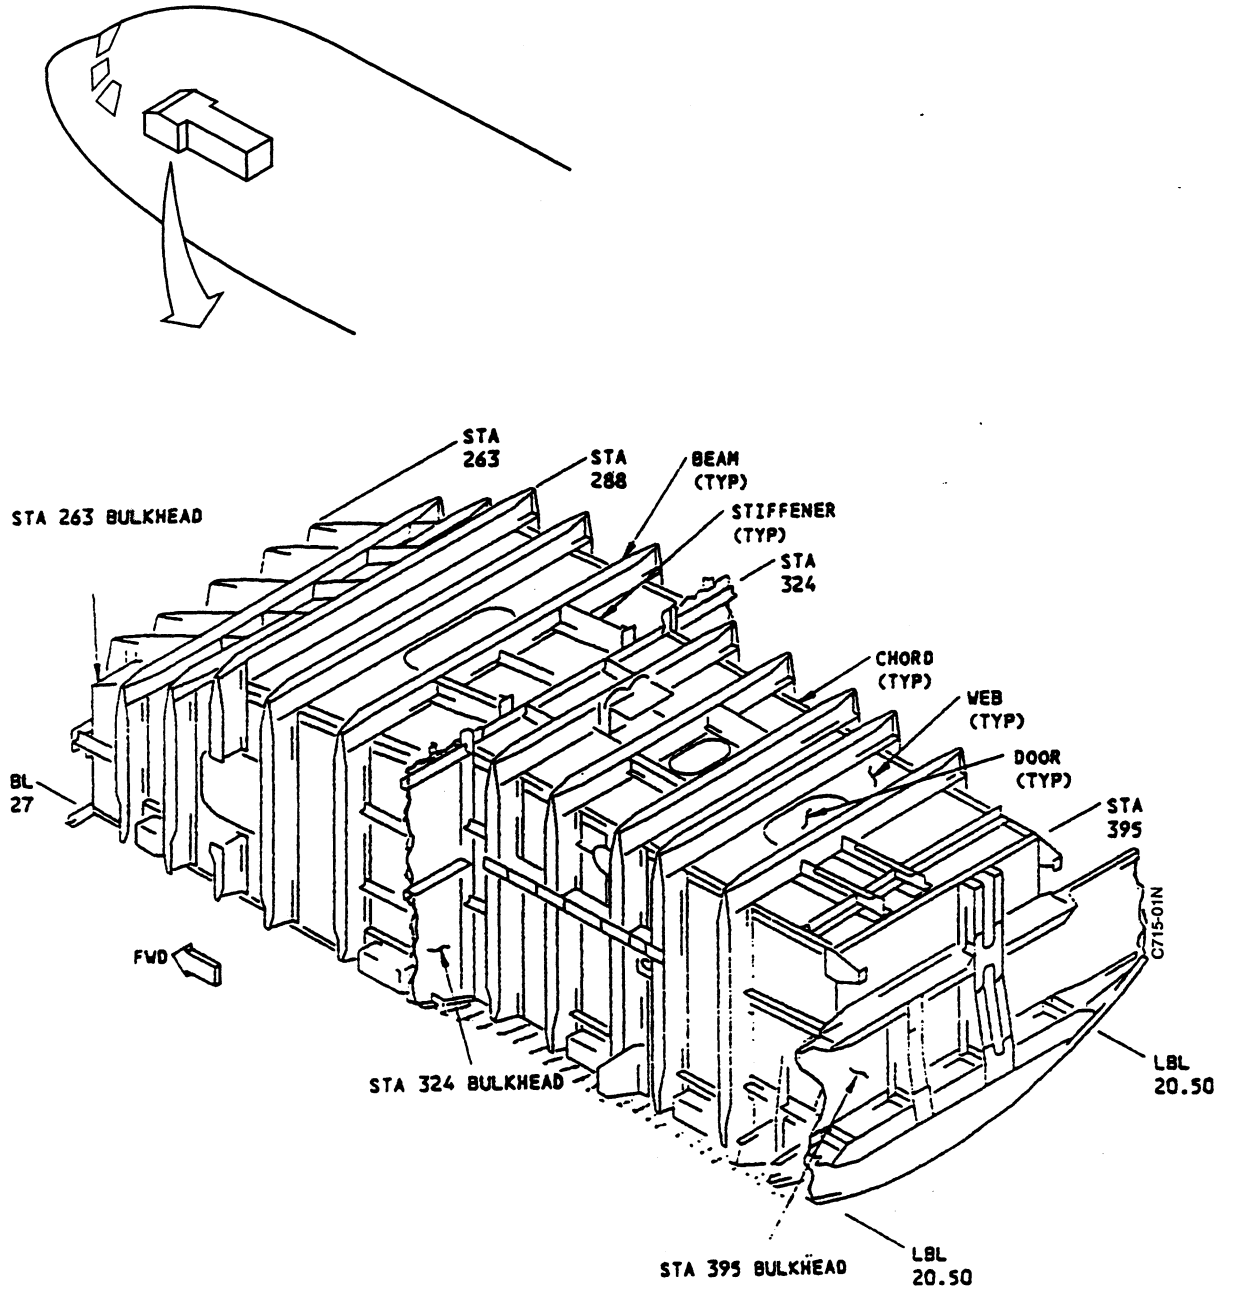
Fig. 1 Nose wheel well structure

The NLG is attached to the wheel well, which is a rigid box structure (so-called dog house). A schematic of the doghouse is shown in figure 1. The dog house consists of a forward and an aft part and is tied to the fuselage main structure at bulkheads STA 263, STA 324 and STA 395. These bulkheads are part of the nose wheel well structure. A left side view of the doghouse showing the NLG attachment fittings is given in figure 2. The NLG main strut attachment fitting is located at A, see figure 2, and the drag brace attachment fitting at location B.
