GENERAL INFORMATION

Identification number:	2007043
Classification:	Accident
Date, time ¹ of occurrence:	12 May 2007, 20.33 hours
Location of occurrence:	Waddenzee, West of Harlingen, the Netherlands
Aircraft registration:	D-EBAA
Aircraft model:	Reims Aviation F182Q
Type of aircraft:	Single engine piston
Type of flight:	Cross-country
Phase of operation:	En-route
Damage to aircraft:	Severely damaged
Cockpit crew:	One
Passengers:	None
Injuries:	Pilot deceased
Other damage:	None
Lighting conditions:	Daylight

SUMMARY

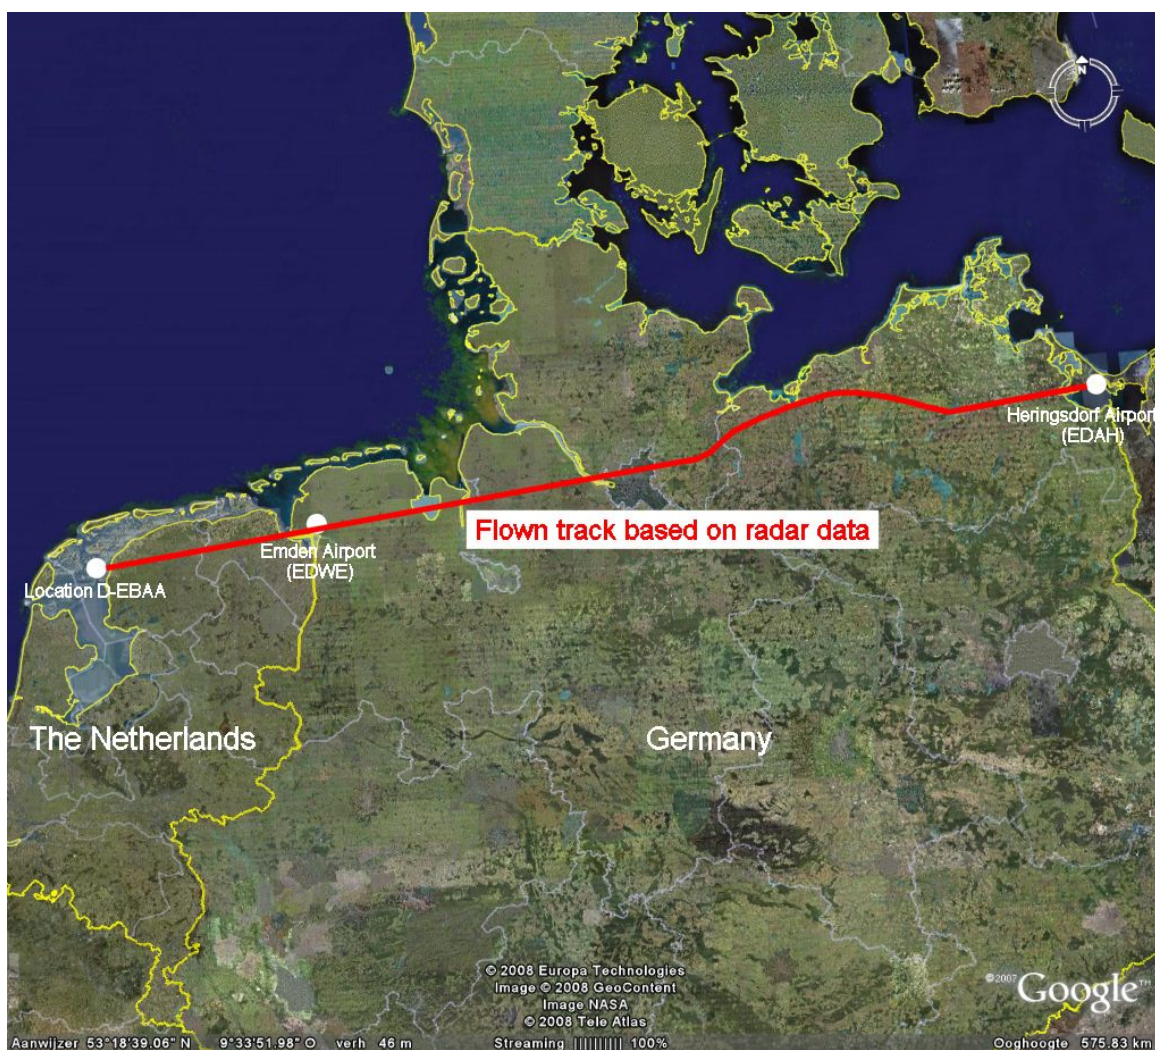
Figure 1: The flown route by D-EBAA.

The aircraft entered Dutch airspace at FL90 at approximately 19.30 hours. Because no radio contact could be established with the pilot, the Royal Netherlands Air Force scrambled two F-16 fighters from Leeuwarden air base to intercept the aircraft. It was reported by the pilots that the head of the pilot of the F182Q hung down and he did not react to signals. The speed of the aircraft was estimated to be between 80 and 100 knots. A military radar plot indicates that at 20.07 hours the aircraft left FL90 and started a descent. According to the pilots the aircraft was flying straight

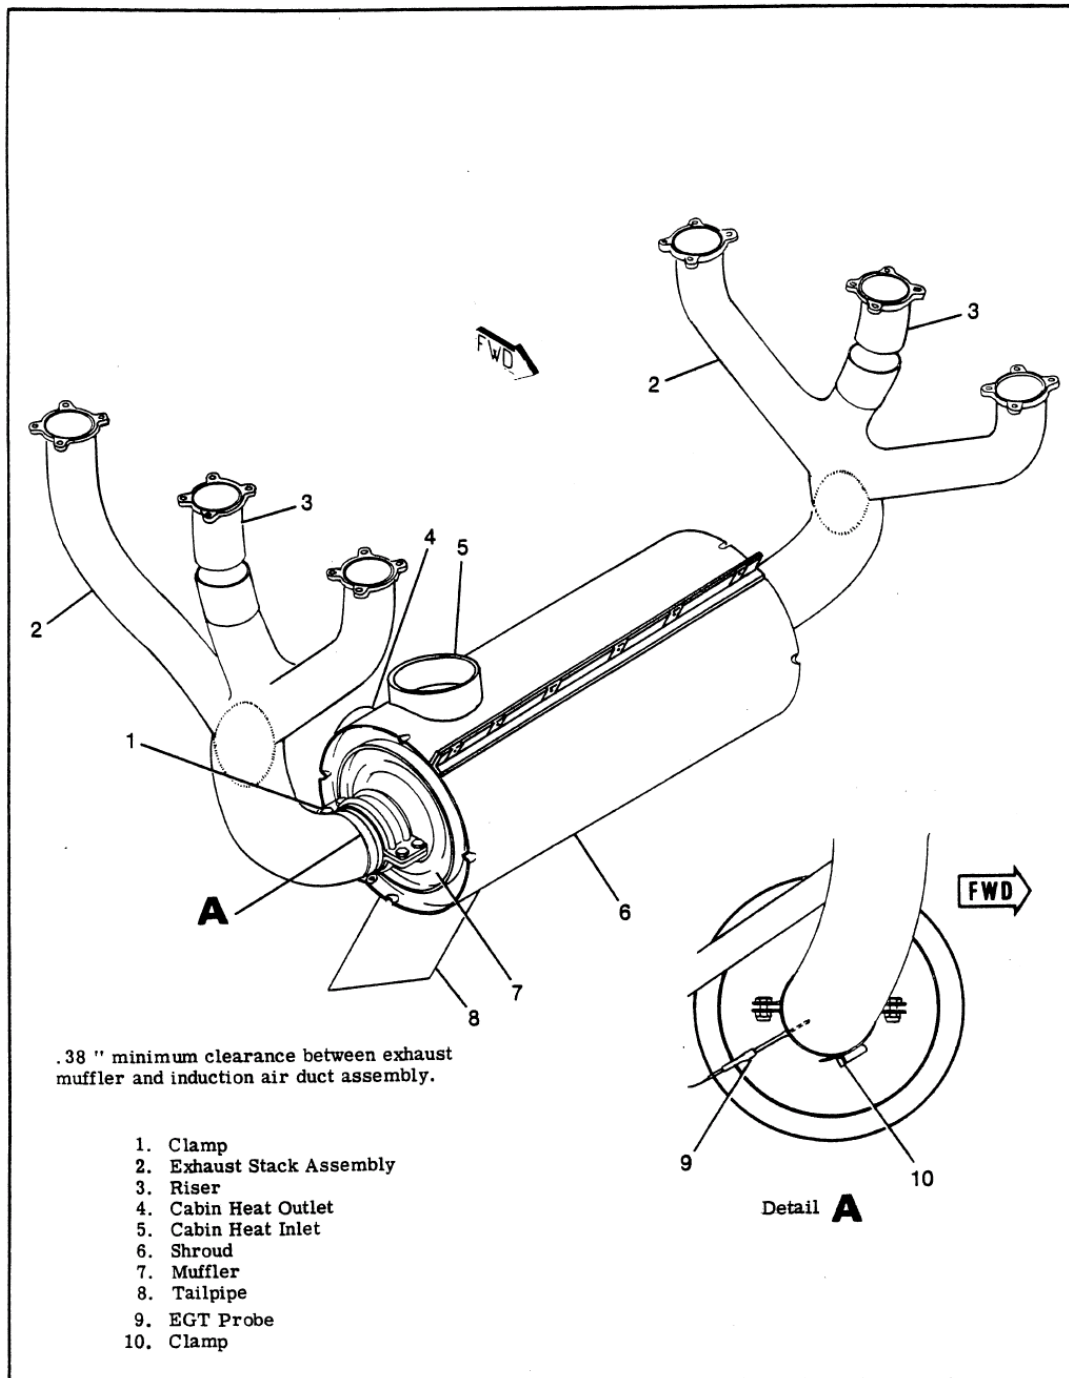
Figure 11-8. Exhaust System

A visual inspection showed some cracks around the exhaust muffler end plates. The exhaust was distorted by impact. The engine exhaust assembly¹³, excluding the heater cuff, was investigated in a laboratory.¹⁴ The corresponding report mentions that the muffler *'is damaged by scaling of the steel used. The effect of the corrosion by the hot exhaust gas is aggravated by the flaking of the protecting scale layers when the muffler cools down. Possibly the destruction of the sensibitized austenitic steel is additionally supported by electrolytic corrosion when the engine is out of operation. In the opinion of the investigator the steel type [...] is absolutely unqualified for the conditions in the muffler. The concentration of the scaling (crack formation) to the both ends of the cylindrical muffler probably results from the highest temperature in the entrance regions of the exhaust gas and from the mechanical stresses induced by the side cover plates'*.

Based on this report, Cessna Aircraft Company concluded that the engine exhaust assembly did not match their type design. Therefore, Cessna Aircraft Company stated there is no verification the part was the correct part, manufactured using the correct materials. Cessna Aircraft Company also concluded that the corrosion is not the result of a few hours of use, rather a prolonged process, which should have been detected using established inspection intervals and procedures.
