## ALGEMENE GEGEVENS

| Nummer voorval: | 2007043 |
| Registratie luchtvaartuig: | D-EBAA |
| Type luchtvaartuig: | Reims Aviation F182Q |

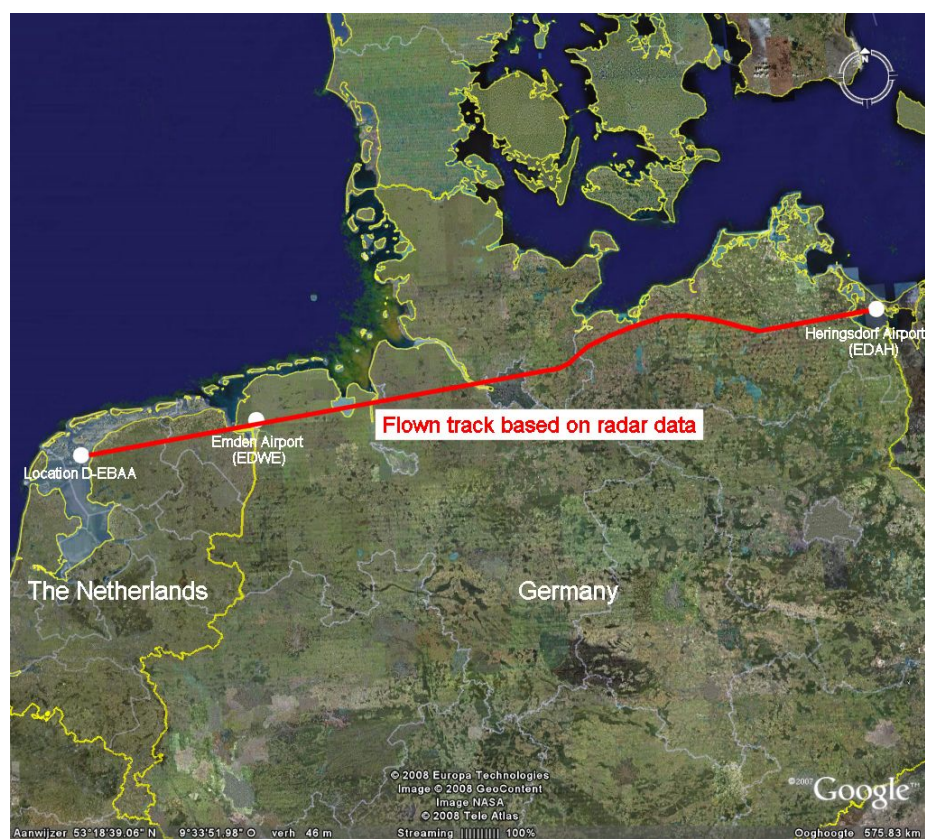
Afbeelding 1: De route gevlogen door D-EBAA.

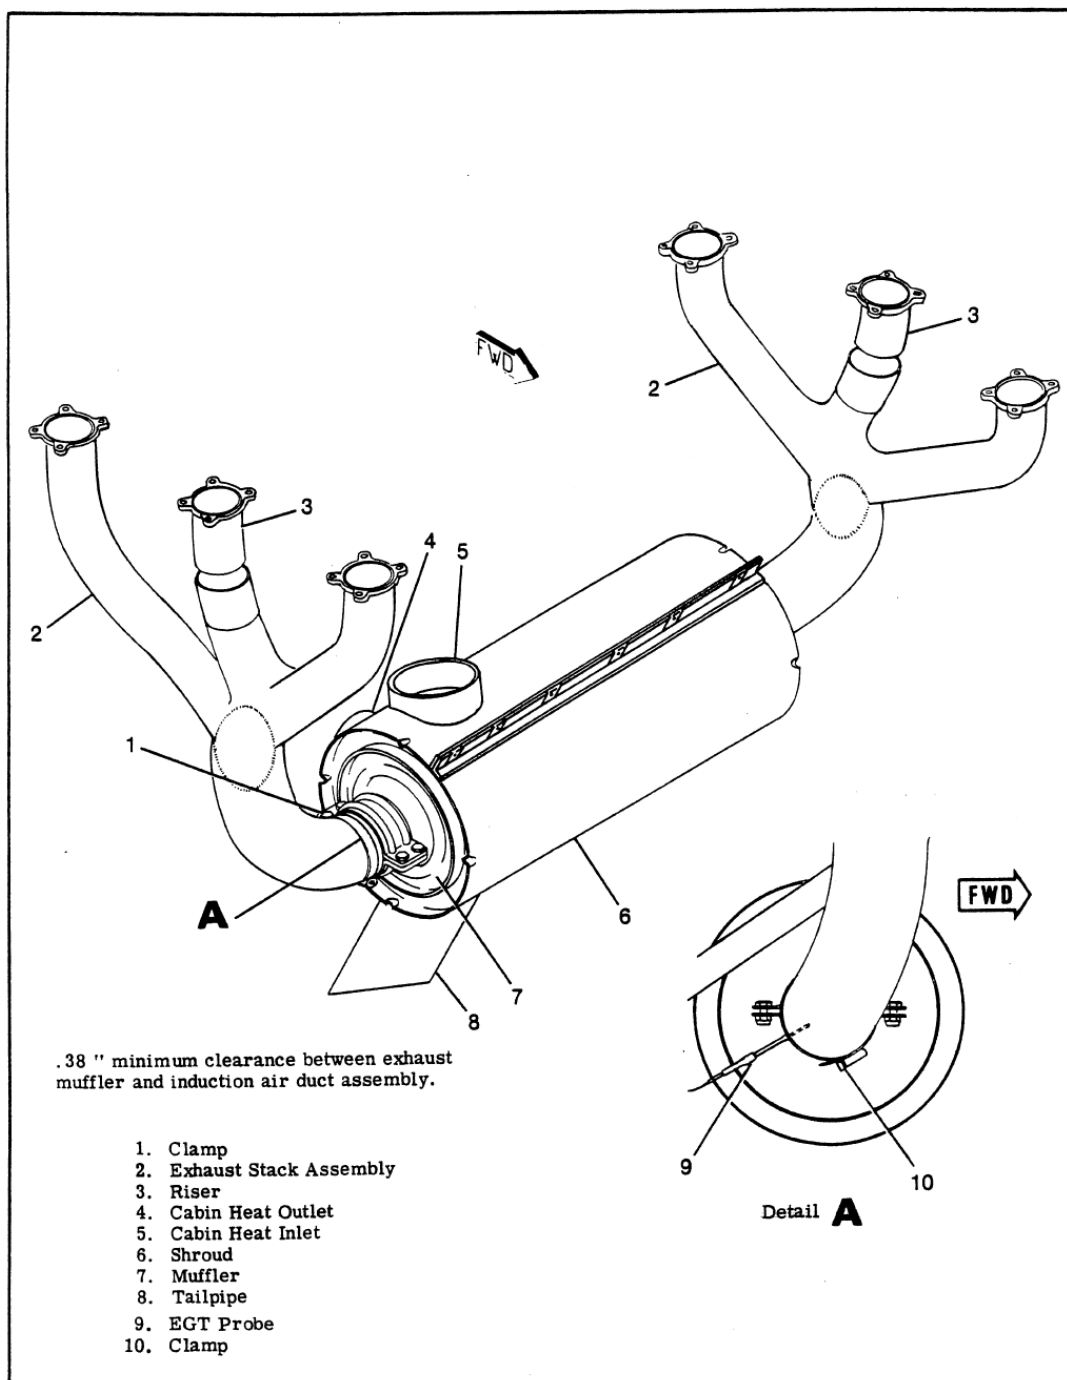
Figure 11-8. Exhaust System

In het onderhoudshandboek voor model 182 en T182 series staat vermeld: *Omdat uitlaatsystemen van dit type onderhevig zijn aan branden, scheuren en in het algemeen verslechteren door afwisselende temperatuurextremen en trillingen, is inspectie belangrijk en moet deze eens per 50 gebruiksuren plaatsvinden. Ook moet een volledige inspectie van het motoruitlaatsysteem gedaan worden om scheuren op te sporen die kunnen leiden tot een verlies van motorvermogen. Om het motoruitlaatsysteem te inspecteren dient als volgt te werk worden gegaan:*

- *Verwijder de motorkap waar nodig zodat ALLE oppervlakten van de uitlaataansluitingen visueel geïnspecteerd kunnen worden.*
- *Na een visuele inspectie, zou een check van het uitlaatsysteem plaats moeten vinden om te controleren op luchtlekken.*
- *Waar een oppervlak niet bereikbaar is voor visuele inspectie, of voor een test met meer zekerheid, wordt de volgende procedure aangeraden:*
  - o *Verwijder "exhaust stack assemblies".*
  - o *Gebruik rubber expansie pluggen om de openingen af te sluiten.*
  - o *Breng, gebruik makend van een manometer of een meetinstrument [...] luchtdruk aan terwijl elke "stack assembly" onder water is. Een lek laat zich zien als belletjes en kan eenvoudig opgespoord worden.*
