DUTCH
SAFETY BOARD

Two cases of wing fire

in Apex DR400 aeroplanes

The Hague, May 2017

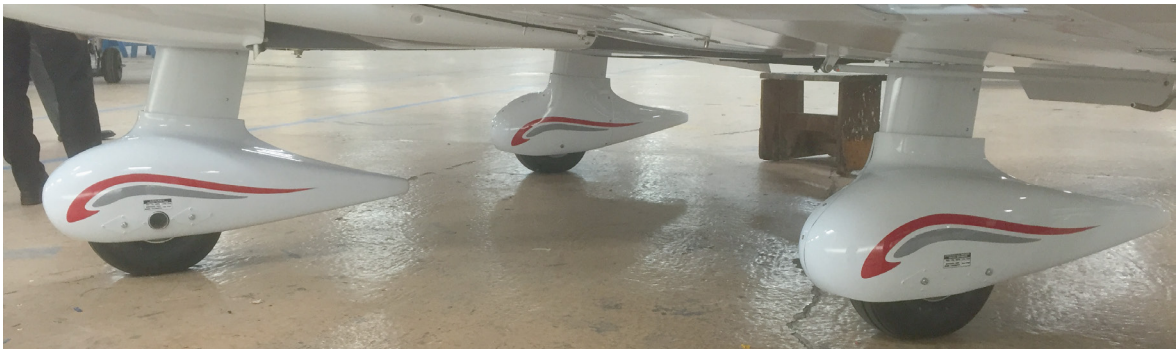
Figure 3: DR400 landing gear strut and wheel fairings. (Photo: Dutch Safety Board)

The aeroplane has a non-retractable tricycle landing gear, consisting of a left-hand and right-hand main gear and a steerable nose wheel. The main gear is attached to the wooden main wing spar. All the gear struts and wheels are covered by fairings, made of synthetic fibre (see figure 3).

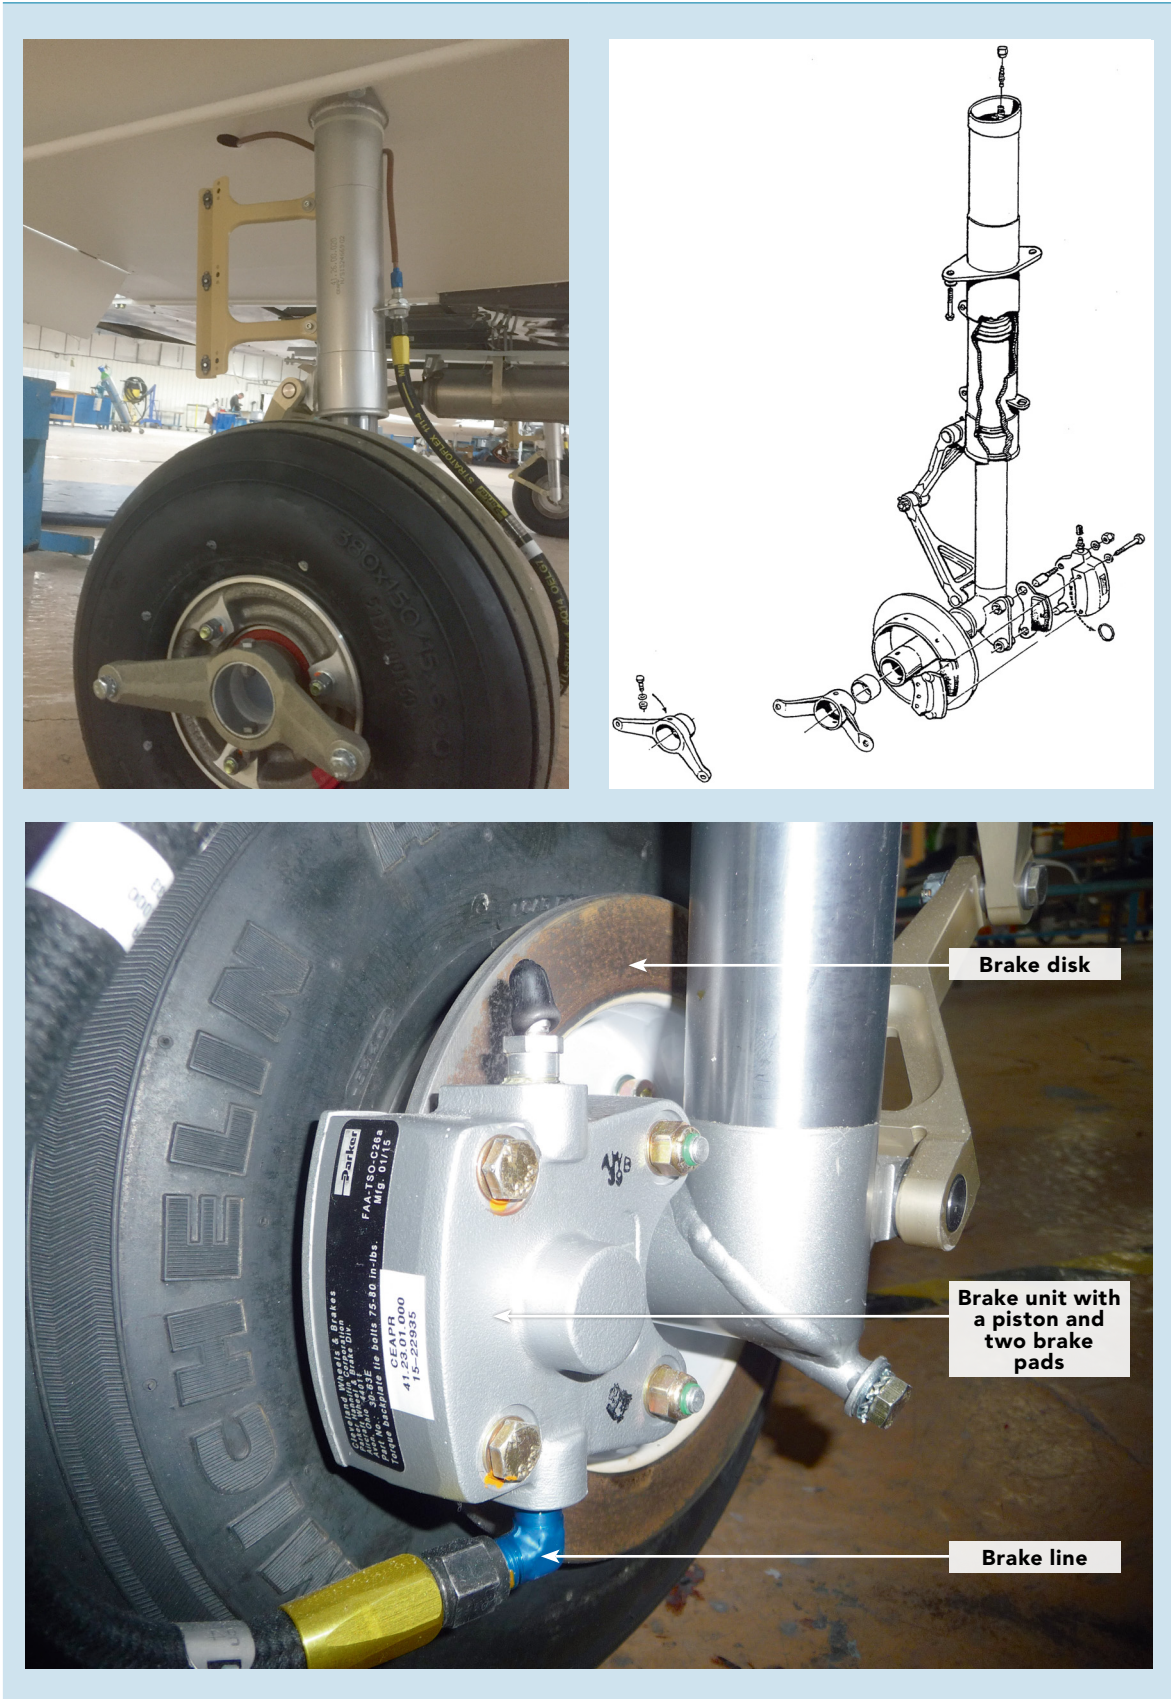
Figure 4: DR400 brake unit, schematically and as seen from either side of the wheel during aeroplane construction. (Source: Dutch Safety Board and Apex DR400 Aircraft Maintenance Manual)

The current braking system consists roughly of the following parts: two brake pedals, two brake cylinders, a parking brake, brake lines, and one brake unit per wheel. The brake unit of each wheel consists of a brake disc and a cylinder assembly (i.e. one piston with two brake pads on either side of the brake disc), see figures 4 and 5.

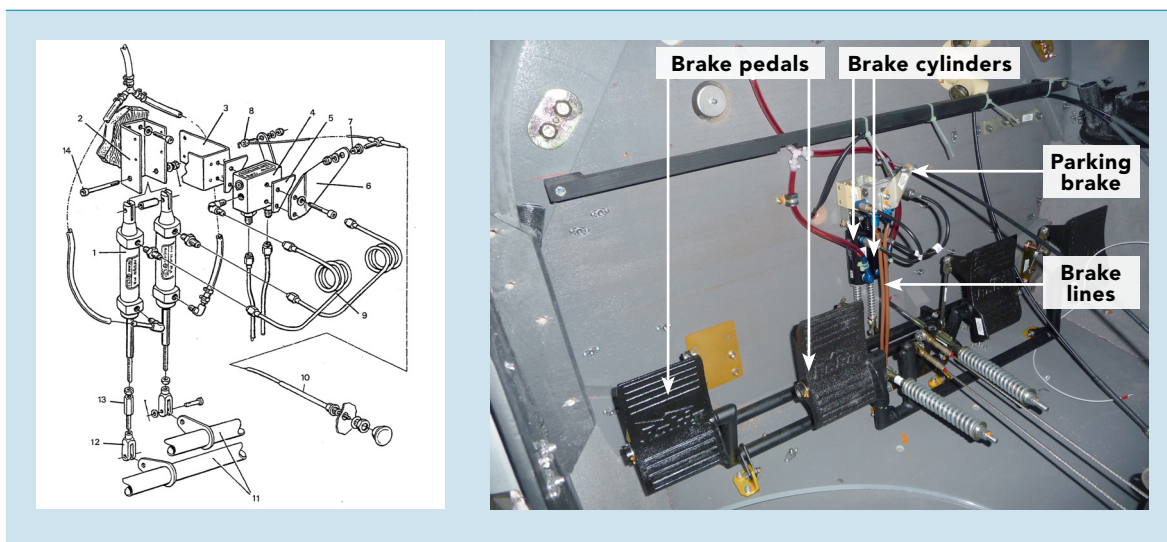
Figure 5: The DR400 brake system during aeroplane construction. (Source: Dutch Safety Board and Apex DR400 Aircraft Maintenance Manual)

By pressing the brake pedal (left, right or both), mechanical movement is applied to the brake cylinder. The cylinder in turn provides hydraulic pressure to the hydraulic oil which runs through a pipe and valve system to the parking brake unit. If the parking brake is not set, the hydraulic oil flows through the brake system to the cylinder assembly. The two brake pads located on each side of the brake disc will press onto the disc itself, resulting in braking action. The brake pads are pushed onto the brake disc by a piston which is sealed by an O-ring seal.

In addition to normal braking, the aeroplane has a parking brake operated by a pull-out knob located under the dashboard. When the brake pedals are pressed and the knob is pulled, the brake pads are locked into position by preventing the hydraulic fluid from flowing back. The brakes are locked and thus the parking brake is set (see figure 5).

Furthermore the pedals of the combined nose wheel steering/brake system are comparatively small. Moreover, contrary to the drawing in figure 13, the pedals in the DR400 are placed in a steep angle, see figure 5. These three factors may lead to feet being misplaced, c.q. inadvertent braking. Brake riding could therefore not be ruled out in either of the two accidents.
