**FINAL**  
KNKT.12.12.27A.04

**NATIONAL  
TRANSPORTATION  
SAFETY  
COMMITTEE**

**Safety Investigation Report**

**Electrical Failure  
Soekarno-Hatta International Airport  
Tangerang, Banten  
Republic of Indonesia**

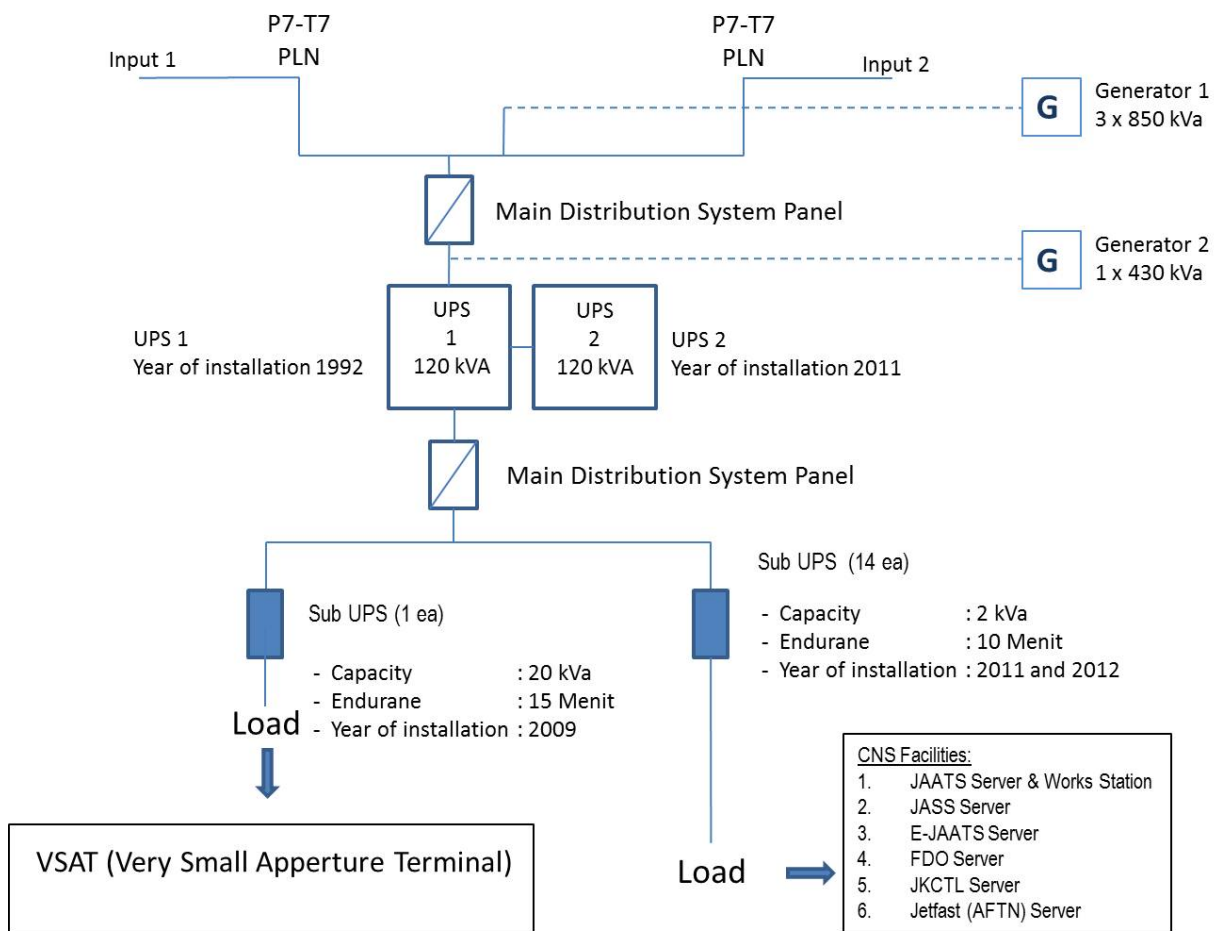
### UPS 1

Country of Manufacturer : France  
 Manufacturer : Socomec  
 Type/ Model : A2S. 3047  
 Serial Number : AFF 5796  
 Year of Installation : 1992  
 Capacity : 120 kVa  
 Endurance : 2 hours

The failure UPS (UPS 1) replaced by UPS 2, and UPS 2 replaced by a spare UPS with same capacity (120 kVa). The UPSs was arranged in series.
