**FINAL**  
KNKT.12.03.06.04

# NATIONAL TRANSPORTATION SAFETY COMMITTEE

Aircraft Accident Investigation Report

**PT. Airfast Indonesia**  
**Eurocopter AS 350B3 ; PK-ODA**

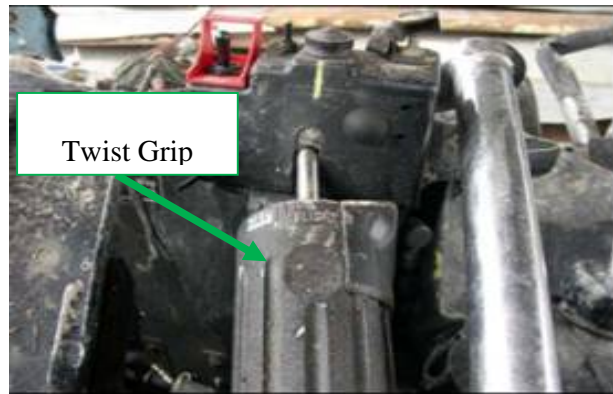
**Figure 8: Twist Grip**

The “twist grip” handle on the collective pitch lever was in the “Flight” position. This is the normal position during flight

The fuel shut-off switch was not activated and was in the open position (red guarded). This is the normal position during flight.

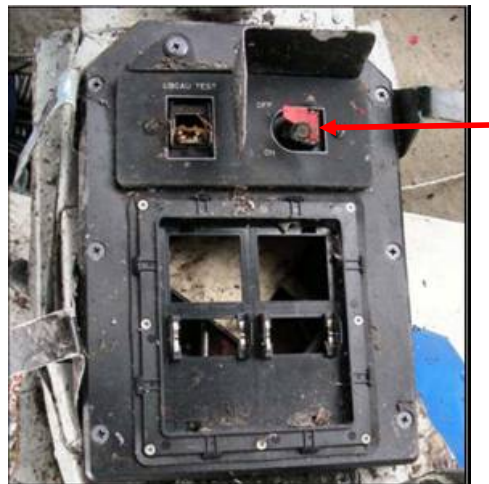
**Figure 9: The engine start switch position “ON”**

The engine start switch was in the “On” position with the guard in the folded down position. This is the normal position during flight.

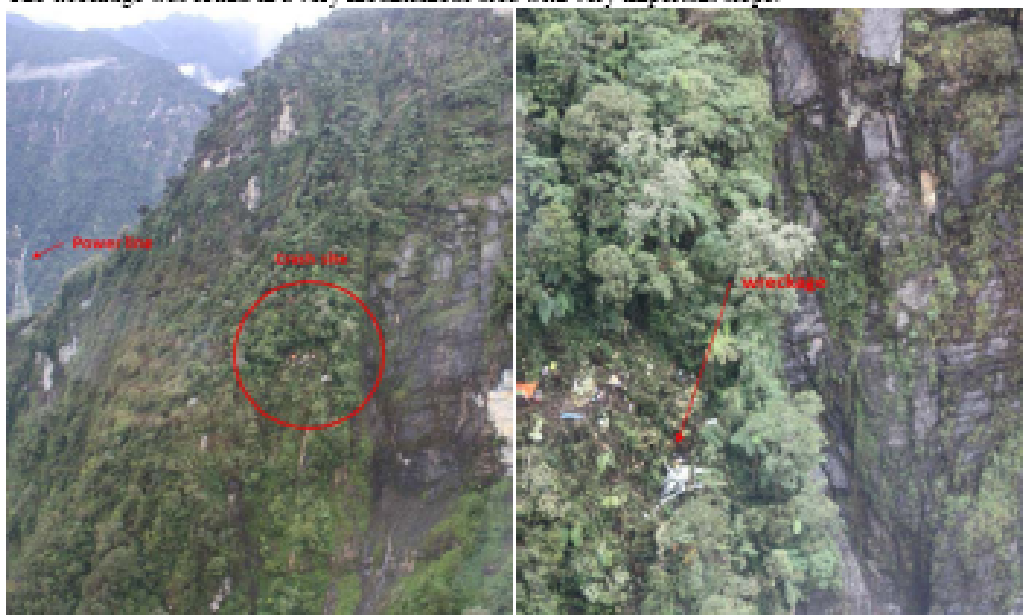
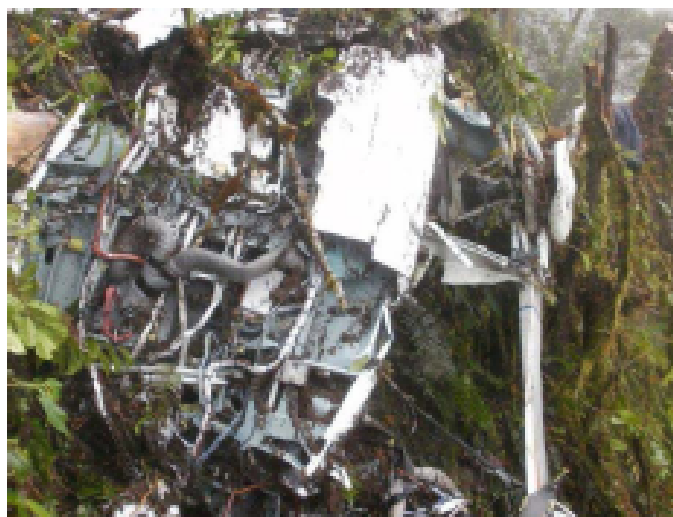
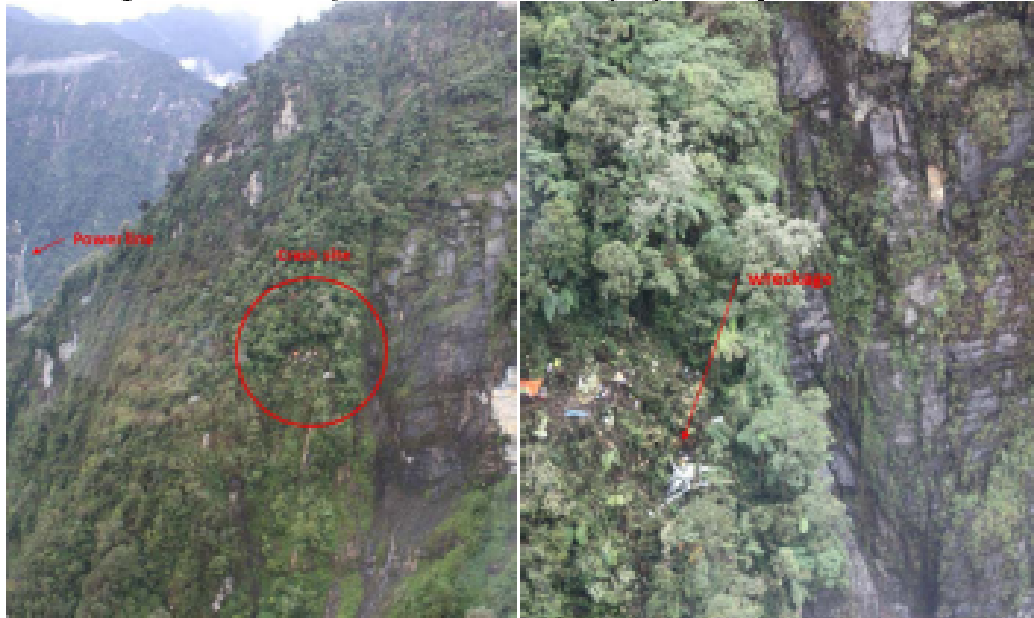
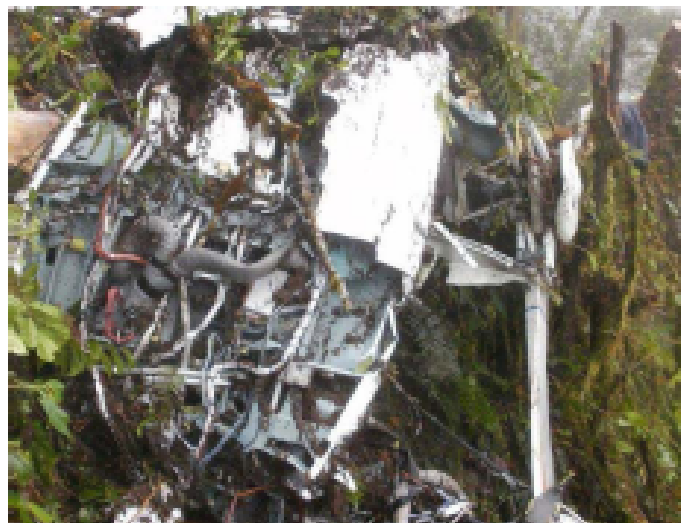
The wreckage was found in a very mountainous area with very important slope.

Due to the area of the crash (forest, high slope...etc), the examination of the wreckage has been performed in a hangar in Timika after the recovery.

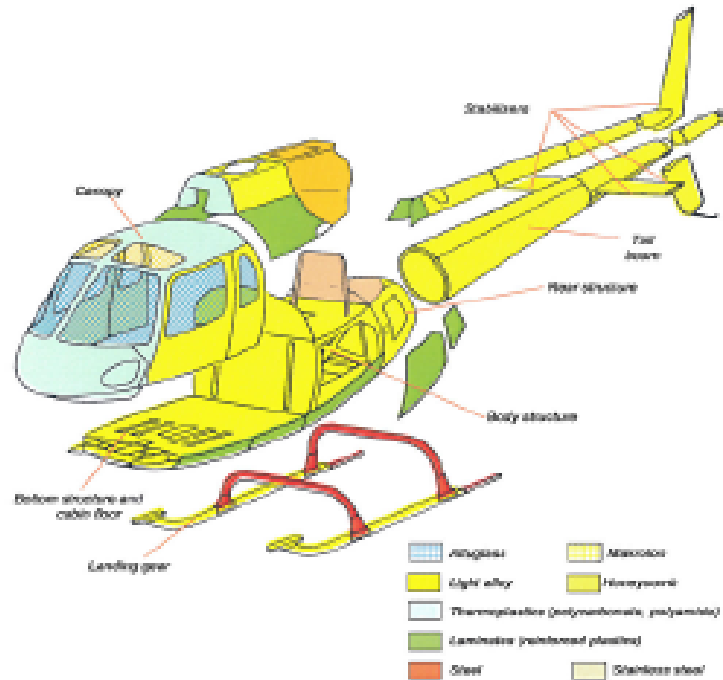
The wreckage examination took place at Timika where the main parts of the wreckage have been transported.

The canopy, parts of the landing skids and the main gear box (MGB) / engine coupling are missing. The blades have been cut for recovery reason.

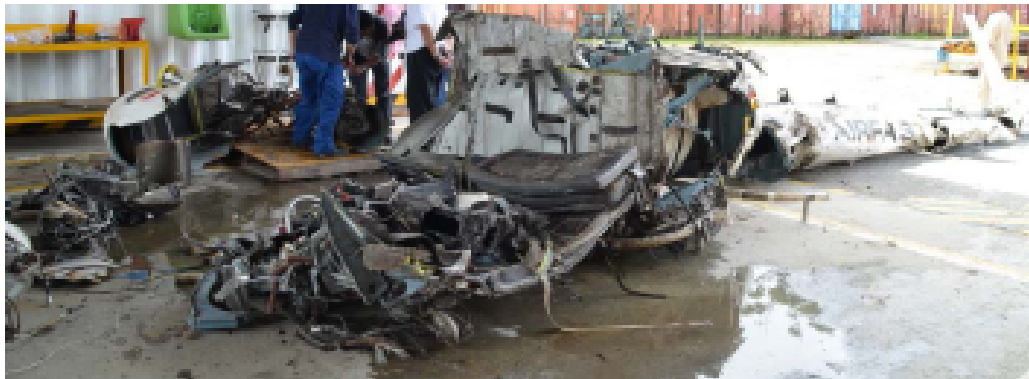
**5.1. Landing Gear:**

The skid landing gear exhibits some damages which are consistent with a significant longitudinal velocity. Indeed, both cross tubes don't present deformation due to vertical load but have swiveled backward conducting to the failure at the junction with the horizontal tubes which are missing.

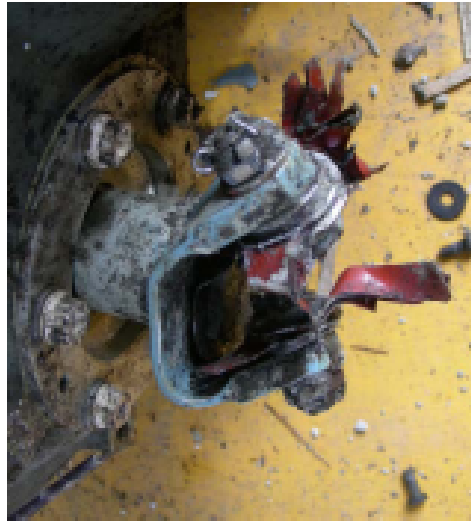
Engine output shaft

The forward steel drive shaft is missing.

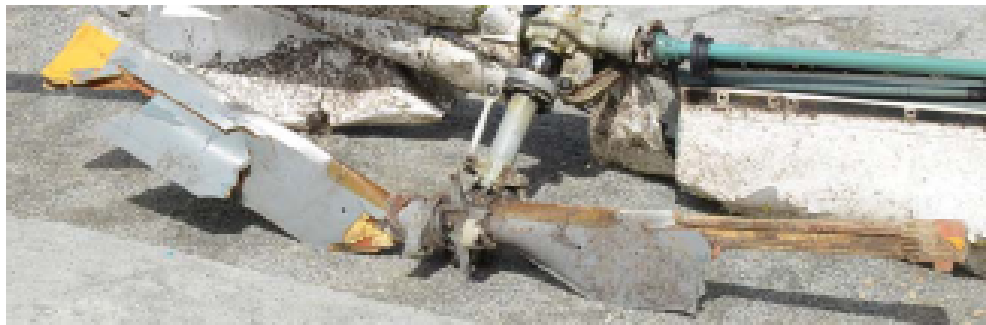
#### General Conditions of the Tail Rotor Blades

The tail rotor blades are severely damaged due to the contact with the trees & the ground. These findings are consistent with a presence of significant rotor speed during the impact.

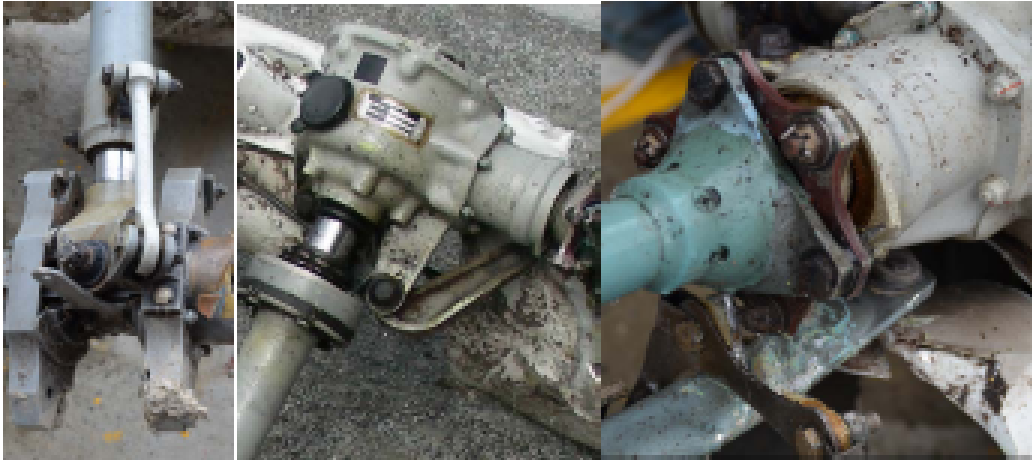
General Conditions of the Tail Gear Box and Tail Rotor Head

No damage observed on the pitch change control system (pitch change ballcrank, pitch change spider, pitch links...).

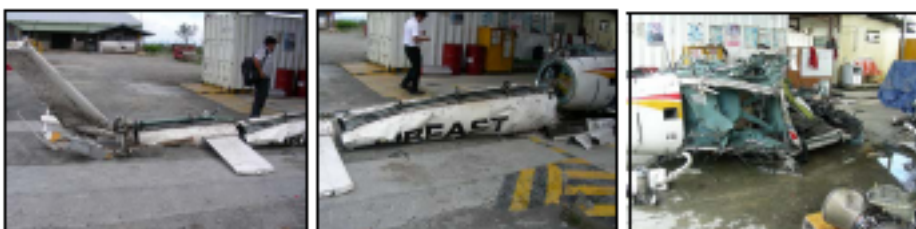
- The airframe was severely damaged. The helicopter's tail rotor, engine, Main Gearbox and dashboard had separated from the main body. The canopy was missing.

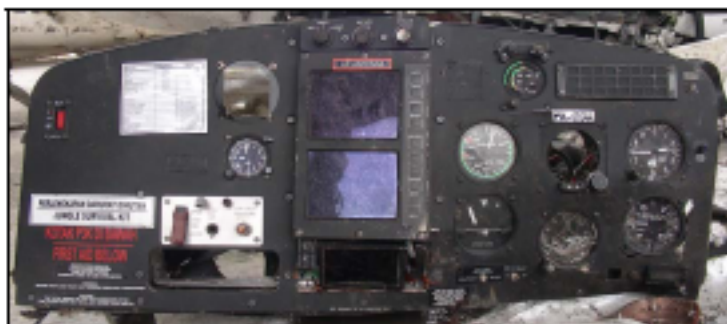
- The cockpit was separated from the main structure. No engine information could be read on the engine parameter indicator.

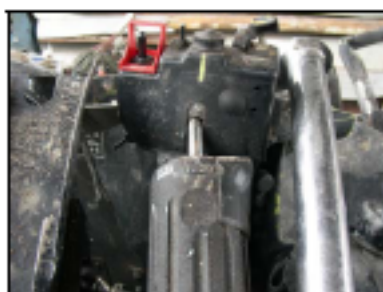
- The "twist grip" handle on the collective pitch lever was in the "Flight" position. This is the normal position during flight.

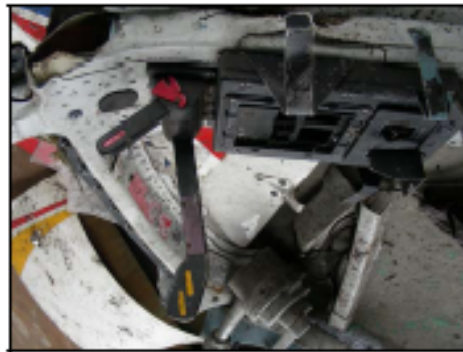
- The fuel shut-off valve was not activated and was in the open position (red handle). This is the normal position during flight.
- The rotor brake handle (yellow handle) was in the activated position although this is not coherent with the damaged condition of the main rotor blades. Therefore, the handle may have been pushed back during the crash or during the recovery efforts.

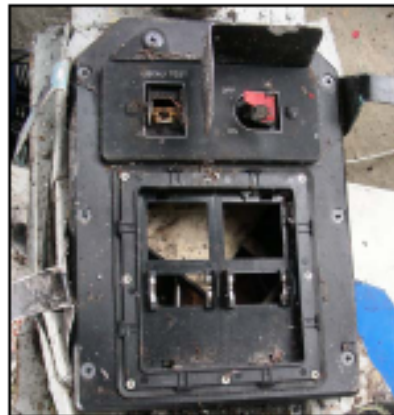
- The engine start switch was in the "On" position with the guard in the folded down position. This is the normal position during flight.

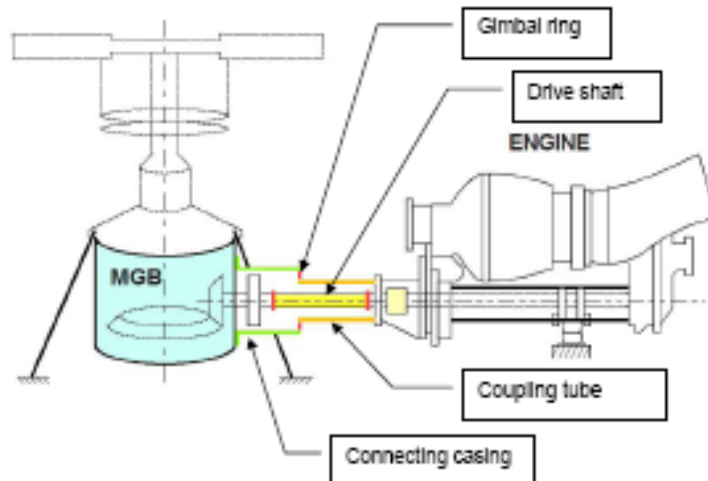
- The Main Gearbox (MGB) was separated from the helicopter and the engine was separated from the MGB. The gimbal ring and the drive shaft were not recovered from the crash site.

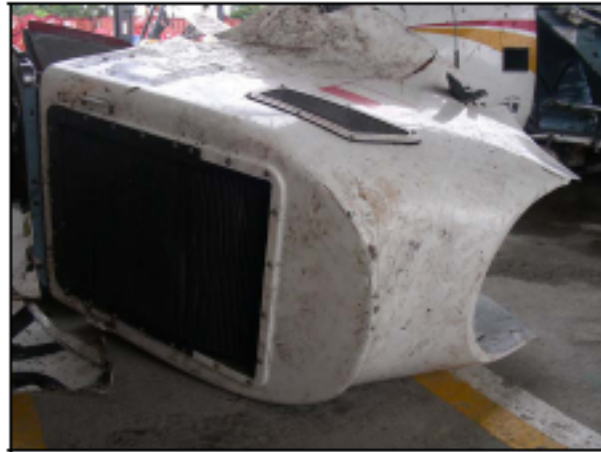
- The engine cowling was mainly intact and did not reveal any pre-crash damage. It was still attached to the engine compartment front fire wall.
- The air intake was fitted with a sand barrier filter that did not present any anomaly.

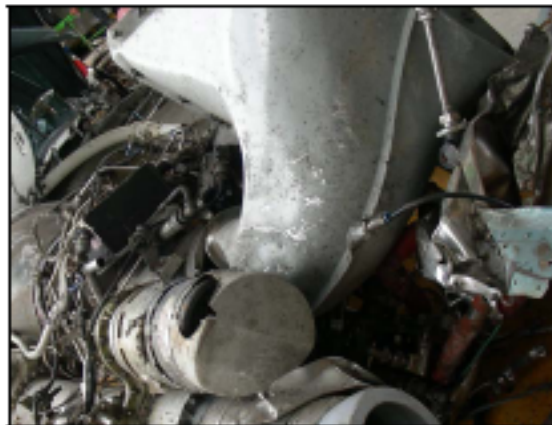
- The air intake was fixed to the engine and exhibited several impact marks resulting from the crash including one area punched inwards near its front flange.
- The removal of the air intake revealed that the punched area had come to rub against the compressor's axial wheel.

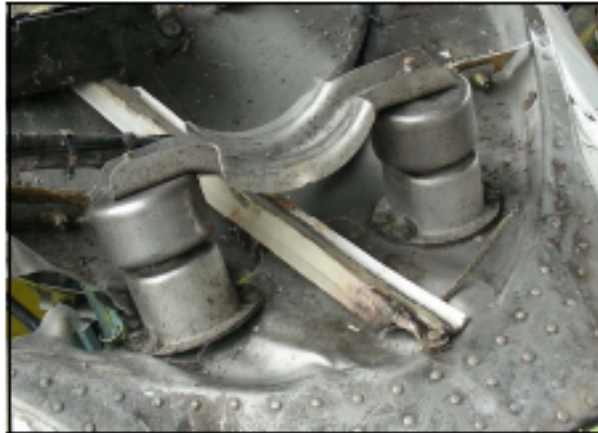
- The rear engine support was in place. The cradle was slightly twisted as a consequence of the crash. The two clamps that fix the engine to the cradle were not recovered.

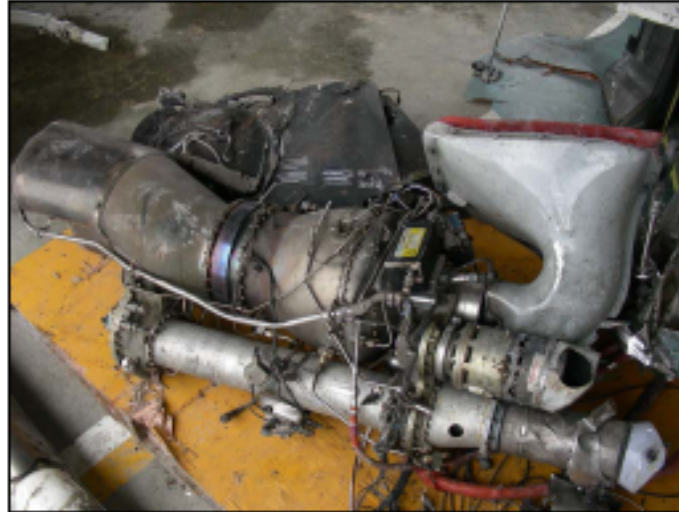
The whole engine was recovered and had retained its integrity during the crash.

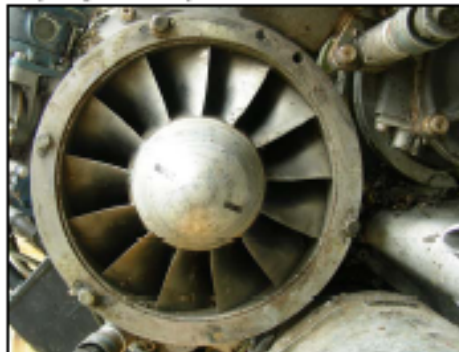
The axial compressor blades were present and were free of impact marks.

The nose cone exhibited circular rubbing marks that are coherent with the punched area noticed on the air intake (see § 5.5 above).

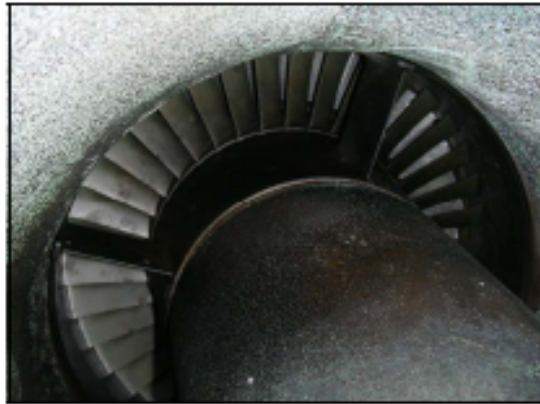
All the Free Turbine's blades were present and appeared in nominal condition.

The free turbine wheel could be rotated by hand. The rotation was silent and smooth.

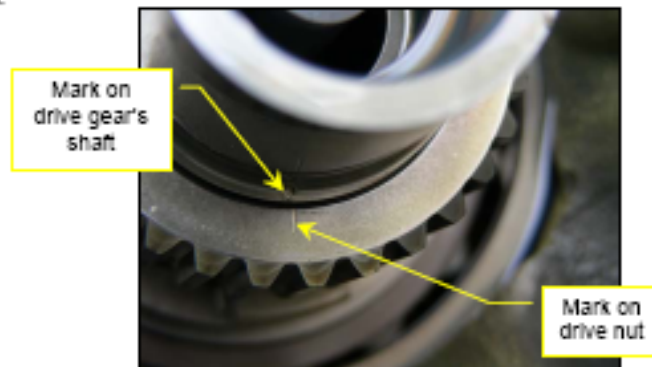
A close examination revealed that the nut had rotated on its shaft by approximately 0.5mm to 1mm.

The misalignment of the mark on the drive nut with respect to the mark on the drive gear's shaft occurred when the engine encountered an important sudden increase in resistant force whilst delivering power. The torque increase is likely to have occurred when the main rotor (blades or rotor head) hit the solid obstacles (trees or ground).

The misalignment indicates that the engine was delivering power at the time of the accident.

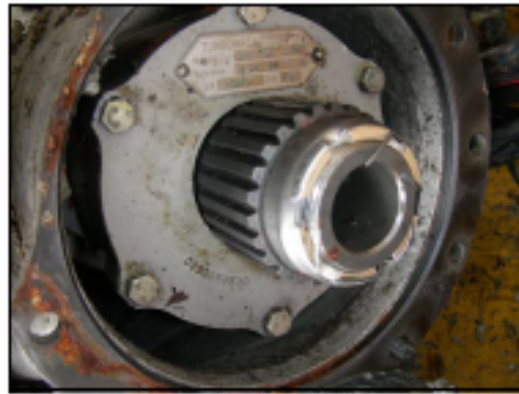
The free wheel could be rotated by hand. Its rotation could be locked or unlocked by rotating the output shaft in opposite directions thus confirming the nominal operation of the free wheeling function.

The splines of the output shaft were in good condition and did not present any surface marks especially at their front ends. This indicates that the torque level was low when the drive shaft disengaged and that the drive shaft was no longer connected to the MGB when that happened. The thin metallic strips at the front end could have been produced by the rubbing of the drive shaft inner diameter on the free wheel shaft's locking washer upon disengagement.

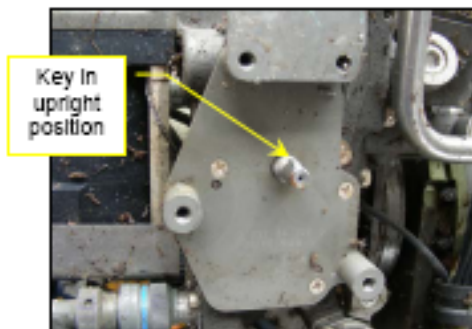
The EBCAU auxiliary control drive unit was removed to reveal that the key on the HMU's auxiliary input drive shaft was in the upright position. Therefore, the auxiliary mode was not used during the last flight and consequently the DECU did not experience any loss of automatic control. This is the normal position of the shaft in DECU controlled automatic mode.

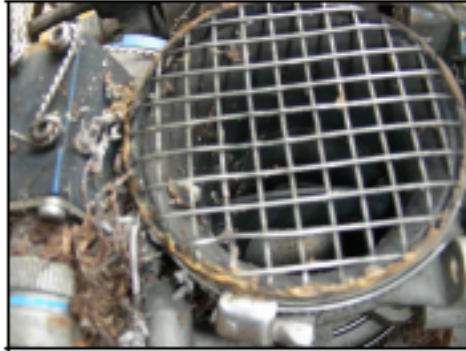
The bleed valve was in the open position which corresponds to the normal position once the engine has slowed down.
