AN OBSERVATION ON THE ACCIDENT OF NON-CONVENTION VESSELS CARRYING PASSENGER SANK IN INDONESIAN WATERS

T Sastrodiwongso and Aleik Nurwahyudy, National Transportation Safety Committee, Indonesia

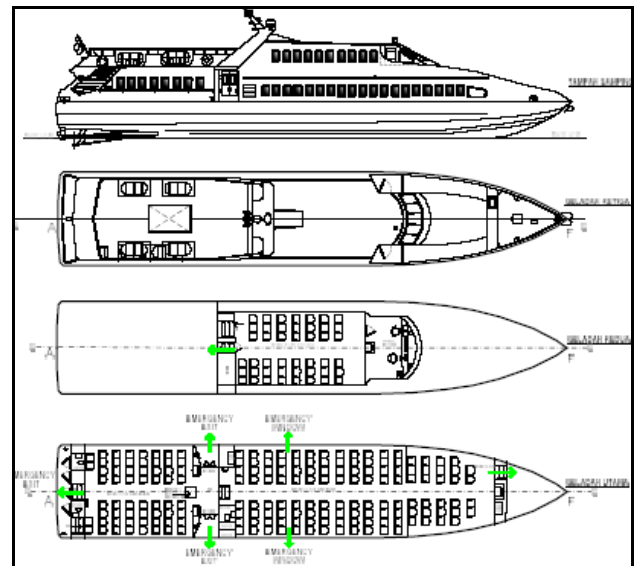
Figure 1: The general arrangement of *KM. Dumai Express 10*.

It is concluded that the loss of the vessel was caused by the progressive penetration of sea water into the forepart of the passenger main cabin through the damage of superstructure's front wall due to the multiple rapid wave pressure against the ahead movement of the vessel. The contributing factors of the accident are related to the construction of the ship and the stability.

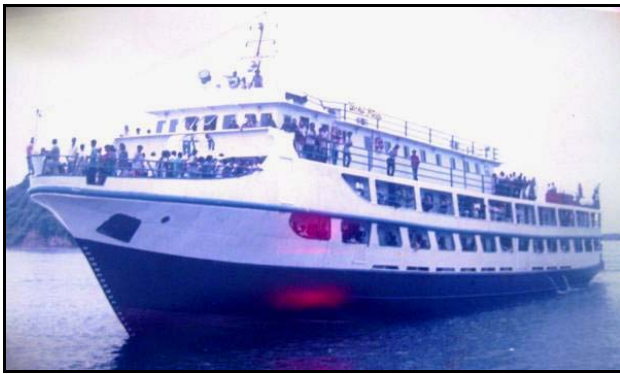
Figure 4: the *KM. Teratai Prima*

It is concluded that the loss of the vessel was caused by the loss of stability. It was due to the condition of the vessel in overweight and improper cargo loading arrangement which was sailed in bad weather.
