**HISTORY OF TAIL ROTOR SHAFT**  
**part number 330A.33.3165 E1, serial number M1941**

**THE DAMAGED TAIL ROTOR SHAFT WITH GEARBOX S/N 187  
AFTER REMOVAL FROM G-PUMH**

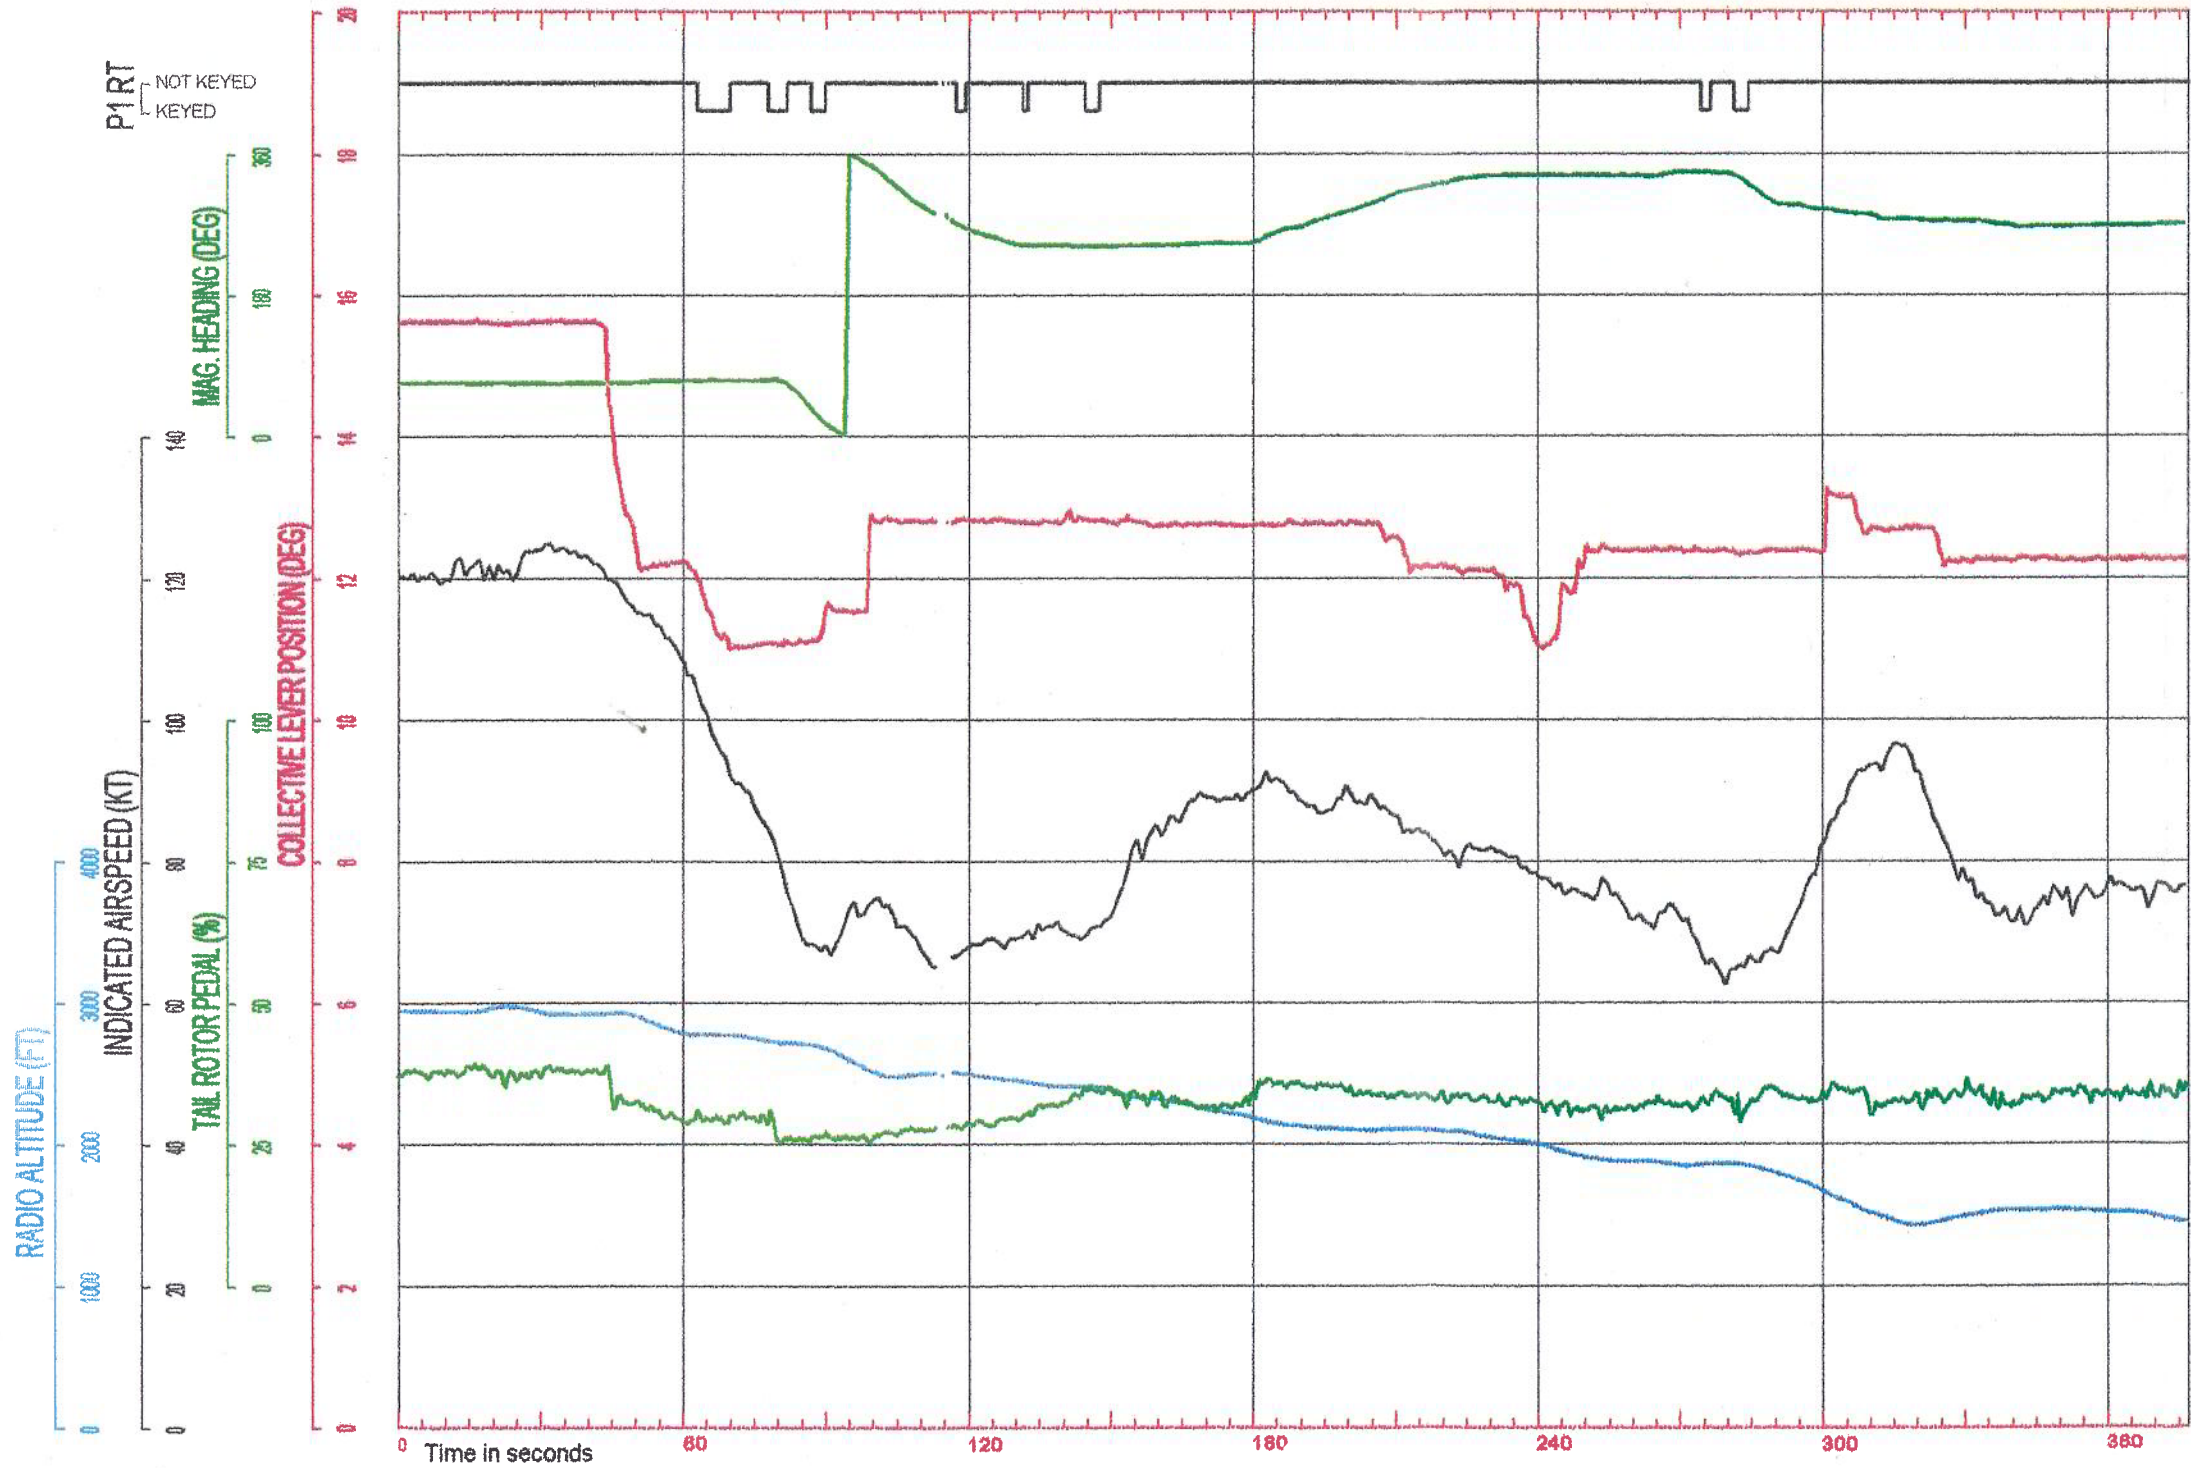
SELECTED CVR TRANSCRIPT  
(RT IN RED)

(P1) REDUCE PITCH, REDUCE PITCH

(P1) WE HAVE A MAJOR VIBRATION...  
(RADAR) MAKE A LEFT OR RIGHT TURN...  
...MAINTAIN 5000 FEET...

(P1) MIGHT BE A FREQUENCY ADAPTOR FAILURE  
(P2) YEAH  
(P1) BRING THE PITCH RIGHT DOWN...  
...TO BELOW 12 PLEASE

ONSET OF VIBRATION

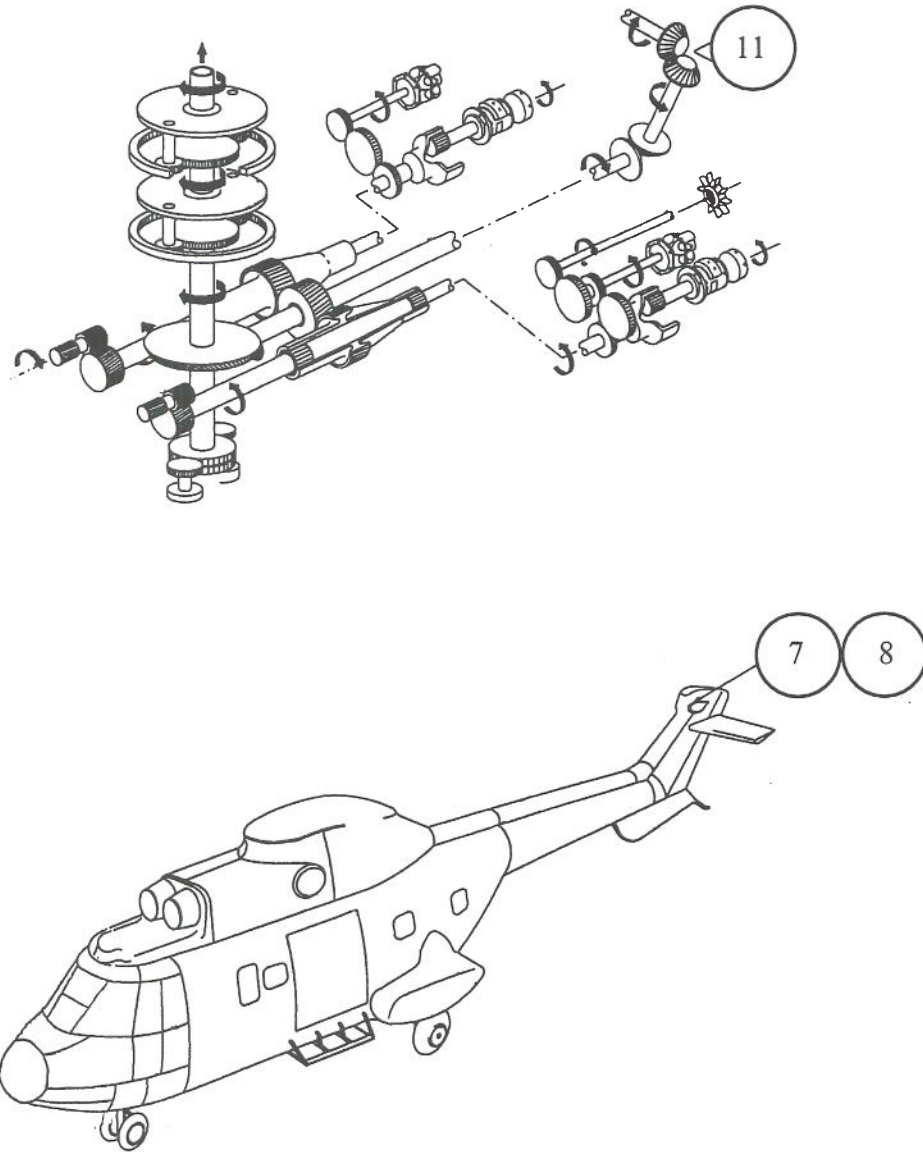
Tail Rotor Accelerometer Locations

ACCELEROMETER	MOUNTING POSITION	MEASUREMENT
Accelerometer 7	On Airframe	Vertical Airframe Vibration
Accelerometer 8	On Airframe	Lateral Airframe Vibration
Accelerometer 11	On Tail Rotor Gearbox	Transmission Vibration

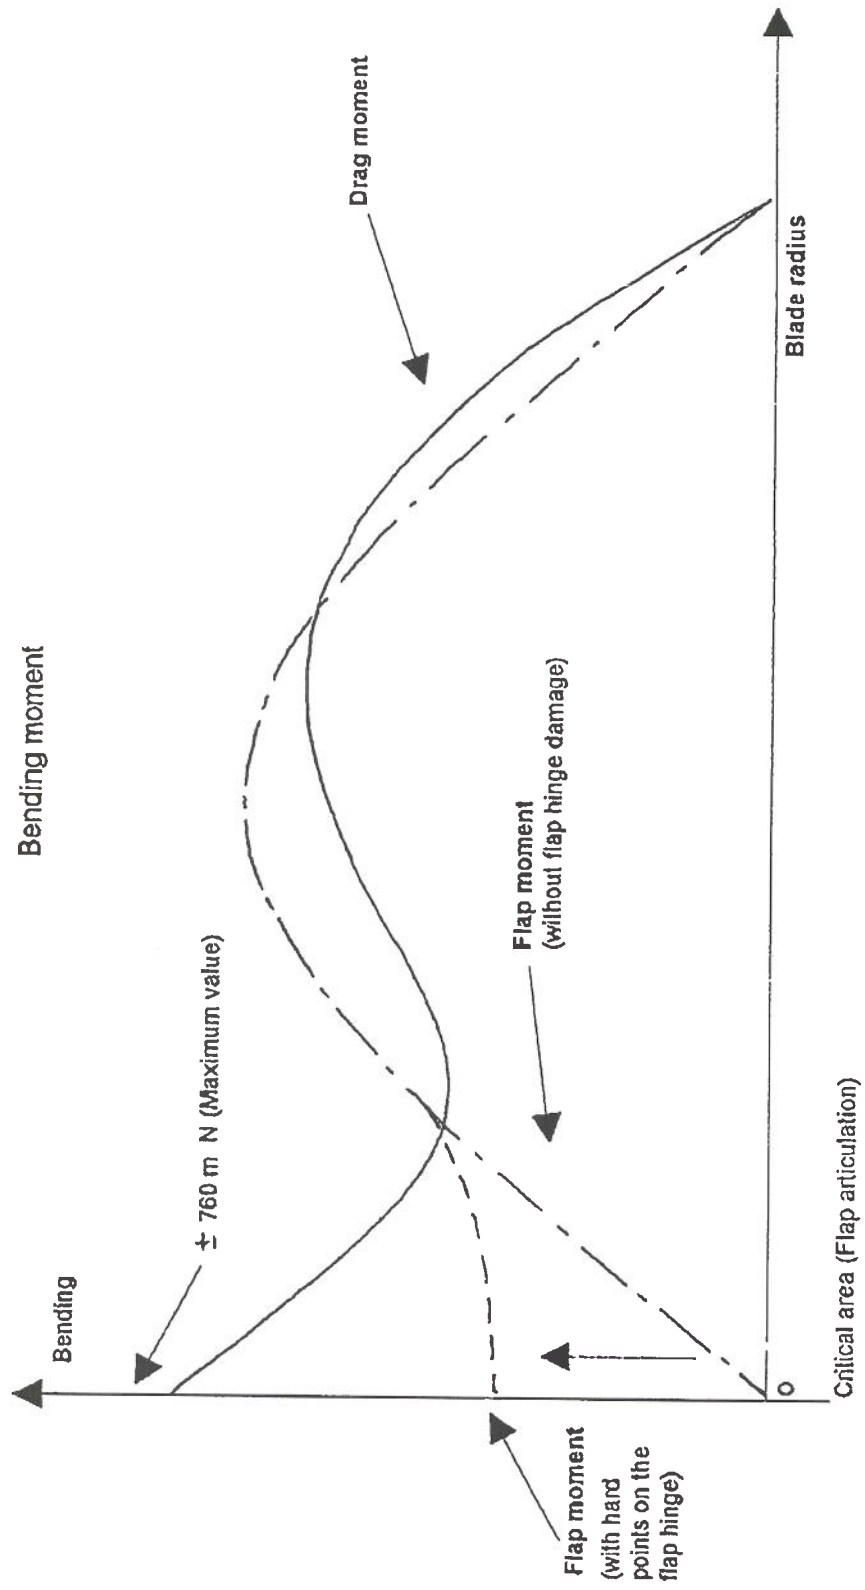
BENDING MOMENT v. BLADE RADIUS

data supplied by Eurocopter - read in conjunction with Appendix J page 2

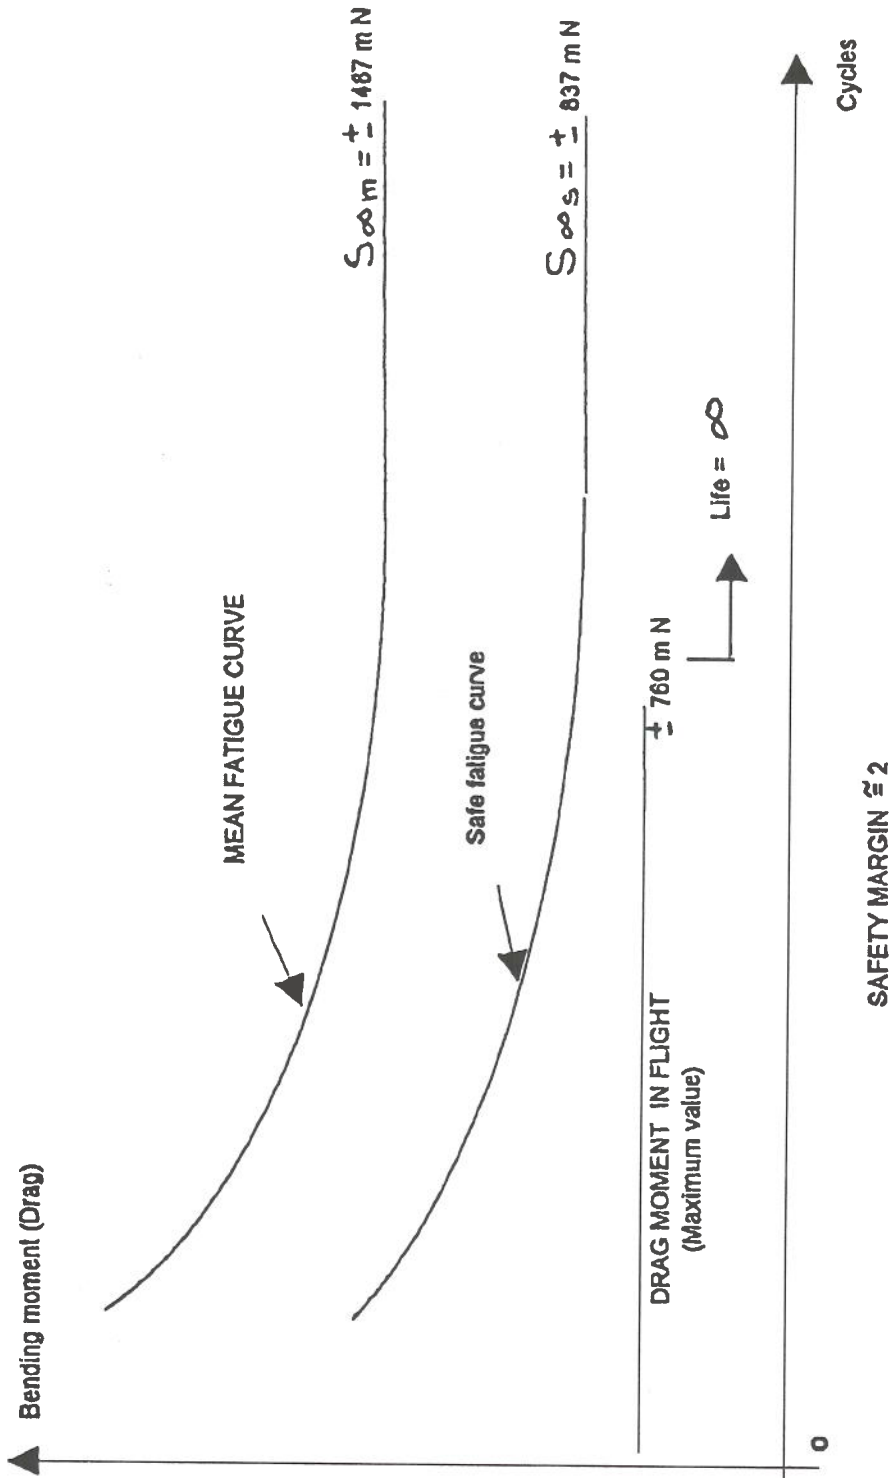
BENDING MOMENT v. CYCLES  
 data supplied by Eurocopter - read in conjunction with Appendix J page 1
