# AIRCRAFT ACCIDENT REPORT 2/2018

Report on the serious incident to  
**Boeing 737-86J, C-FWGH**  
Belfast International Airport  
on 21 July 2017

**Air Accidents Investigation Branch**

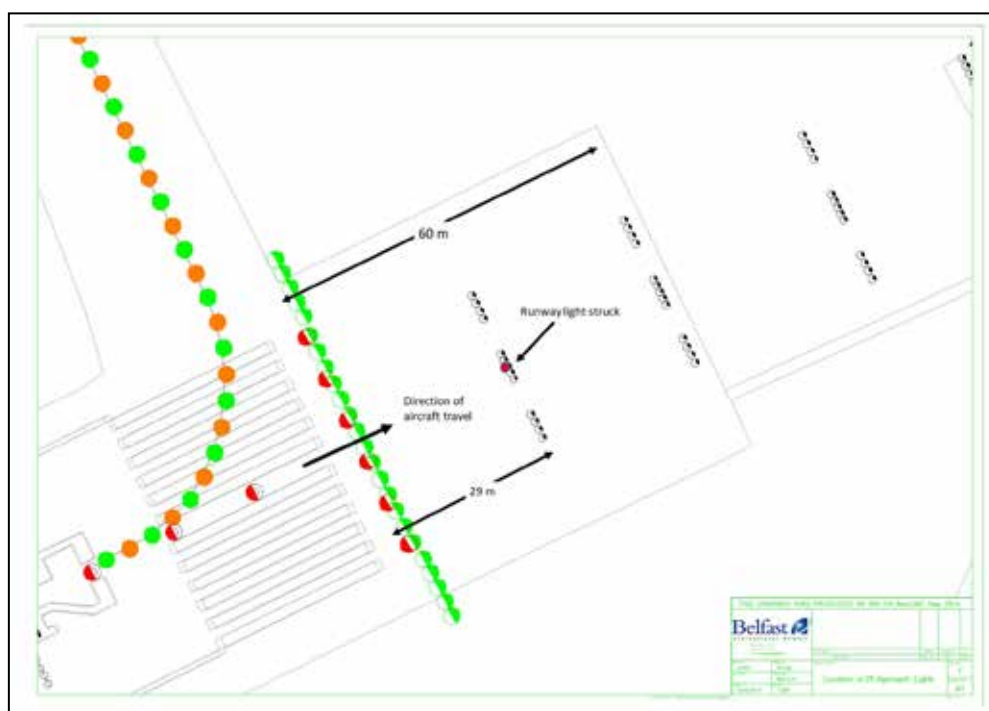
**Figure 5**

Within the stopway were two sets of supplementary approach lights for Runway 25. Each of these sets had thirteen lights set out in three groups across the tarmac. These lights were positioned 36 cm above the stopway surface. The first set of lights was 29 m beyond the end of Runway 07, with the stopway ending 60 m beyond the end of Runway 07. The aircraft struck the centre light within the first set of supplementary approach lights. Figure 5 shows the layout of the lights, together with the dimensions of the stopway and indicates the direction of travel of the aircraft and the light the aircraft struck. Figure 6 shows the view from the stopway with the centre light missing.

Dimensions of stopway and lighting positions

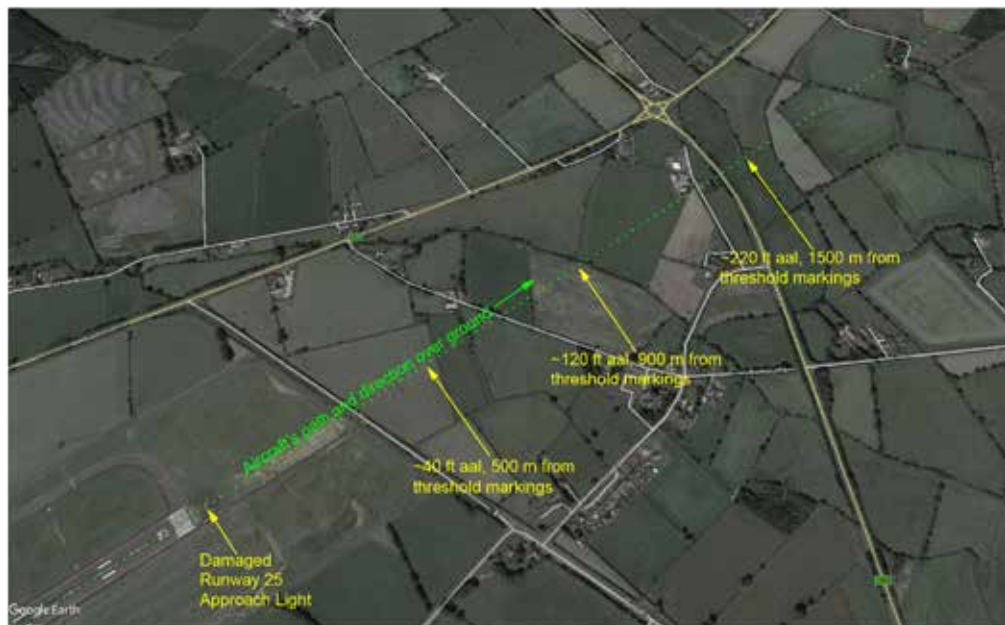
**Figure 11**

Figure 11 shows spot heights above the elevation of BFS (268 ft amsl) for the aircraft's initial climb, derived from the aircraft's ADS-B reports.

Vertical profile for the initial climb-out  
 © 2018 Google

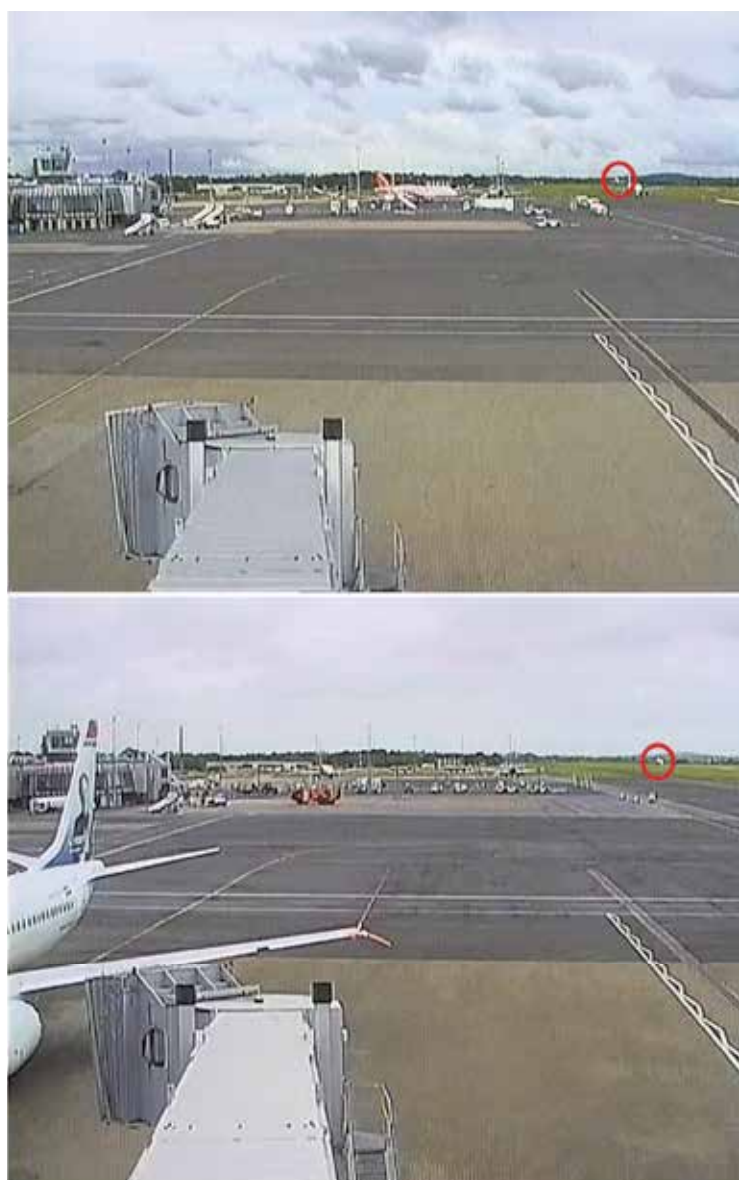
**Figure 13**

The second camera captured the rotation, lift off and initial climb-out of C-FWGH. The resolution and sightline angle of this CCTV recording did not allow calculations of distance to be made, but the airport operator provided another CCTV recording from the same camera of an aircraft lined up for departure on the reciprocal Runway 25. Using this recording, and the recording showing C-FWGH's departure, it was possible to confirm that C-FWGH lifted off at the extremity of Runway 07. Figure 13 shows a comparison of these recordings; C-FWGH is shown immediately after lift-off at the top of the figure, compared with the aircraft lined up on Runway 25 ready to depart at the bottom of the figure. In both images, the aircraft have been highlighted by a red circle.

The second CCTV recording showing C-FWGH's lift off at the top, compared with an aircraft lined up for departure on the reciprocal runway at the bottom

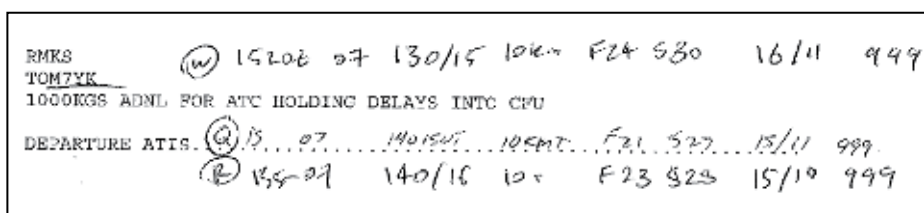
**Figure 21**

The FCOM states that it is the PF who normally completes the initial setup of the FMC. The PM must verify the entries. The FMC CDU is designed with a sequence of data entry pages with boxes and spaces into which data should be entered, with a prompt at the bottom right of the page to lead the pilot onto the next page requiring entries. The pre-flight setup includes entering a top-of-climb OAT into the T/C OAT field on the right side of the PERF INIT page as shown in Figure 19. The pilot is then prompted to move onto the N1 LIMIT page where they must enter the current airfield OAT value into the OAT field on the top-left of the page as shown in Figure 20. The top-of-climb OAT is obtained from the flight plan and the airfield OAT is obtained from the ATIS broadcast, which the PM had copied down onto the operator-supplied pilot's log (Figure 21).

ATIS as recorded by PM on the pilot's log
