**SERIOUS INCIDENT**

| <b>Aircraft Type and Registration:</b> | BAE Systems (Operations) Ltd ATP, SE-MHE | |

**Synopsis**

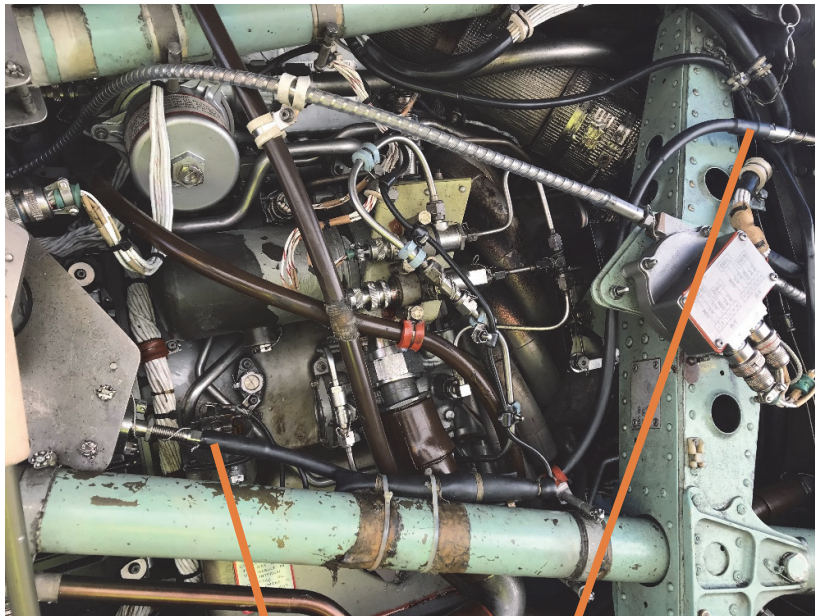
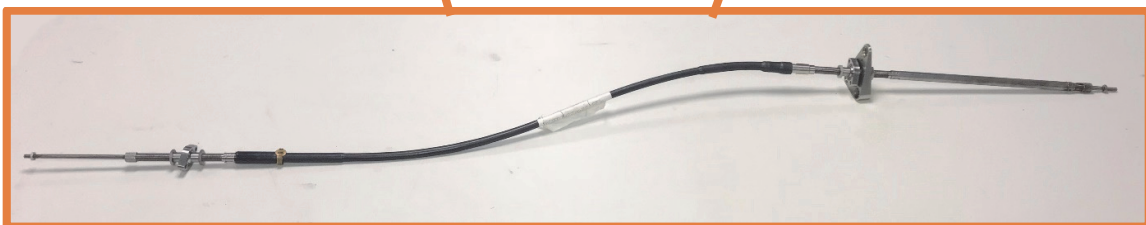
**Figure 7**

Between 2014 and 2018, the operator recorded six events on their ATP fleet where pilots reported 'restricted', 'stiff / notchy' or 'frozen' power levers. There was no confirmed link between the events but the engine power 'Bowdenflex' control cables were cited as a possible cause because of their apparent susceptibility to moisture ingress and freezing; the control cables are under the engine cowl (Figure 7).

Bowdenflex cable

Both engine control cables on SE-MHE were post-modification standard with heat shrink sleeving applied. Irrespective of this, however, they were removed for further examination and testing. The harnesses were subjected to freezing conditions but showed no evidence of restricted movement.

have been a number of reports that moisture ingress together with low temperatures has led to cables becoming difficult to move". The configuration change was optional and formally approved under modification JDM60170A. As part of the investigation following the incident on SE-MHE, the operator checked the modification status of their operational fleet and found that some aircraft were post-modification, some were pre-modification and some were of mixed build standard.

In 2016, the operator introduced a Technical Instruction '*To reduce delays and cancellations due to frozen power lever cables on the northern routes*'. The instruction describes the use of '*a power lever heating kit*', which was commissioned by the operator and is available for use at three airports in Norway and Sweden; the equipment is used (if deemed necessary) to direct warm air onto the engine power control cables when the aircraft is on the ground. Concurrently, the operator introduced a procedure to purge moisture from the cables using low pressure nitrogen or air. The cables are purged every 400 flying hours, but the procedure is not applicable if the heat shrink sleeving has been installed.

In December 2017, the manufacturer introduced an electronic Service Information Leaflet (eSIL) 76-ATP-800-1, recommending operators to periodically purge moisture from the cables using low pressure nitrogen or air. The manufacturer recommended a periodicity of 150 flights but stated that operators should amend the frequency based on their in-service experience and operational environment.
