**AIRCRAFT ACCIDENT REPORT 1/2005**

**Report on the accident to  
Sikorsky S-76A+, G-BJVX  
near the Leman 49/26 Foxtrot platform  
in the North Sea  
16 July 2002**

**Air Accidents Investigation Branch**

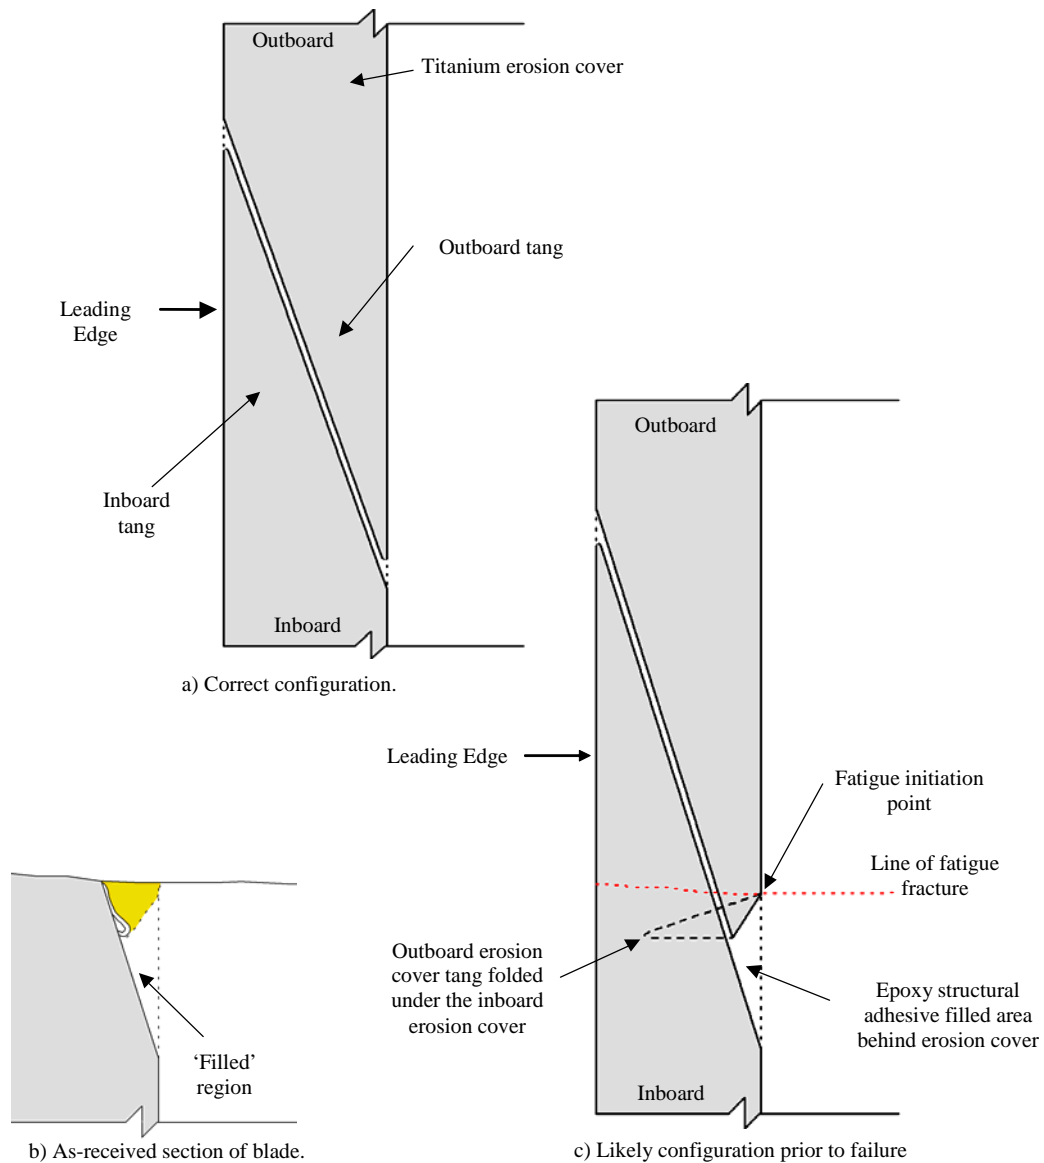
**Figure 7 - Scarf joint configuration.**

The temperature required to produce the microstructural change was in excess of 995°C. This martensitic transformation would have altered the beneficial compressive residual stress from shot-peening, and probably resulted in an unfavourable, localised, residual tensile stress. The untempered martensitic material is also somewhat softer than the normal alpha-beta material. (Note that this is opposite to the effect seen in martensitic steels.) These localised changes resulted in greater susceptibility to fatigue initiation. The area where the change in the microstructure had occurred was where the tip of the tang of the inboard end of the outboard titanium leading edge cover had come into contact with or extremely close to the spar. There was no evidence to indicate whether the tip had or had not contacted the spar. The defect had arisen because of a manufacturing anomaly which had caused the tang to become folded under the outboard end of the inboard leading edge cover (see Figure 7).

The manufacturing anomaly had been present since the blade was manufactured in 1981, some 21 years prior to the accident. There was very good evidence to indicate that the titanium microstructure change had been caused by very rapid localised heating of the spar at the point where the tip of the tang had come into contact or extremely close to it, followed by rapid cooling. This evidence was in a form that resembled an electrical spot weld. The heat discoloration at the surface of the spar adjacent to the origin and the heat affected microstructure indicated a possible scenario whereby electrical current flow during a lightning strike had been able to pass from the titanium leading edge cover to the titanium spar through the folded tang.

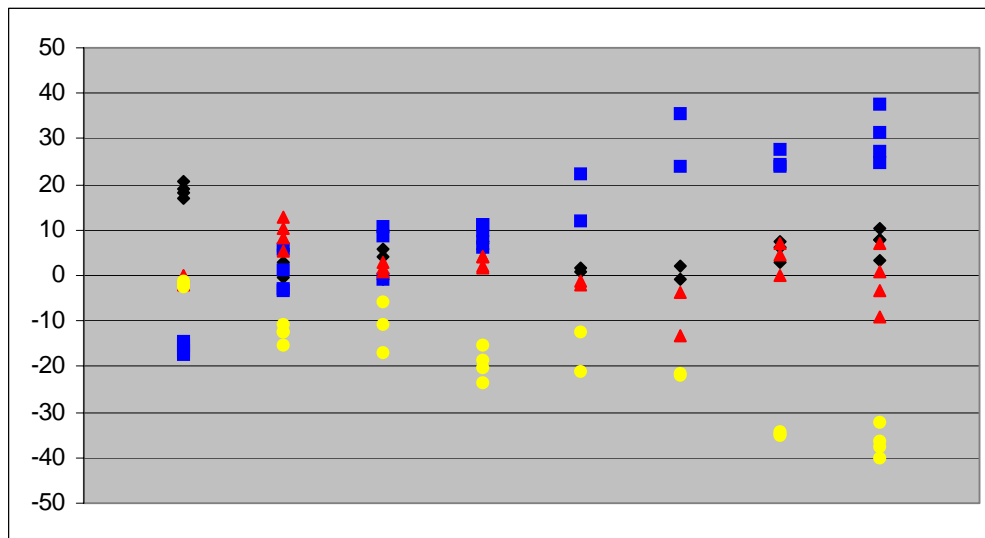
**Figure 3 Blade Track (mm) plotted for RTB Flight Regimes**

The trend of blades rising or falling with increasing airspeed is typical of an aircraft in service and this range of track splits would not give rise to concern.

The RTB data downloaded into the groundstation has been shown at Figure 3 Blade Track (mm) plotted for RTB Flight Regimes. It was described previously as not particularly unusual for a helicopter to have a track variation like that.

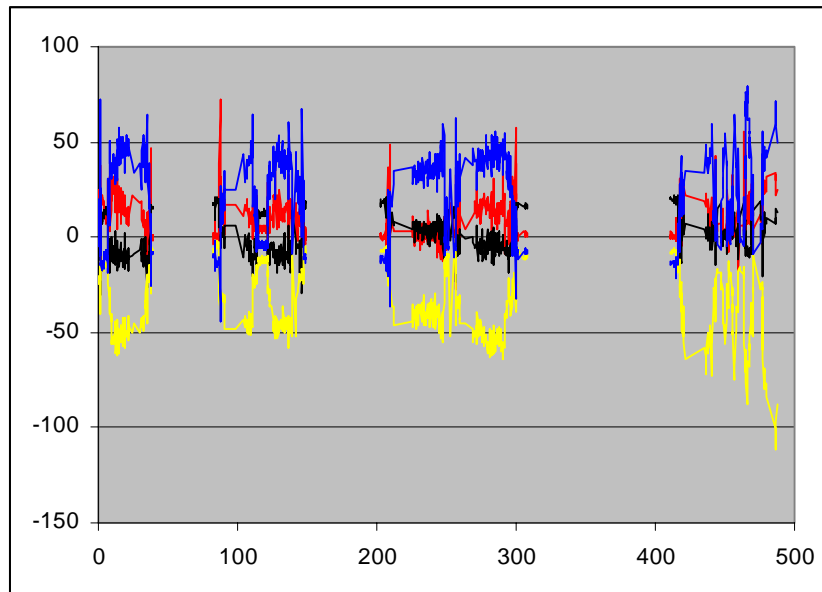
**Figure 4 Track Data (mm) from FDR vs Pseudo Time (min)**

This is one of the key graphs in this analysis. From the figure above the track pattern on the latter half of the second flight of the day (0 to 40 minutes) and the third and fourth flights (80 to

On the final sortie, (400 to 500 minutes with many takeoffs and landings) the yellow blade can be seen to dive progressively on each sector flown. This type of graph is plotted with a mean track of zero, hence an apparent increase in red, blue and black track.

What is very clear from these two graphs is that the degradation of the yellow blade occurred on the final operation, progressing as each leg was flown.

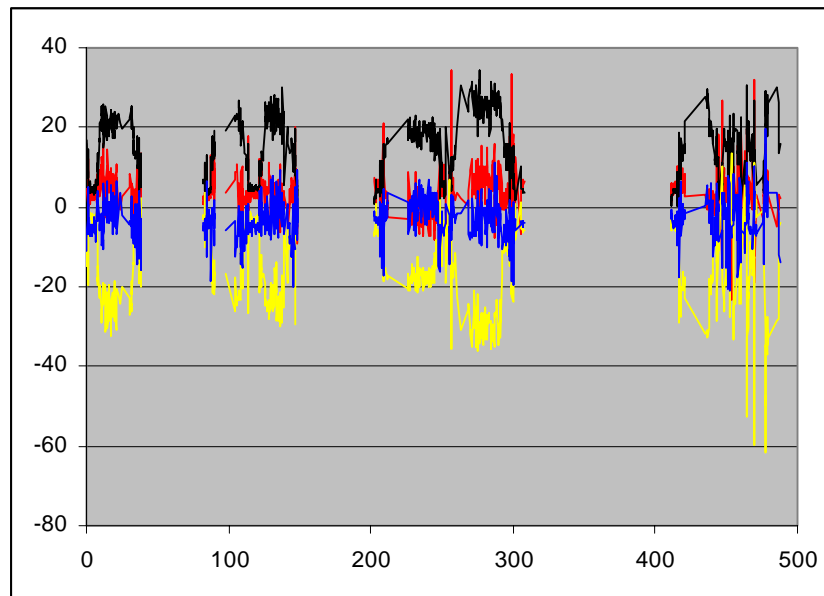
**Figure 5 Blade Lag Data (mm) from FDR vs Pseudo Time (min)**

There is a similar pattern visible in the lag data, although here the degradation on the second half of the fourth operation of the day (250 to 300 minutes) appears clearer.

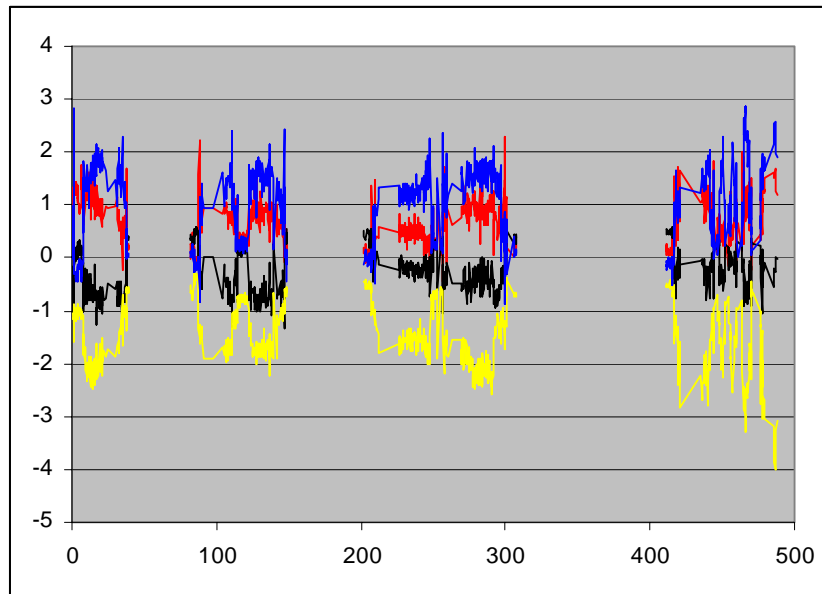
**Figure 8 Blade Velocity Variation (m/s) vs Pseudo-time (min)**

The data integrity check “Tracker data suspect at CRUISE” clearly only just breaks the threshold and, in any other circumstances, would be ignored. The significance of this parameter is considered by looking at a plot of blade velocities, using the same graph format as used for the track and lag plots earlier.

The increased blade velocity variation in the cruise during the fourth operation of the day was in fact measured at 14:06, corresponding to 211 minutes on the graph scale used here. At this time, the velocity split was not significantly worse than on previous sectors flown that day.

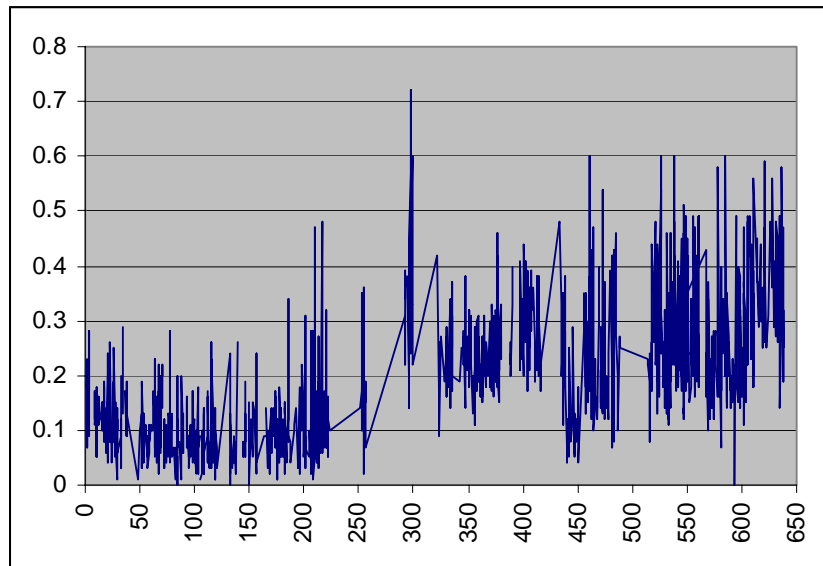
**Figure 9 Pilot Vertical 1R Vibration at MPOG (IPS) vs Flying Days**

It can be seen from the previous graph, which starts at the beginning of 2000, that it is commonplace for the 1R vibration at MPOG to exceed the threshold of 0.4 IPS.

There are two reasons why this is considered acceptable. Firstly, the parameter is being measured and the maintainers are in a position to identify the cause of any persistent exceedance and secondly because the aircraft spends most of its time in the cruise, where vibration levels are kept low – to some extent at the expense of higher vibration on the ground.

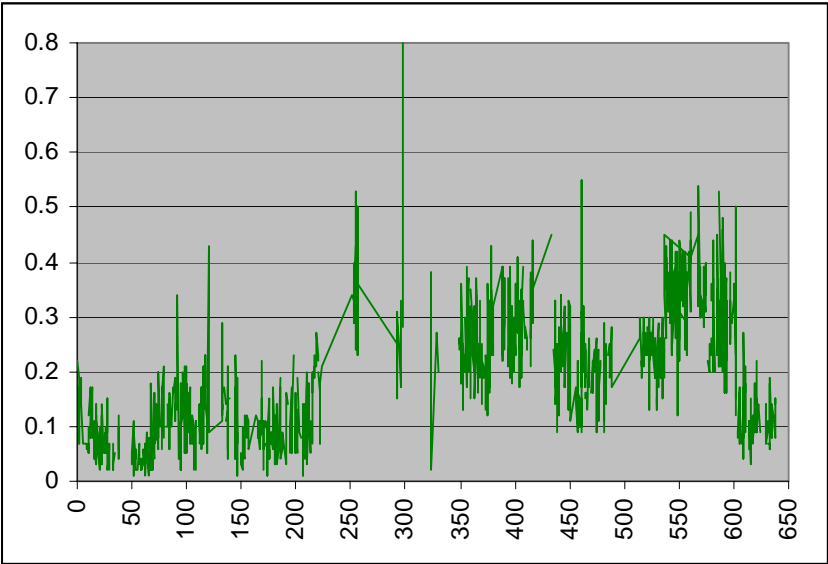
**Figure 10 Pilot Vertical 1R Vibration at Cruise (IPS) vs Flying Days**

Looking at the more important cruise vibration level in Figure 10 above, the 0.1 IPS level maintained by this aircraft was very good.

While it is clear that something odd was going on with the rotor, and that the aircrew were complaining, there is no clear evidence of this in the 1R vibration records. This period corresponds to about 460 “flying days”, see Figure 9 and Figure 10 above. In general, the vibration levels were lower than the 0.4 IPS limit, and lower than at other periods in the life of the aircraft.

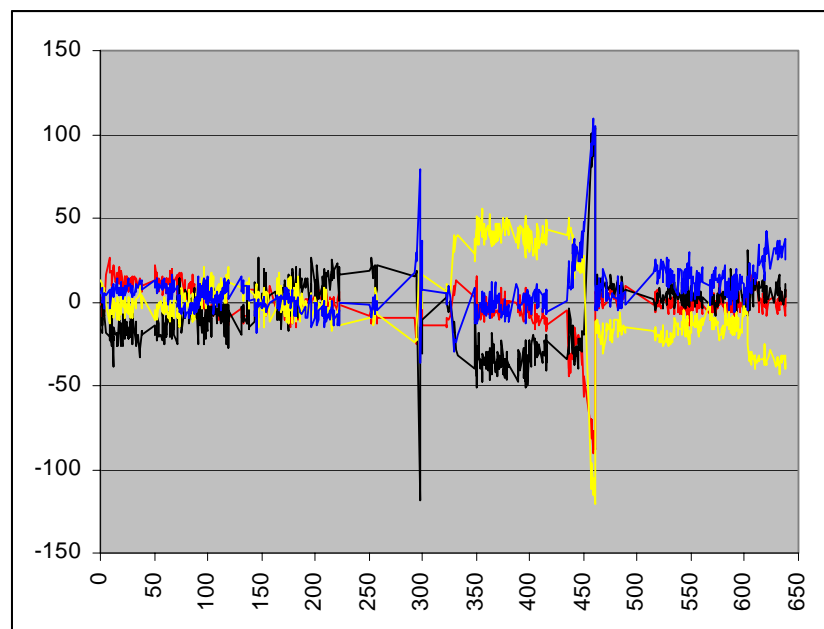
**Figure 11 Blade Track in Cruise (mm) vs Flying Days**

The calendar period covered by the graph above is two and a half years, with probably 1500 flight hours.

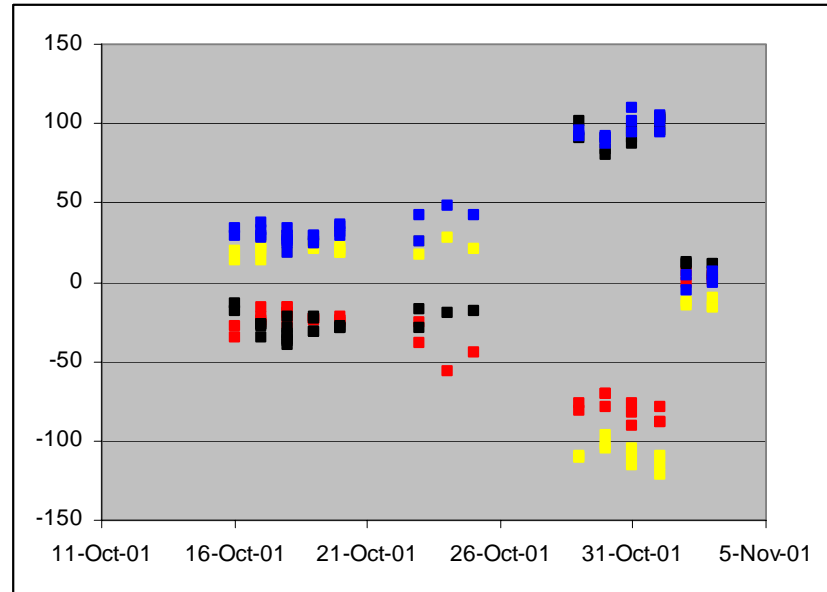
Of greater interest is the developing track split at around 450 flying days, and this section has been expanded below:

There are multiple downloads on each flying day, hence the multiple sample points on each daily “slice” of data.

As can be seen, around 26<sup>th</sup> October something happened which caused a significant change in track pattern and this was present in eleven samples taken between 29<sup>th</sup> October to 1<sup>st</sup> November. Maintenance records include the following:

What is perhaps more remarkable than the vibration levels is that the aircraft was operated over this period with an overall track split in excess of 200mm – greater than that immediately preceding the blade failure.

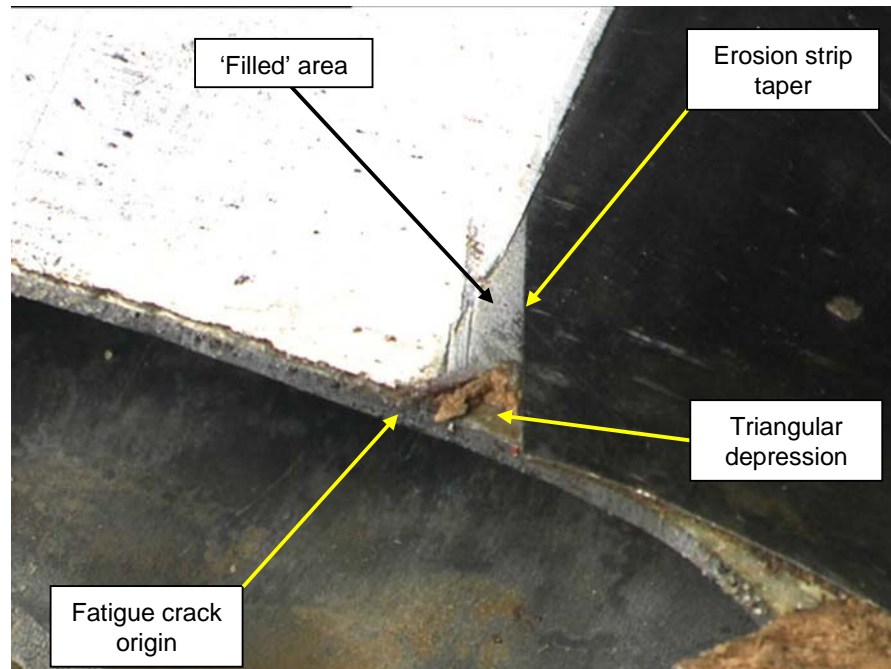
Figure 6. Detail of blade at edge of fracture face

The fatigue crack origin corresponded with the position of the trailing edge of the titanium erosion strip (figure 5). Figure 6 shows this area in detail. It was observed that at a distance of approximately 20mm from the fracture, the erosion strip began to taper towards the leading edge at an angle of approximately 18°. It was ascertained that this was part of the scarf joint present between the two-part titanium erosion strip. The majority of the area behind this scarf joint taper was filled with a yellow adhesive material (appeared to be painted white) so that it was level with the fibre glass skin and titanium erosion strip in this area. Within this filled region there was a triangular depression at the edge of the fracture surface (figures 6 and 7). Within the triangular depression there was a trough which ran parallel to the edge of the filled region (figure 7), the end of the trough coincided with the origin of the fatigue crack and also a mark on the top surface of the spar (figure 8) which ranged in colour from dark blue at the edge of the fracture to dark orange/light-yellow as it moved from the edge. This colouring was characteristic of heat tinting. Measurements of the thickness of adhesive in this depression found that it varied from 340µm at the apex of the triangle, tapering to 240µm at the edge of the fracture. The thickness in the trough also tapered from 220µm at the apex of the triangle to 150µm just before the edge of the fracture.

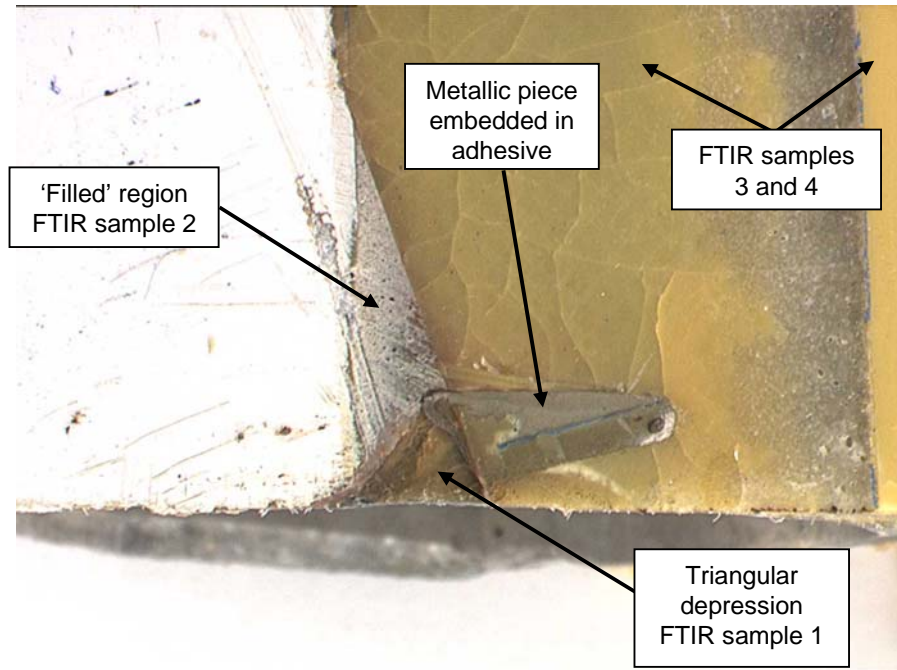
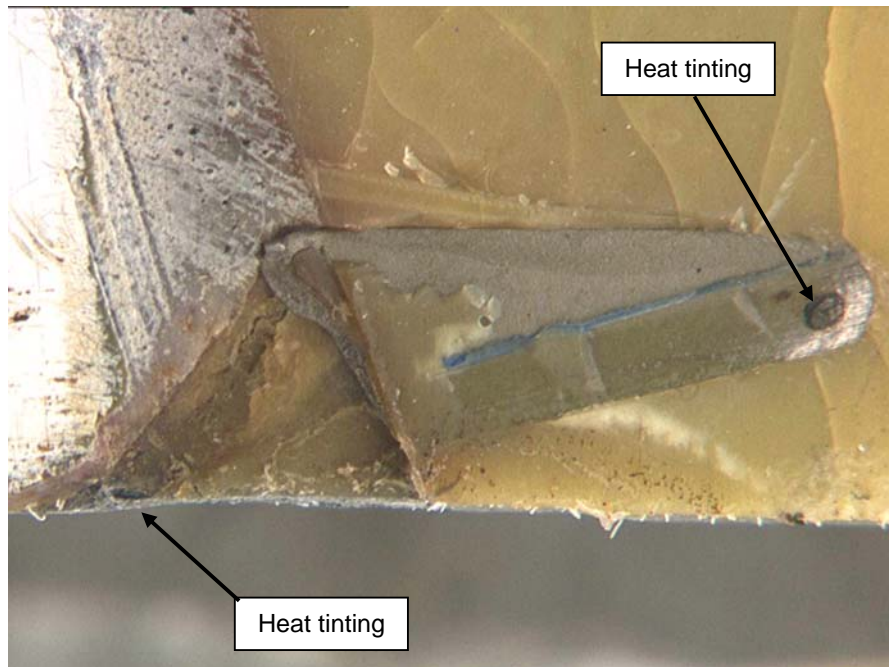
Figure 9. View of blade top surface after removal of erosion strip.

Liquid nitrogen was used to embrittle the adhesive allowing removal of the titanium erosion strip from the leading edge of the rotor blade. Figures 9 and 10 show the top surface of the blade in the region of the triangular depression after the erosion strip had been removed. It can be seen that the metal piece that was protruding from the edge of the strip was the edge of a larger piece, approximately 10mm long and 5mm at its widest, which tapered towards its end. The size and shape of the metal piece corresponded to that of the filled region which was present behind the tapered scarf joint of the erosion strip (refer to figure 6). It was also observed that a small area of heat tinting (approximately 0.5mm in diameter) was present at the tip of the metal piece.

Figure 10. Detail view of figure 9.

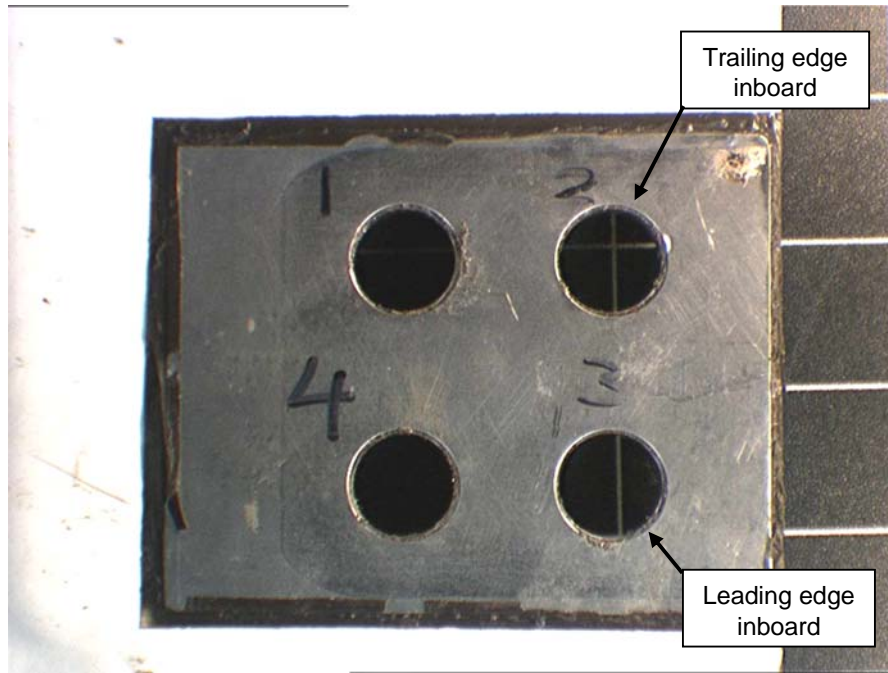
Figure 11. Root end of rotor blade showing position of attachment holes.

The root end of the rotor blade was examined for signs of damage that may have been caused by a lightning strike. The root end of the blade is shown in figure 11. The four holes, containing bushings, allow four through bolts to attach the blade to the spindle. It is sometimes possible for the bushings and bolts to show evidence of arc strikes after rotor blades are struck by lightning. The bushings and bolts were examined and it was found that the bush identified in figure 11 as number 3 (leading edge, inboard), contained a defect, which was examined under high power stereo microscopy. The defect did not show any signs of local heat tinting or melting of the surface which would suggest arcing, which can occur during a lightning strike. There was no corresponding damage observed on the bolt. The bush defect appeared to be a mechanical score and as such appeared to be unrelated to the failure.

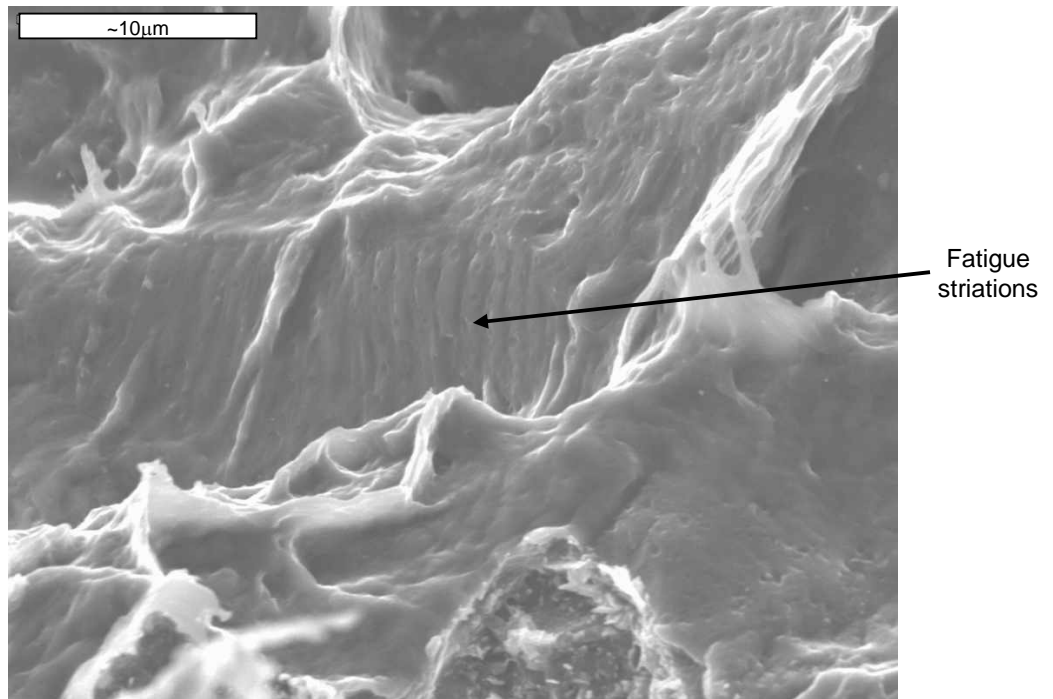
Figure 12. Replica of fracture surface towards end of leading edge crack.

The fracture surface of the rotor blade was examined in detail with a scanning electron microscope (SEM) in order to confirm that the crack had propagated by fatigue as was suggested by the visual examination. Initially acetate replicas were taken of the fracture surface prior to any cleaning (i.e. the dilute nitric acid wash described during visual examination). The replicas had the dual effect of cleaning the fracture surface of loose debris and obtaining a record of the fracture surface topography. The replicas were carbon coated and examined in the SEM. Examination of the initial replicas of the origin showed the loose debris that was removed from the surface, no fracture surface detail was visible. Repeated replication of the origin failed to show any detail that would indicate the mode of failure, however towards the end of the flat section of the fracture surface on the bottom surface of the blade, some of the replicas showed evidence of striations (figure 12), which confirmed the mode of failure as fatigue.

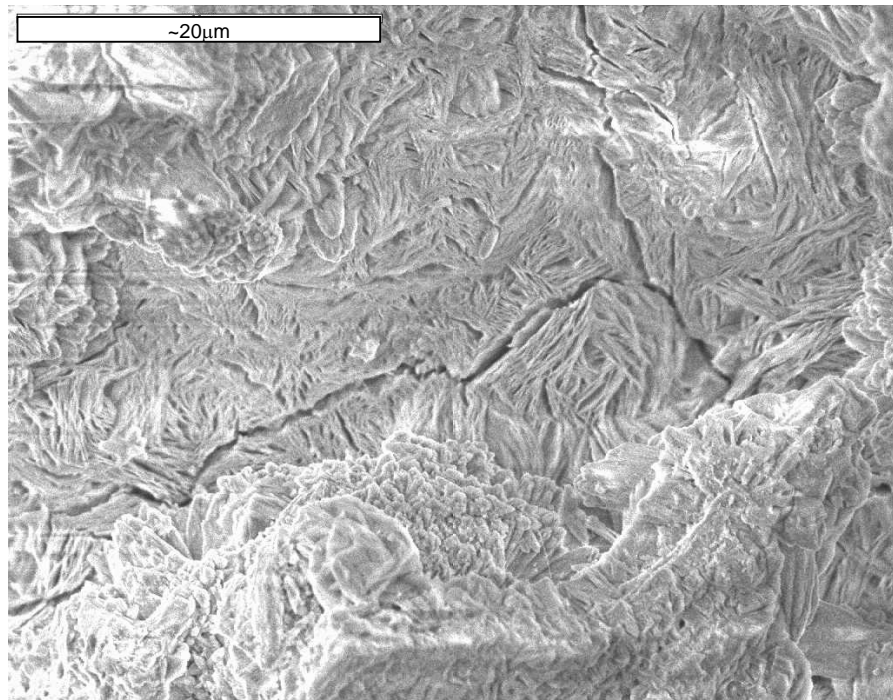
Figure 13. Deposit on fracture surface of rotor blade.

Initial examination of the leading edge section in the SEM showed little fracture surface detail around the origin. The majority of the fracture surface was covered by a surface deposit which masked any detail. Figures 13 and 14 show the deposit that was observed. However, there were areas where the surface detail was visible and figure 15 shows an example of the fatigue striations that were observed approximately 15mm from the origin.

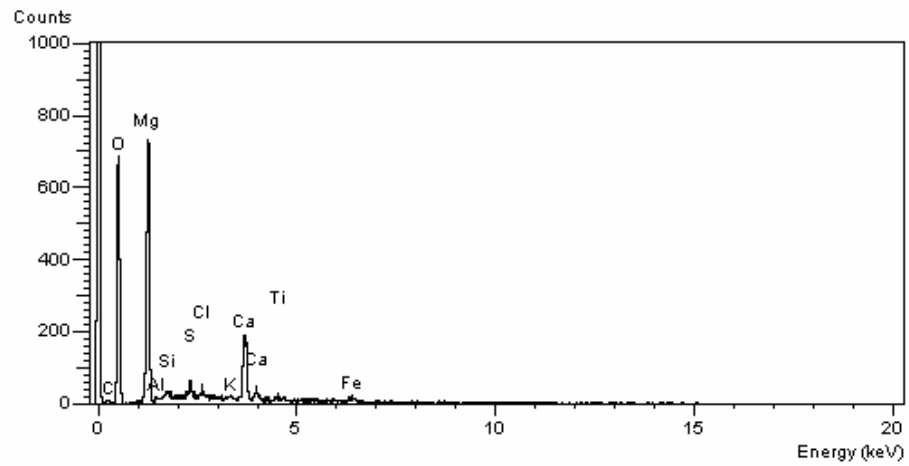
Figure 16. EDX spectrum from fracture surface deposit.

Energy dispersive x-ray analysis (EDX) was carried out on the deposit to identify its composition. Figure 16 shows the EDX trace from the deposit, it can be seen that as well as the titanium (Ti) and aluminium (Al) which would be expected there are large peaks for oxygen (O), magnesium (Mg) and calcium (Ca). There are also peaks for carbon (C), silicon (Si), sulphur (S), chlorine (Cl), potassium (K) and iron (Fe).

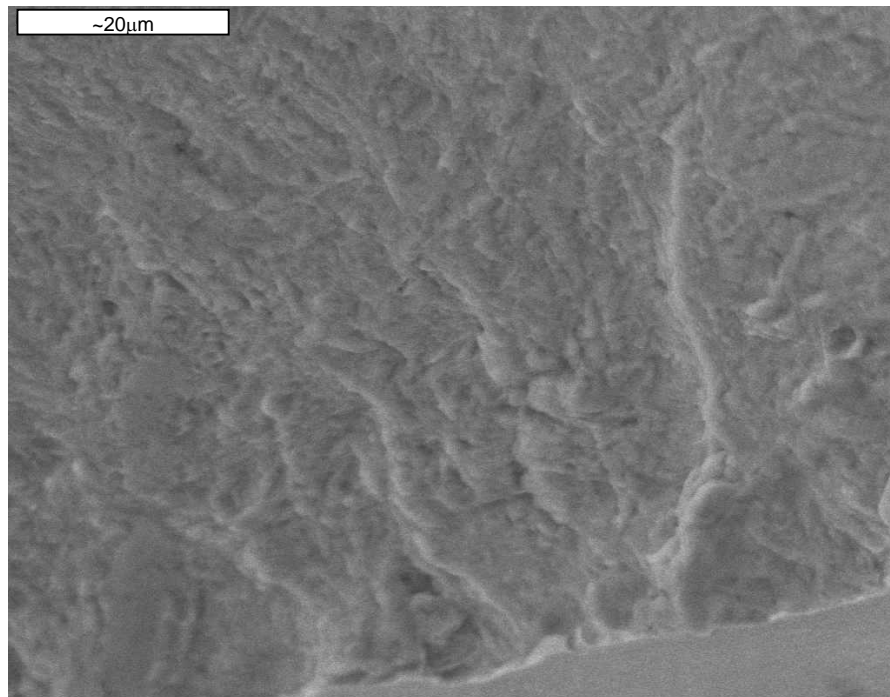
Figure 18. Fracture surface within flat region identified in figure 17.

In order to remove the deposit the fracture surface was cleaned with a dilute solution of nitric acid in water. Re-examination of the surface showed that the majority of the deposit had been removed and that most of the fracture surface detail was evident revealing fatigue striations across the majority of the fracture surface. Figure 17 shows the fracture surface at the fatigue crack origin. A semi-elliptical region of relatively flat topography was present at the origin, measuring approximately 1.23mm in width and 230 $\mu$ m in depth. A detailed view of the fracture surface within this region is shown in figure 18. This region of flat topography corresponded with the area of heat tinting observed on the surface of the spar, which suggested that the microstructure in this region was different from the rest of the spar material.

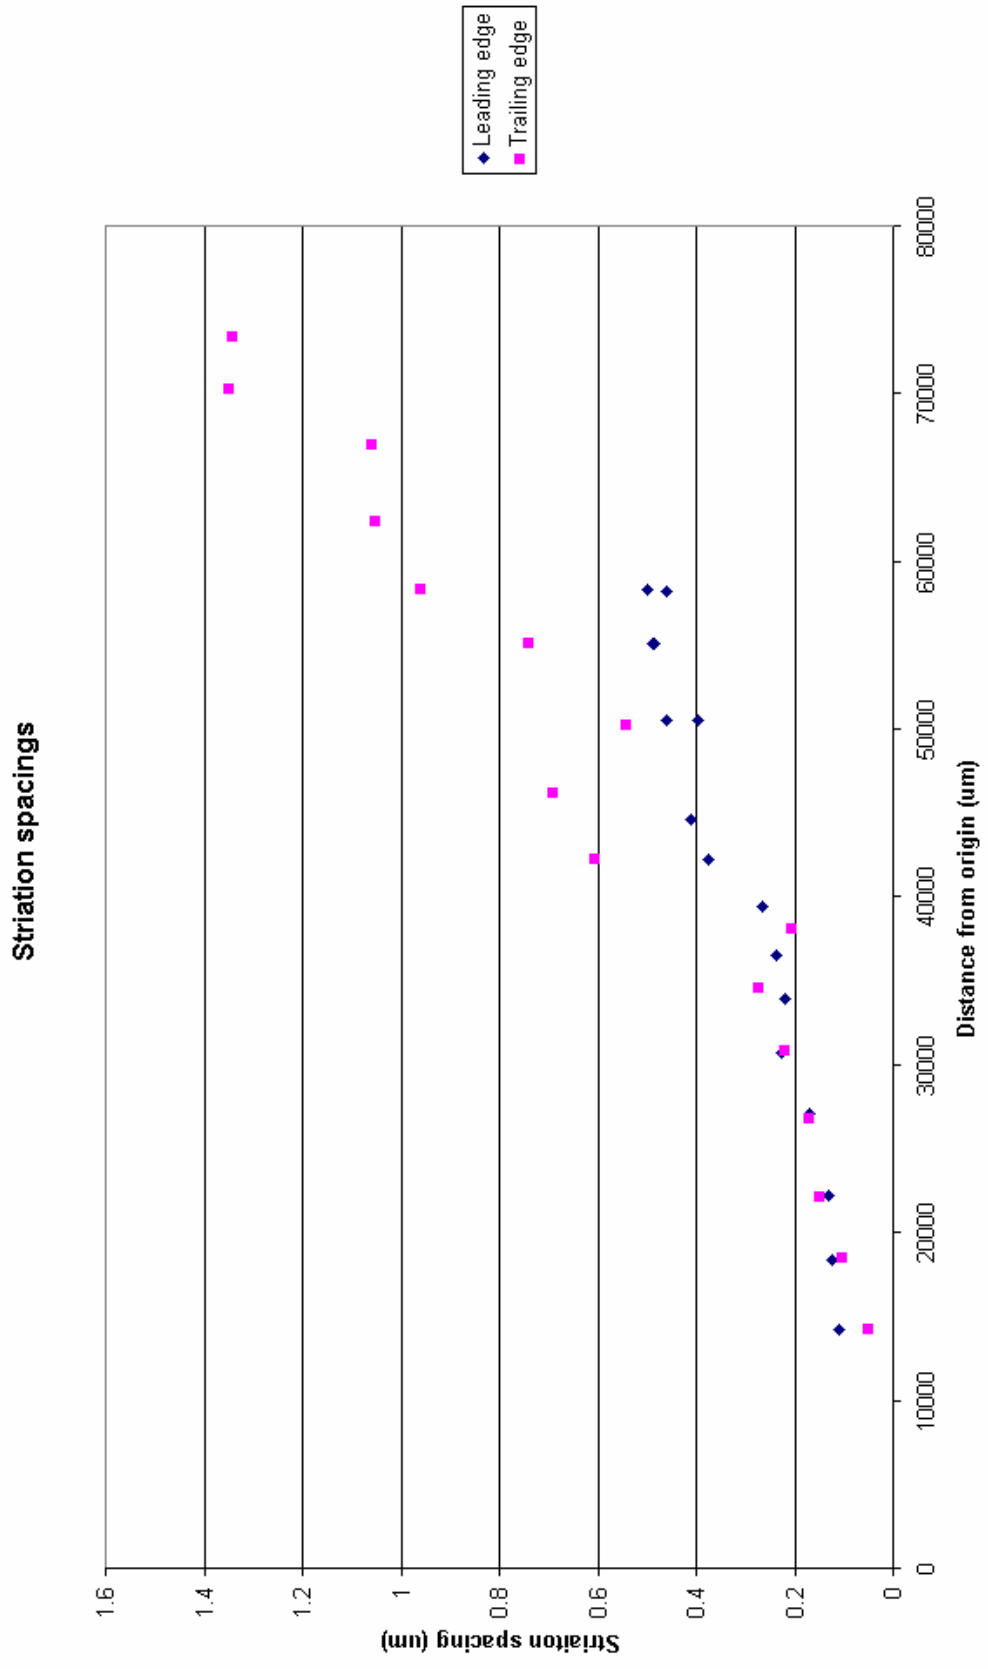
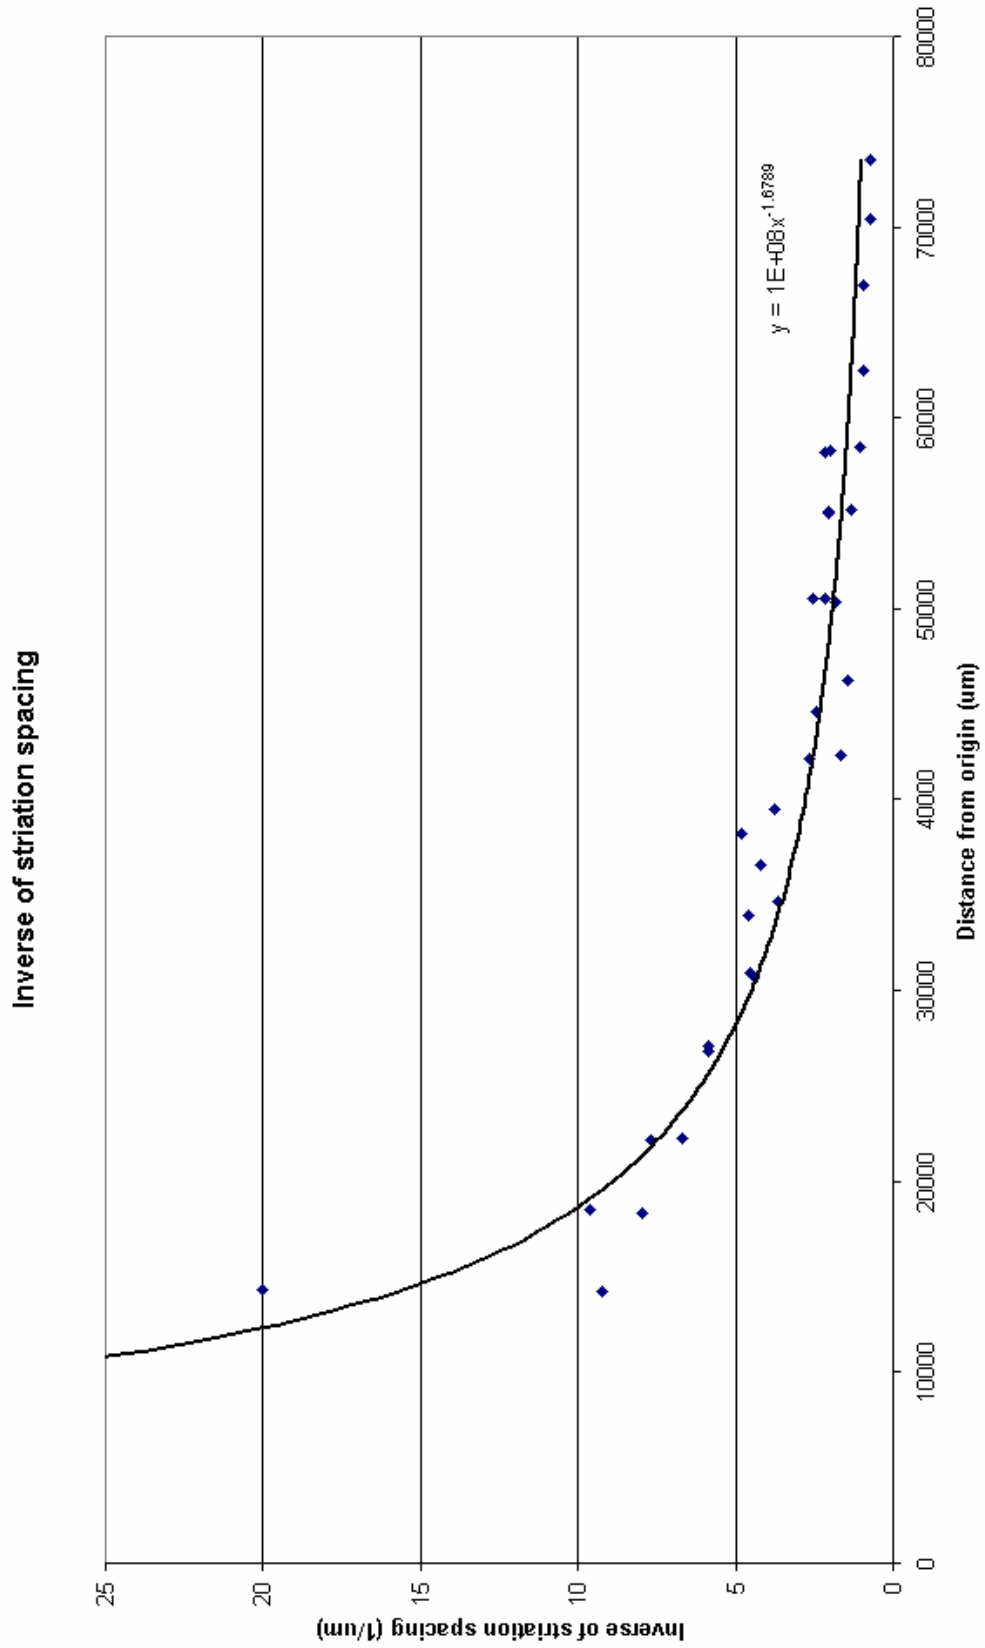
Figure 20. Striation spacing of leading and trailing edge cracks.

The spacing of fatigue striations were measured to estimate the number of load cycles required to propagate the crack to failure (appendix A). The fracture was assumed to be two separate cracks both initiating at the same origin and propagating in opposite directions, one towards the trailing edge and the other to the leading edge of the blade. The fracture surface was examined in detail at various points from the origin of the fatigue crack to the end of the fatigue region. Where patches of striations were clearly visible, the spacing was measured and then plotted to estimate the total number of cycles across the fatigue crack. With reference to figure 19, it was evident, especially towards the ends of the cracks, that the striations appeared to consist of regularly repeating units of large striations (yellow) with smaller striations in-between (red). The striation spacing was measured as the distance between the large striations (yellow, figure 19) as these were assumed to be due to one blade rotation, with the finer striations in-between being due to aerodynamic buffeting<sup>[1]</sup>. Figures 20 and 21 show the striation spacing and the inverse of the striation spacing plotted against distance from the origin for trailing and leading edge cracks. In both cases patches of striations only become clearly visible at distances of approximately 14mm from the origin. A best-fit line was added to the inverse striation data for both half of the cracks and the equation of this line integrated between 14mm and the end of each crack to estimate the number of load cycles required to propagate the crack from approximately 14mm to failure.

Figure 21. Inverse of striation spacing of leading and trailing edge cracks.

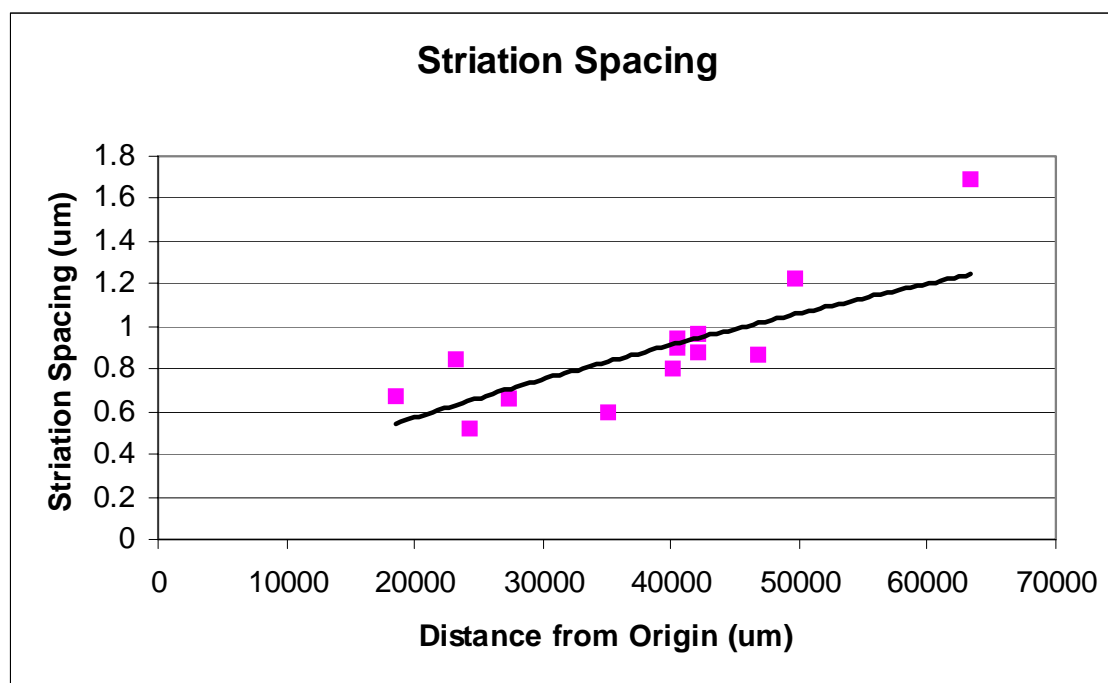
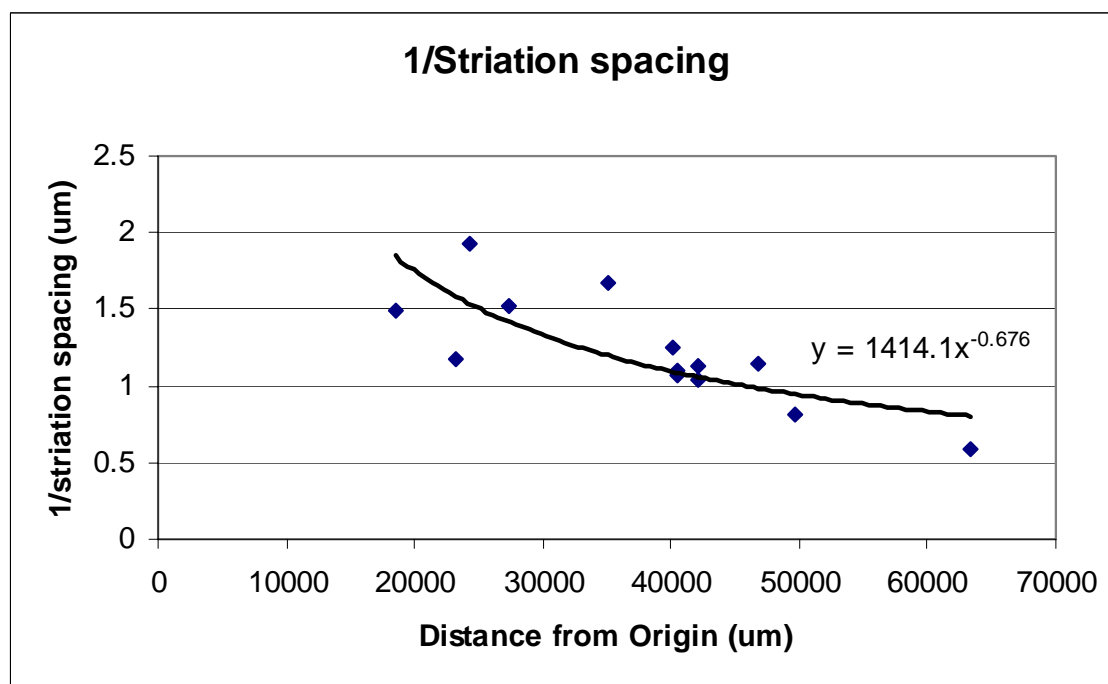
Figure 4. Striation spacing against crack length.

The static jumps were removed from the total load cycle estimates. In essence, the total number of striations was calculated between the areas of fatigue crack growth (ie 100 $\mu$ m – 45mm, 46.9mm – 47.2mm, 49mm – 50.2mm and 55.2mm – 64.3mm) based on the best fit curve through the data (figure 5). This assumes that there is no appreciable difference in the fatigue crack propagation before and after the static jump, that is, the crack continues to propagate in a steady state across the whole crack length despite the static jumps. In reality it is possible that after a static jump the fatigue crack would need to initiate again and therefore the total time for crack growth could be considerably longer than the estimated 7.3 hours.

Figure 5. Inverse of striation spacing against crack length.

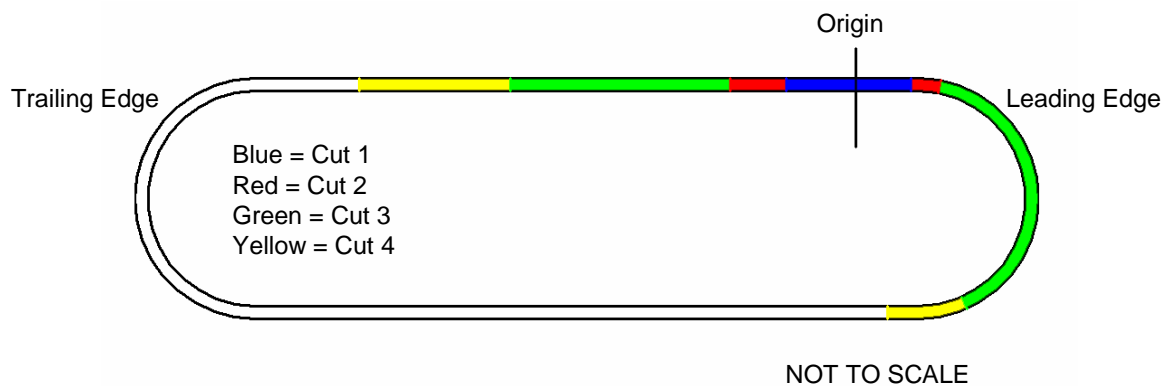
Figure 1. Cross section through spar showing crack positions.

A position at the trailing edge of the erosion strip on the top surface of the blade 1950mm from the root was marked as the origin of the fatigue crack and a 30mm transverse slot was cut into the blade at this point to represent a crack propagating in the leading edge direction for 14mm and the trailing edge direction for 16mm. The distance between the blade tip and the floor was measured and the slot extended to represent increasing crack lengths. In total, the blade droop was measured at four different crack lengths. The different crack lengths are represented in figure 1 and the results of the blade droop are shown in table 1. Figure 2 shows a series of photos taken from a fixed camera position at the various crack lengths. Figure 3a shows the blade tip before cutting and figure 3b shows how the position changed after each cut. For each cut the blade is coloured differently and the results overlaid. The results of the blade droop are also shown in graph form in figure 4.

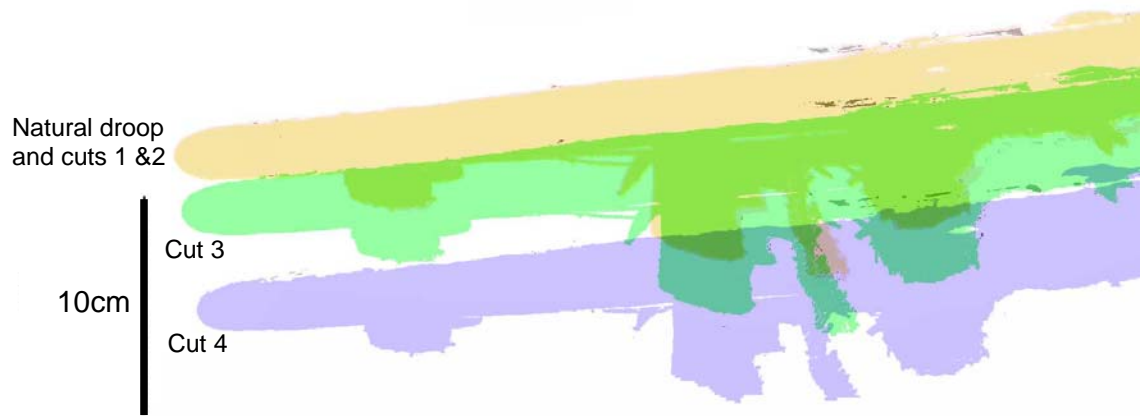
Figure 2. a) blade droop, b) change in droop at different crack lengths.

From the experiment, it was found that at a crack length of 19mm in the leading edge direction and 22mm in the trailing edge direction (cut 2), there was no increase in the blade droop. Fatigue striation measurements carried out in QINETIQ/FST/SMC/LR024608 and reported in QINETIQ/FST/SMC/LR026770 indicated that an approximate time before failure at the crack length of cut 2 was 5hrs 20mins which corresponds to the evening before the day of the accident when a visual inspection of the aircraft was carried out. Approximately one hour before failure, a pre-flight inspection was also carried out. The corresponding crack length at this time (cut 3) produced an increase in blade droop of 23mm over the blade length of approximately 6m.
