No: 8/89

**Aircraft Type
and Registration:**

BAe. 146-100, G-BKHT

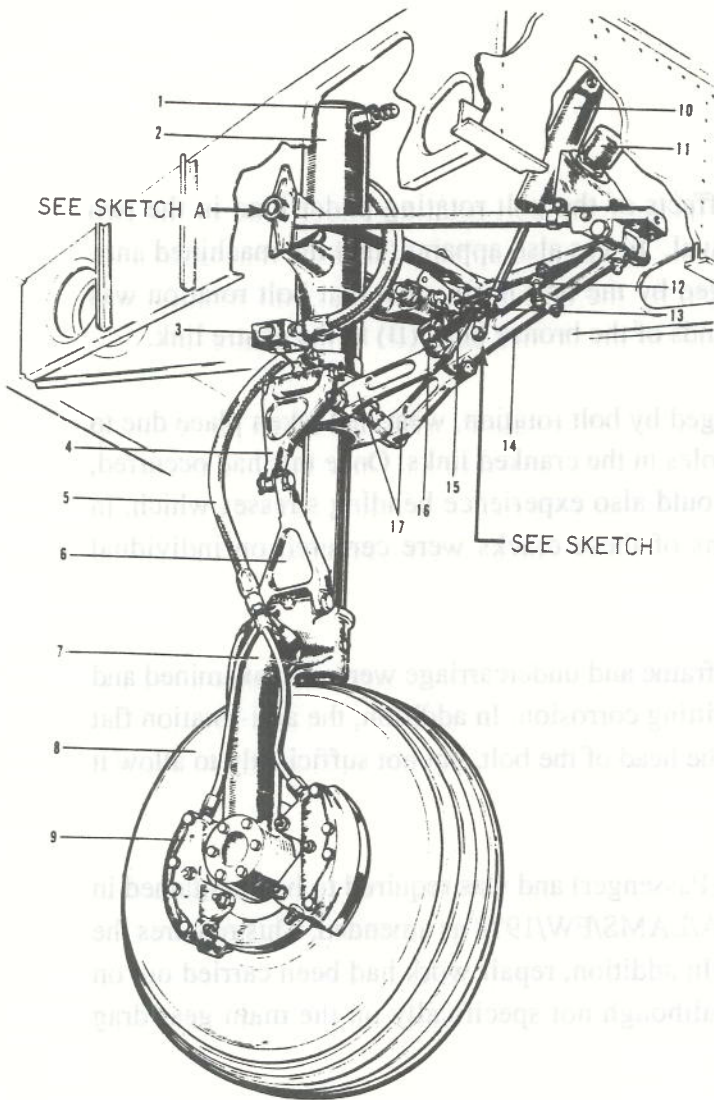
Examination of the right undercarriage revealed that the drag stay had failed, which in turn had allowed the undercarriage leg to pivot rearwards and jam under the wing. Specifically, the centre pivot bolt of the drag stay was found to have failed close to its mid point.

Detailed examination of this bolt revealed that it had failed in reverse bending fatigue and also that it was in poor condition generally. It was apparent that most of the shank showed signs of pitting corrosion

and there was surface damage consistent with the effects of the bolt rotating under load in the two cranked links. The bolt holes in these links (*) were oval. It was also apparent that the machined anti-rotation flat on the inboard link (A) had been damaged by the bolt head, such that bolt rotation was possible. Ovality was also present towards the outer ends of the bronze bush (B) in the centre link.

It was thus apparent that, after the flat had been damaged by bolt rotation, wear had taken place due to continued rotation in the unbushed and unlubricated holes in the cranked links. Once this had occurred, the bolt was no longer working purely in shear but could also experience bending stresses which, in turn, precipitated the two fatigue cracks. The origins of these cracks were centered on individual corrosion pits.

DAMAGE TO ANTI-ROTATION 'FLAT'
