AAIB Bulletin

10/2018

ACCIDENT

Aircraft Type and Registration:	AS350 B3e Ecureuil, G-MATH	
No & Type of Engines:	1 Turbomeca Arriel 2D turboshaft engine	
Year of Manufacture:	2016 (Serial no: 8274)	
Date & Time (UTC):	5 May 2017 at 0830 hrs	
Location:	Wycombe Air Park, Buckinghamshire	
Type of Flight:	Training	
Persons on Board:	Crew - 2	Passengers - 1
Injuries:	Crew - 1 (Fatal) 1 (Serious)	Passengers - 1 (Serious)
Nature of Damage:	Extensive	
Commander's Licence:	Commercial Pilot's Licence (Helicopters)	
Commander's Age:	45 years	
Commander's Flying Experience:	5,747 hours (of which 579 were on type) Last 90 days - 53 hours Last 28 days - 17 hours	
Information Source:	AAIB Field Investigation

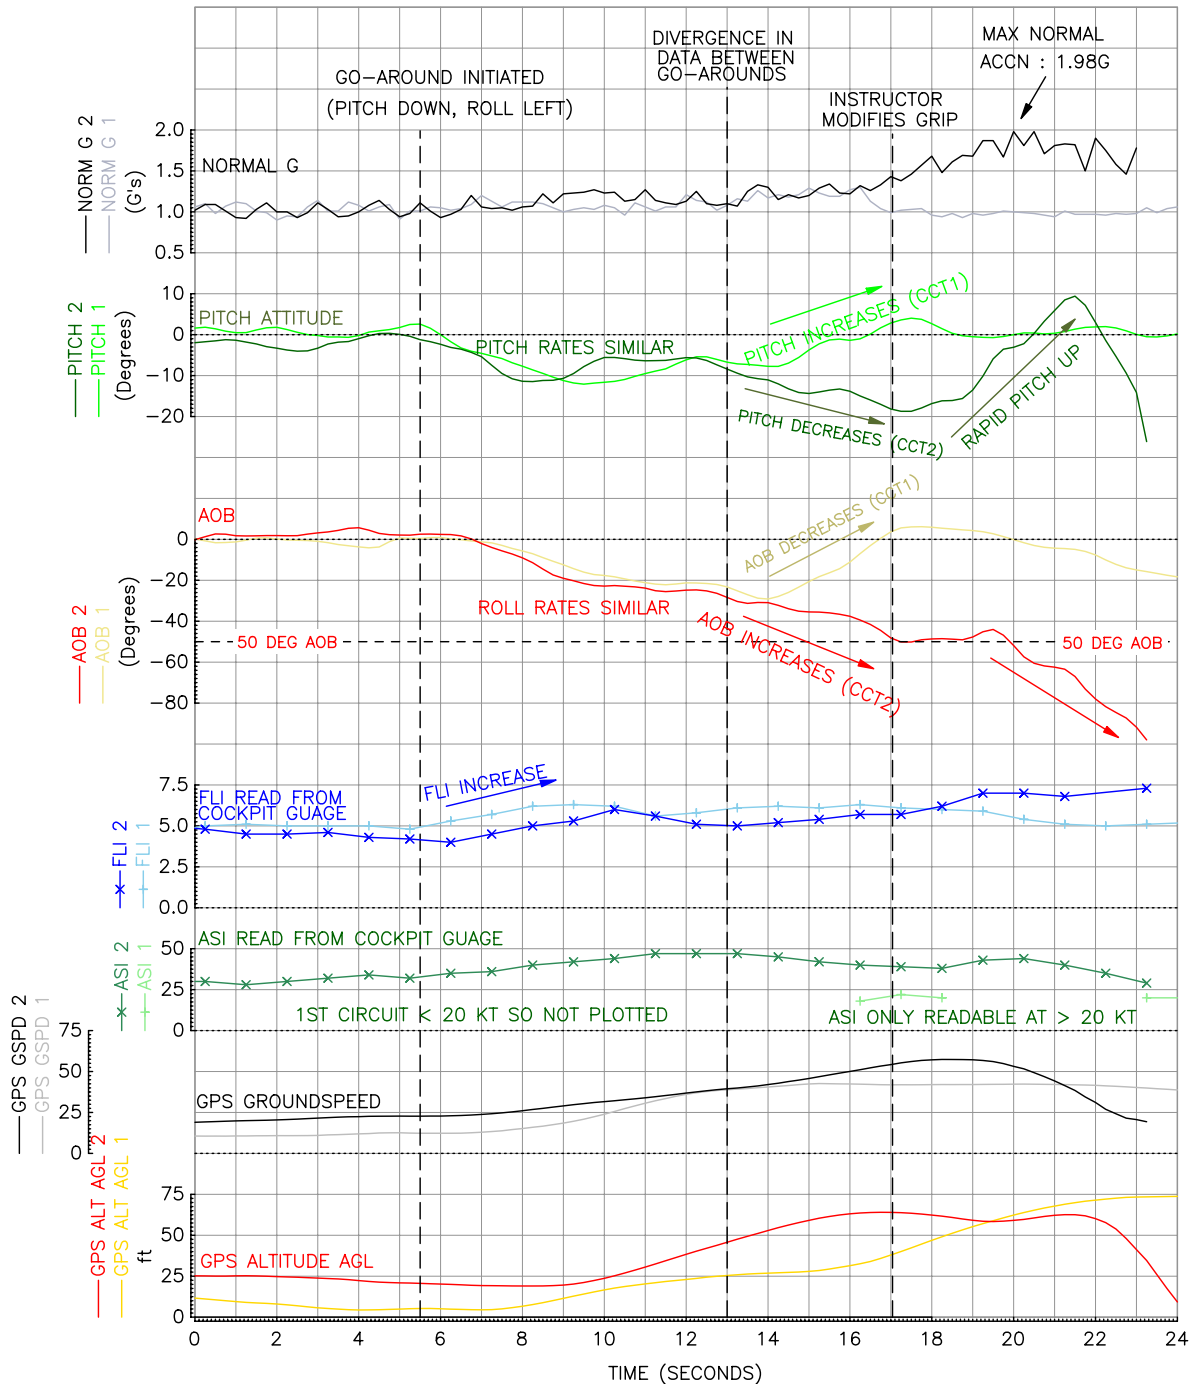
Figure 5 presents data from both go-arounds, aligned at the point when the helicopter began to pitch nose-down. This figure shows that the helicopter attitude during the initiation of the go-around was similar on both occasions. The helicopter pitched down and rolled to the left to approximately the same attitudes and at similar rates in the first 7.5 seconds of the turn. The rates of turn were $-11.9^\circ/\text{sec}$ and $-10.6^\circ/\text{sec}$ respectively.

height, with the helicopter approximately 25 ft higher on the second go-around. The Vision 1000 data also showed the instructor applying more left pedal in the second go-around.

The ground track and turn radius of the first 180° turn of each circuit were similar despite the difference in the AOB; this was due to the higher airspeed on the second go-around. The second go-around was commenced when on the final approach heading.

G-MATH comparison of two go-around manoeuvres.

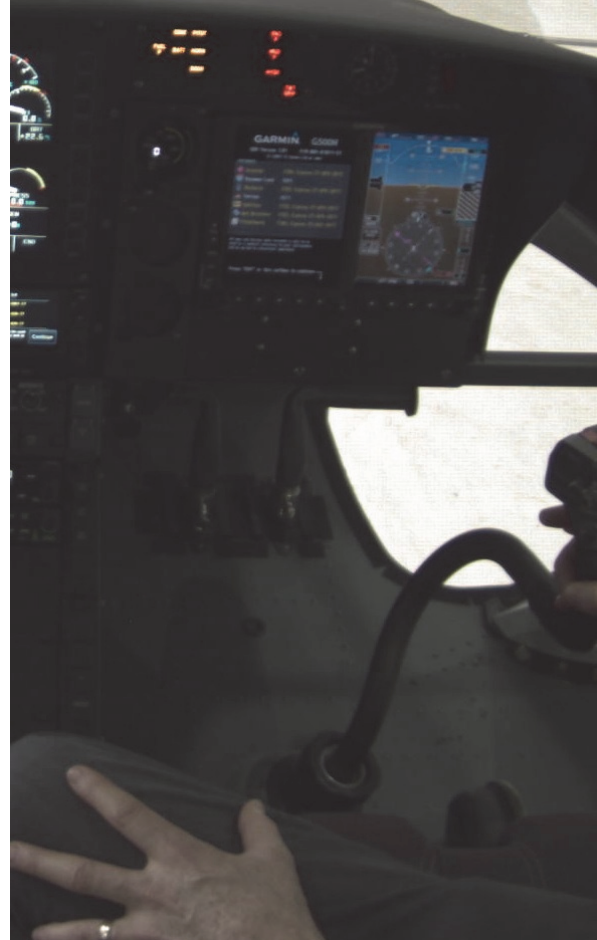
Figure 10

During the final stages of the flight, only the right-seat pilot's cyclic was visible as the instructor had changed his hand position, obscuring the Vision 1000 view of his controls. The video imagery showed that at 0832:58 hrs and a left AOB of 62° (3.5 seconds prior to impact), the right-seat pilot's cyclic was positioned in the furthest right position which is shown in Figure 9. This figure also shows how his grip had tightened on the cyclic. While the exact cyclic position could not be established, when comparing to the 'full and free' check performed on the test helicopter, it shows that the cyclic had not reached its right limit (Figure 10).

View from exemplar helicopter Vision 1000 showing full right cyclic in mid fore-aft position

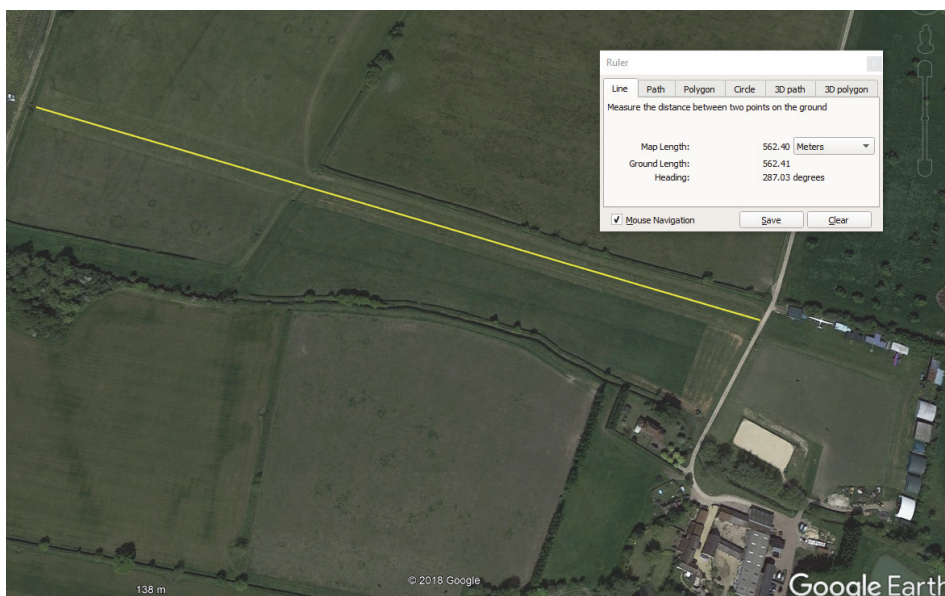
Figure 2

The runway is orientated 29/11 and has a grass surface. Its condition was reported as dry and newly rolled. The farm's website states the runway length is 600 yards (549 m). The pilot reported that he had measured the strip and found it to be 615 m long. Measurements taken from aerial imagery of the airfield more closely match the length stated on the farm's website. Adjacent to the Runway 29 threshold and under the approach path are a parking area and hangars, (Figure 2).

View of Eaton Bray Farm Airfield indicating runway length
