AAIB Bulletin

12/2018

BAE Systems (Operations) Ltd ATP	SE-MHF	14-Dec-17	3
BAE Systems (Operations) Ltd ATP	SE-MHE	14-Feb-18	15

Aircraft Type and Registration:	BAE Systems (Operations) Ltd ATP, SE-MHF	
No & Type of Engines:	2 Pratt & Whitney Canada PW126 turboprop engines	
Year of Manufacture:	1989 (s/n 2013)	
Date & Time (UTC):	14 December 2017 at 0606 hrs	
Location:	On approach to East Midlands Airport	
Type of Flight:	Commercial Air Transport (Cargo)	
Persons on Board:	Crew - 2	Passengers - None
Injuries:	Crew - None	Passengers - N/A
Nature of Damage:	None	
Commander's Licence:	Airline Transport Pilot's Licence	
Commander's Age:	29 years	
Commander's Flying Experience:	2,089 hours (of which 1,854 were on type) Last 90 days - 82 hours Last 28 days - 29 hours	
Information Source:	AAIB Field Investigation

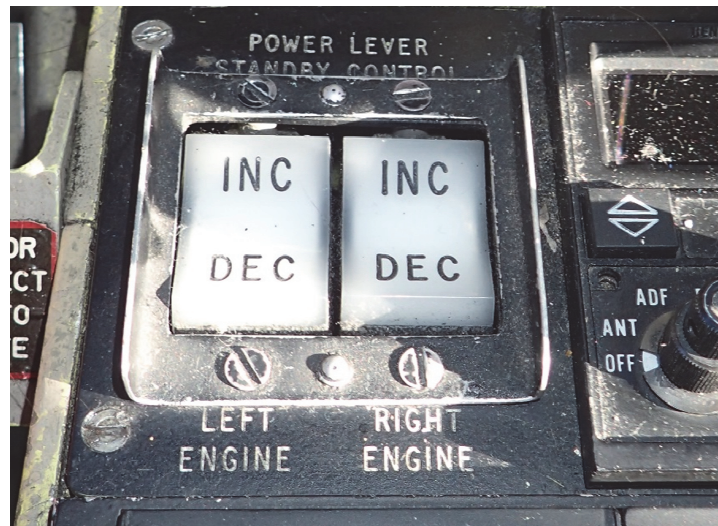
Figure 6

The power lever standby controls

Both systems were found to operate throughout their normal range but the right system was occasionally observed to be 'notchy', possibly indicating excessive resistance in the system or that the stepper motor was under-performing. The operator returned the aircraft into service without installing a replacement stepper motor. The right system was subsequently found to be non-operational when the aircraft was examined again three months after this incident and a replacement motor was installed.

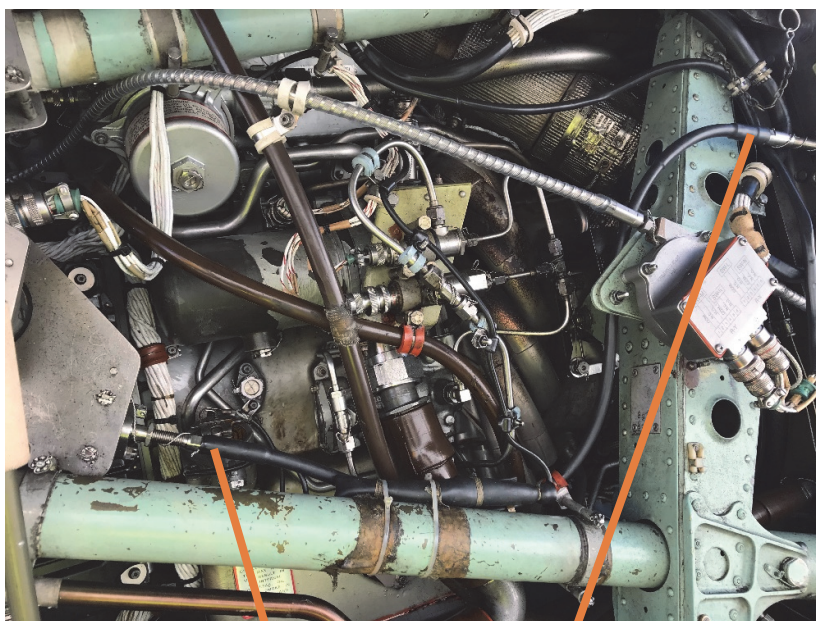
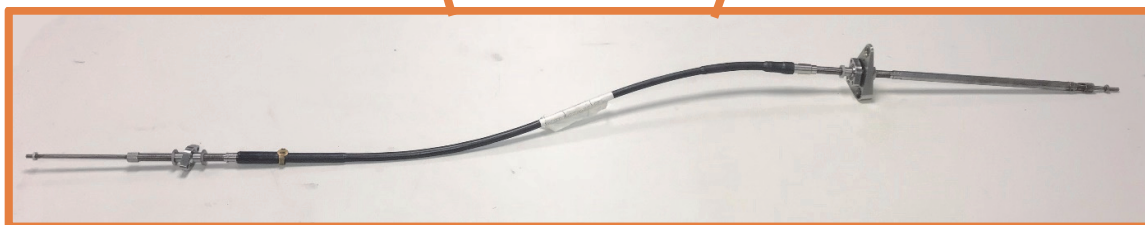
Figure 7

Between 2014 and 2018, the operator recorded six events on their ATP fleet where pilots reported 'restricted', 'stiff / notchy' or 'frozen' power levers. There was no confirmed link between the events but the engine power 'Bowdenflex' control cables were cited as a possible cause because of their apparent susceptibility to moisture ingress and freezing; the control cables are under the engine cowls (Figure 7).

Bowdenflex cable

In December 2017, the manufacturer introduced an electronic Service Information Leaflet (eSIL) 76-ATP-800-1, recommending operators to periodically purge moisture from the cables using low pressure nitrogen or air. The manufacturer recommended a periodicity of 150 flights but stated that operators should amend the frequency based on their in-service experience and operational environment.
