ACCIDENT

(Aerospatiale) Eurocopter
AS 350B1, EI-IHL

Ballynacally, Co. Clare
Ireland

12 July 2007

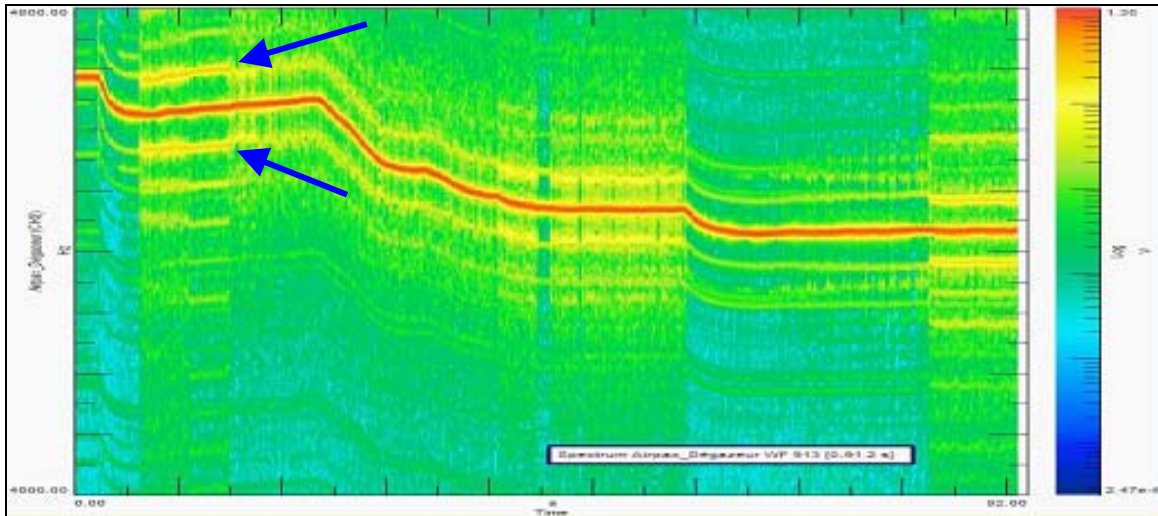
Figure E7: Order 37 frequency, with sidebands (indicated), measured at the ‘Breather Gear’ speed and position sensor (for an N1 variation between 68.4% and 64.6%)

The following diagrams illustrate the vibration behaviour of the 41-tooth Bevel Gear during a starter-generator test in helicopter configuration. The Campbell diagram (**Figure E8**) shows that, using the APC 150A Starter-Generator with a tightened damping system, side bands appear around the signature of the 37-tooth ‘Breather’ gear (Order 37) when the frequency corresponding to the excitation voltage is below 65 Hz (indicated by black arrows).

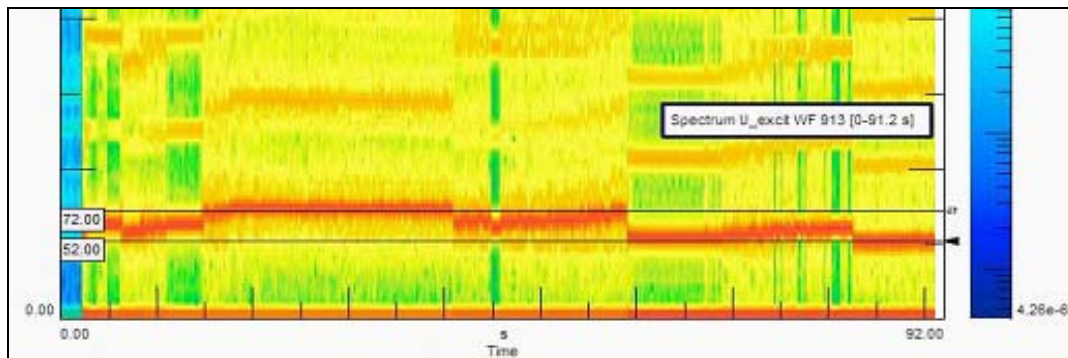
Figure E8: Frequency (Hz) corresponding to Excitation Voltage

On the 41-tooth gear similar sidebands appear around order 41 with a particularly remarkable phenomenon; the attenuation of order 41 signature (**Figure E8** and **Figure E9**) or even, in certain cases, the disappearance (in **Phase 1**) of order 41 signature and replacement by sidebands (see **Figure E10** and **Figure E11**). This means that during this phase, the gear no longer meshes at its typical teeth passage frequency but at the frequency of the sidebands, which indicates gear flapping.

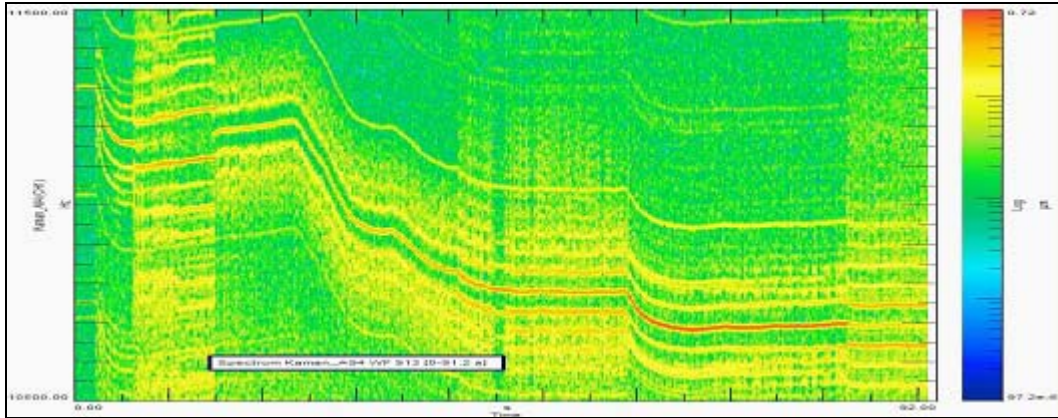
Figure E11: Order 41 frequency (+ sidebands) measured at the A94/Gear Z41 speed and position sensor (for an N1 variation between 68.4% and 64.6%)

In addition, on the 41-tooth gear, at low frequency, the sensors detect a higher-amplitude signature on order 2 of the modulation frequency observed on order 41.
