Air Accident Investigation Unit Ireland

ACCIDENT REPORT
Irish Air Corps 265, PC-9(M)
Cornamona, Connemara, Co. Galway
12 October 2009

AAIU Formal Report No: 2011-016

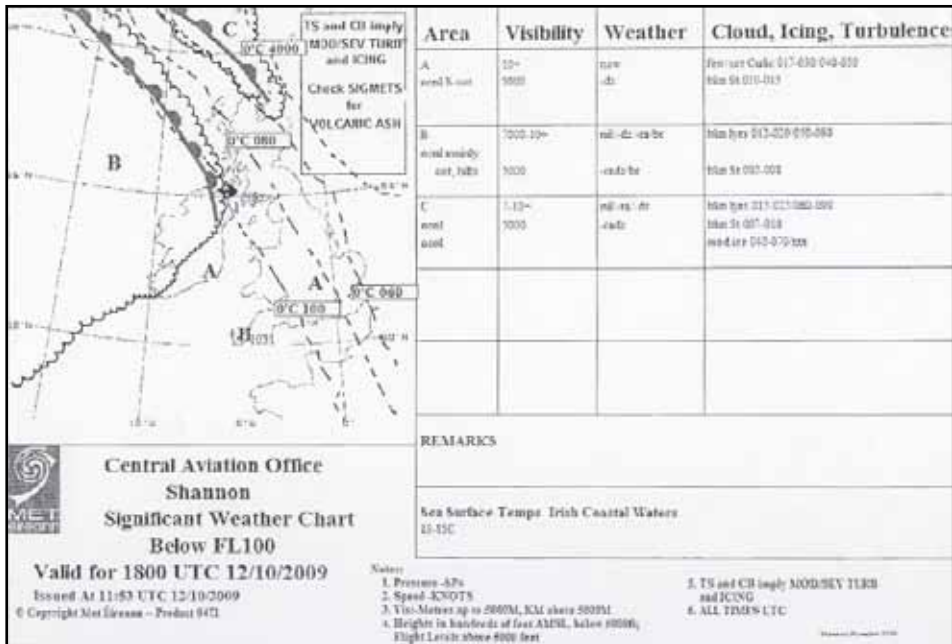
Figure No. 7: 18.00 hrs Low Level Significant Weather (Met Éireann)

The later low level significant chart for 18.00 hrs (**Figure No. 7**) forecasted that the warm front would have passed the West of Ireland, but the general area (B) still shows a misty aftermath of stratus cloud with light rain or drizzle and little improvement in the general weather conditions.

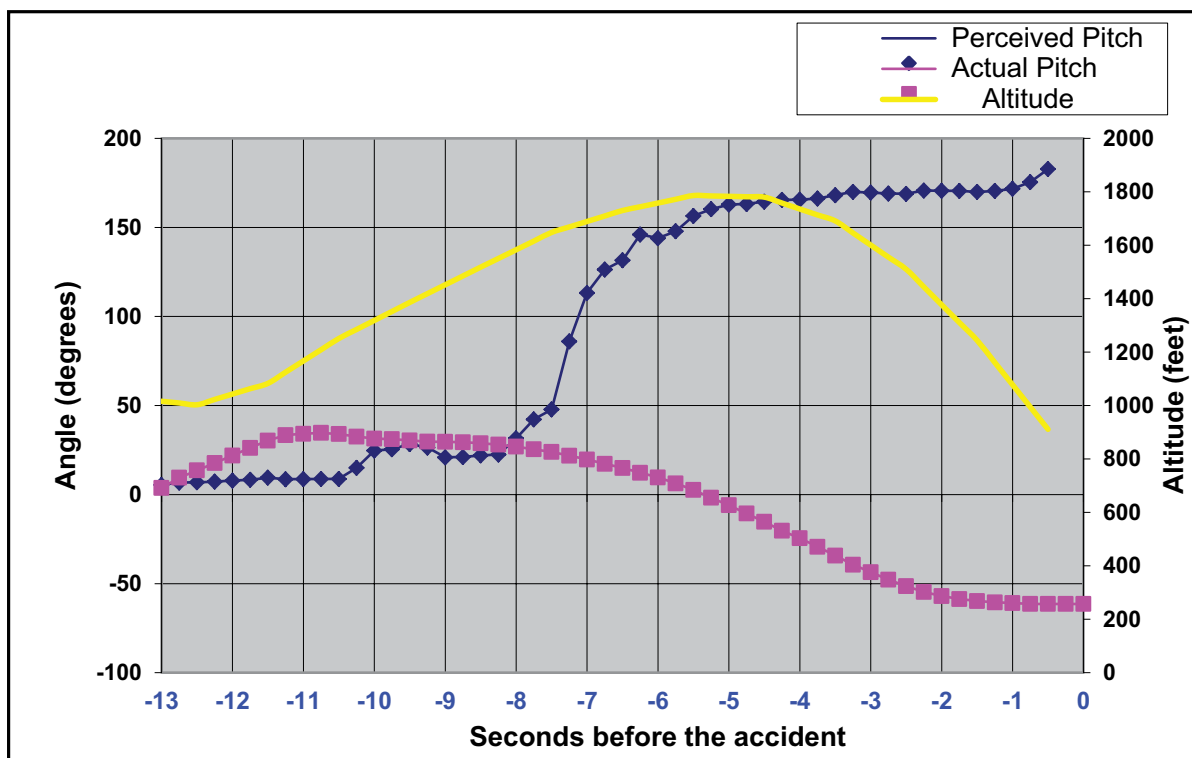
Figure (ii): Perceived versus Actual Pitch, with Altitude

The Investigation calculated the perceived pitch angle ($\text{ArcTan } G_x/G_z$), and compared this with the actual pitch recorded on the aircraft. This comparison is presented in **Figure (ii)** & **Figure (iii)**. For ease of reference, the aircraft altitude was also plotted on the right axis of **Figure (ii)**, while elevator position is plotted on the right axis of **Figure (iii)**. **Figure (ii)** & **Figure (iii)** show the divergence between actual and perceived pitch at time-point -8 sec. This divergence develops rapidly and then persists.

This analysis of perceived pitch rates may provide the sensory stimulus to explain the Pilot's initial stick forward action, which then became self-perpetuating for the reasons explained above. This effect can be seen by closely studying **Figure (ii)** and comparing the actual aircraft pitch and the perceived aircraft pitch between -10.5 seconds and -9.75 seconds. **Figure (vii)** shows the actual and perceived pitch along with the Elevator Position (a linear function of stick forward (negative)/aft (positive) position), which further illustrates and supports the hypothesis regarding the stimulus for push-over initiation.
