**航空事故調査報告書**  
**全日本空輸株式会社所属**  
**ボーイング式747-400型 J A 8 0 9 6**  
**東京国際空港**  
**平成5年5月2日**

平成6年12月1日

航空事故調査委員会議決

All Nippon Airways Boeing 747-400, JA8096  
Tokyo International Airport, May 2, 1993

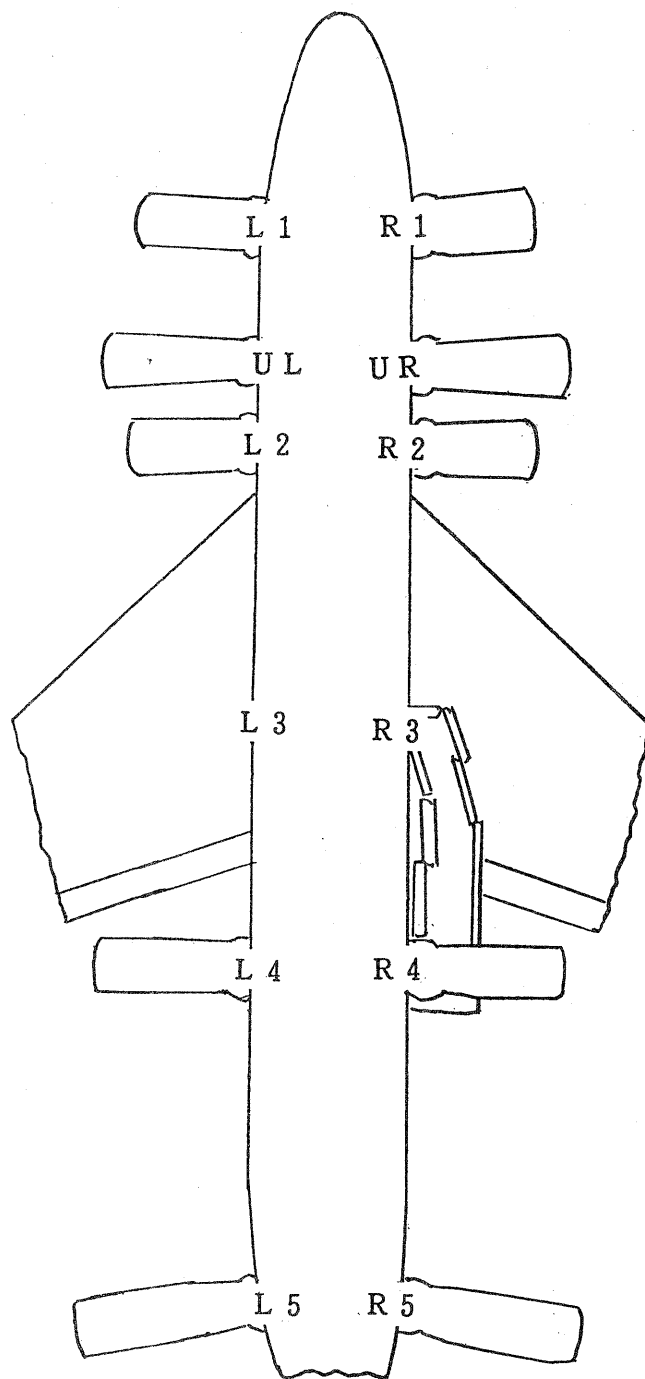
付図3 緊急脱出口及び展開された脱出スライド図

備考1 : L 3 脱出口は使用されなかった。

備考2 : 各脱出スライドの取付け高さ (地上高)

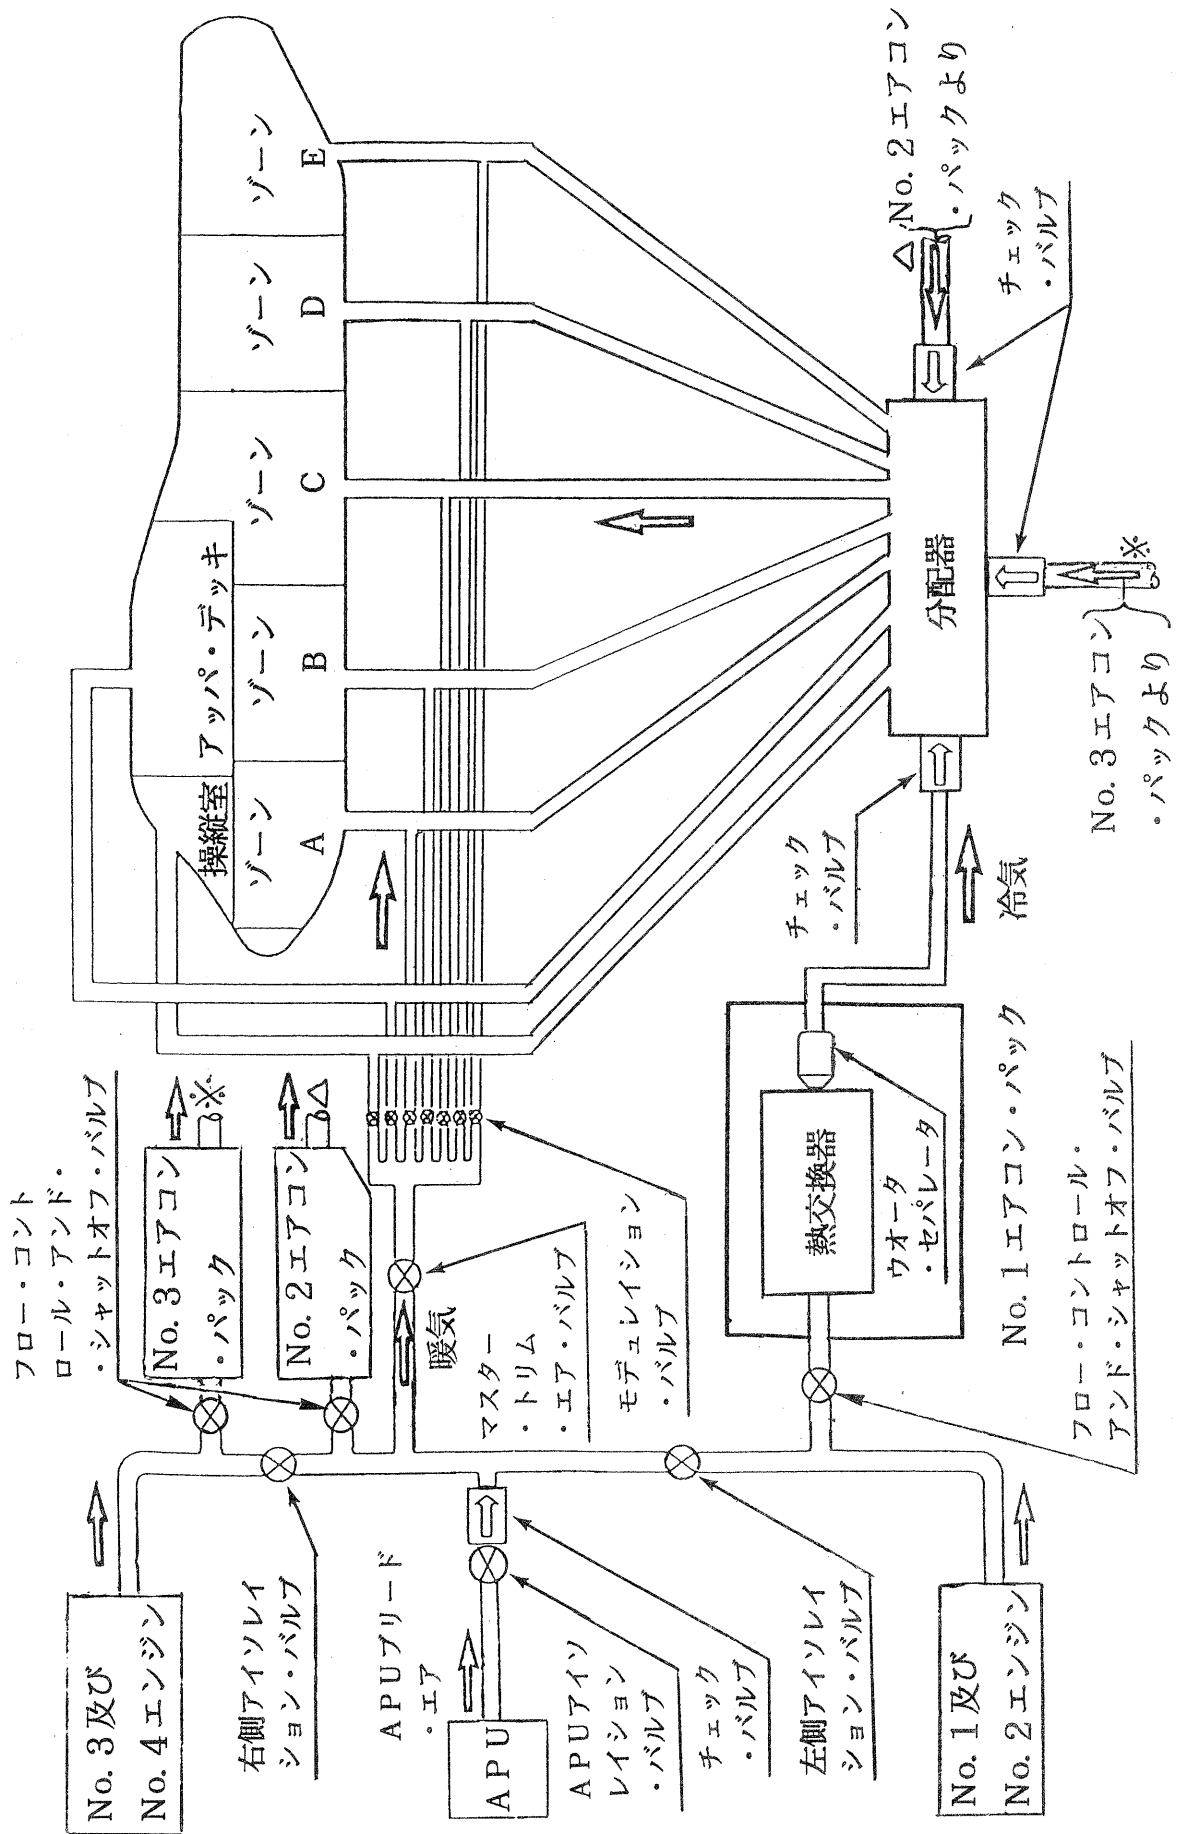
付図 4 エアコン・システム概要図

目撃者の口述によれば、当時、APUの排気口から白煙が出ていたとのことから、APUの外観調査を実施したので、その結果を次に示す。(付図4及び付図5参照)

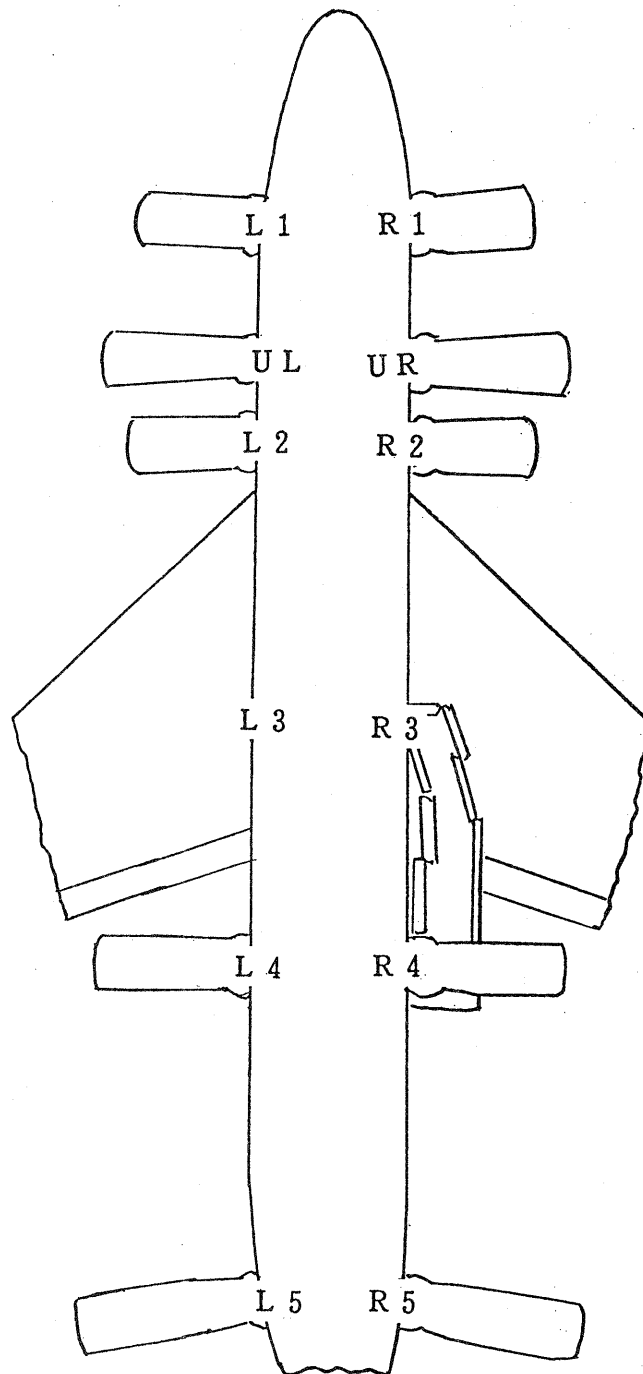
Fig.3 Emergency Exits and Escape Slides

The following are diagnosis of the injuries by the hospital and statements of the seriously injured on how they evacuated:  
(see attached Fig. 3)

Note1: L3 exit was not used

Note2: sill height of slide

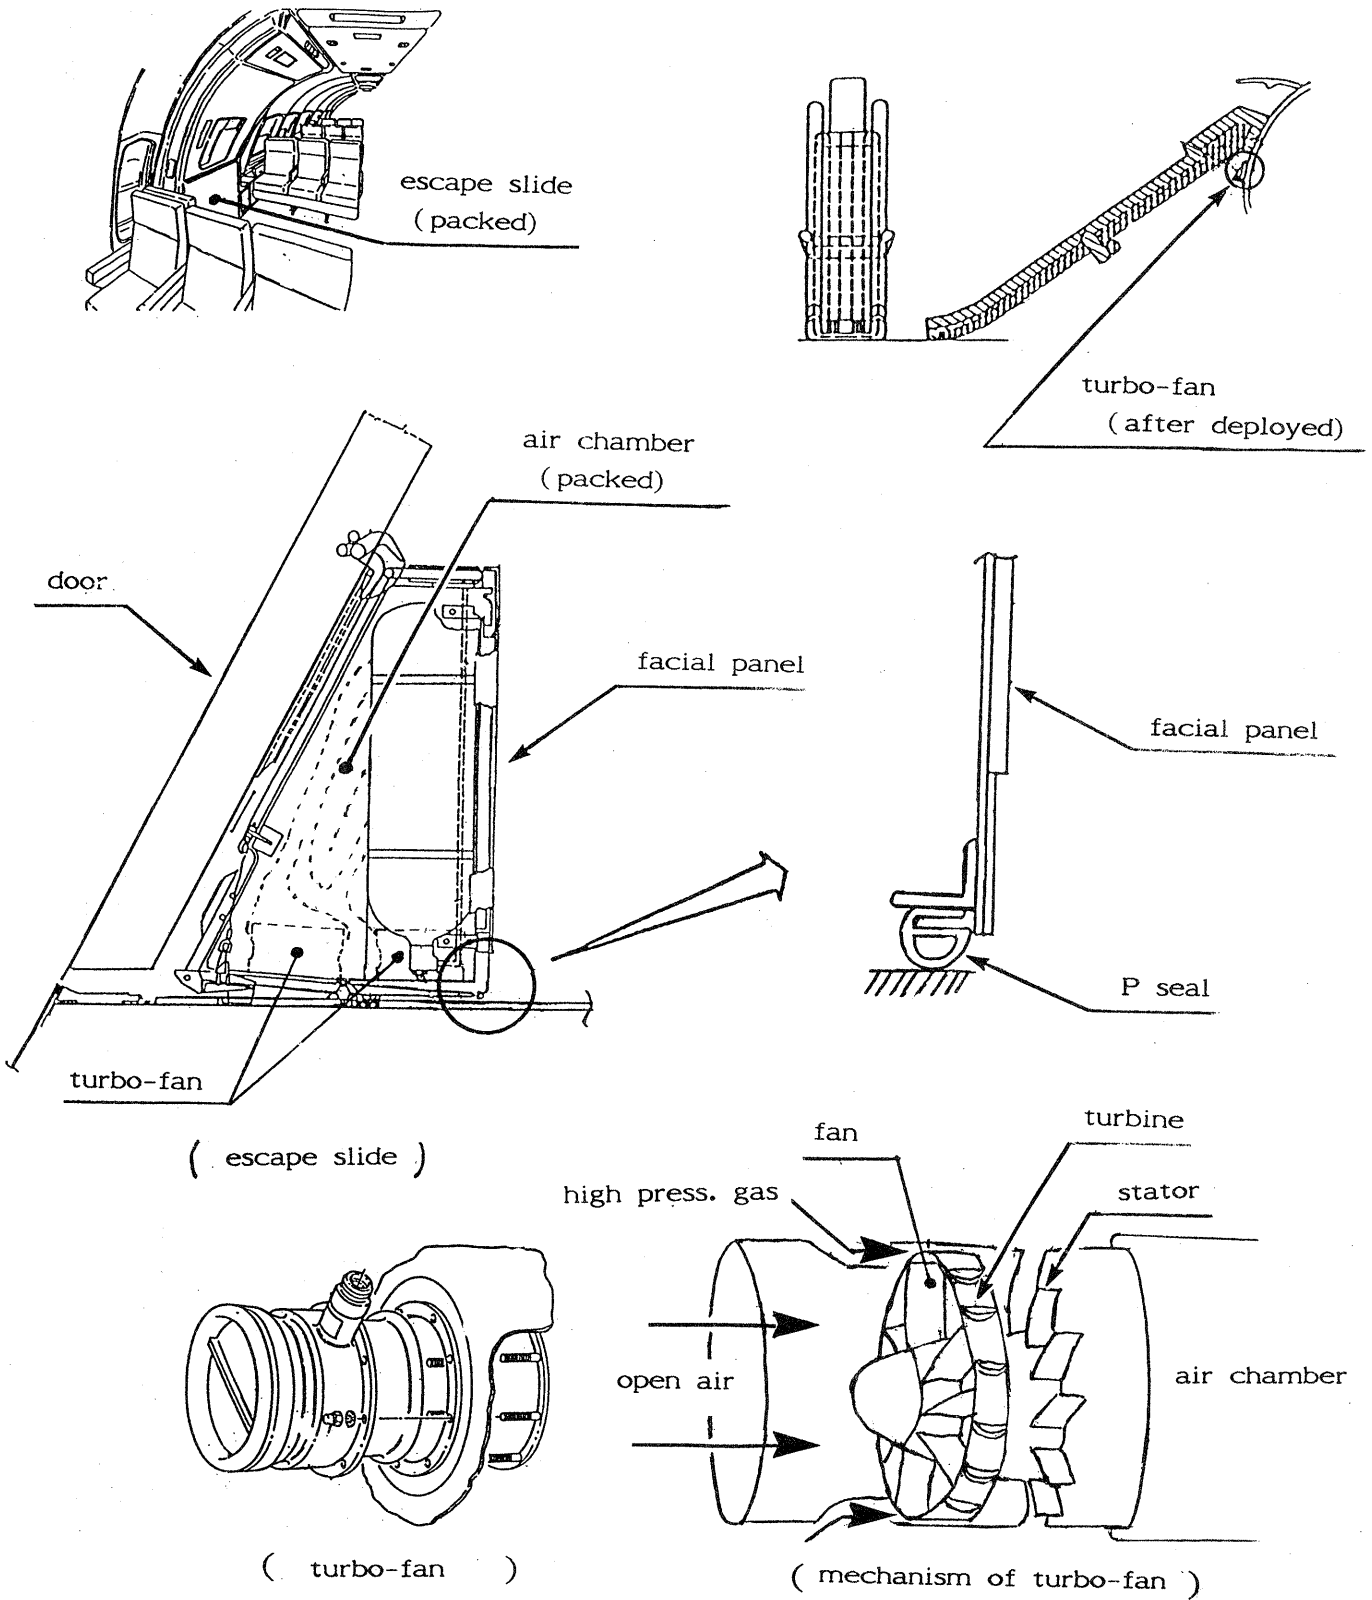
Fig.6 Upper-deck Escape Slide

The high-pressure gas is brought into the air chamber after rotating the turbine, and the fan is rotated by the rotation of the turbine, and the air chamber is inflated by the open air thus sucked in. The turbine and the fan rotate at 3,000 rpm (nominal). (see attached Fig.6)

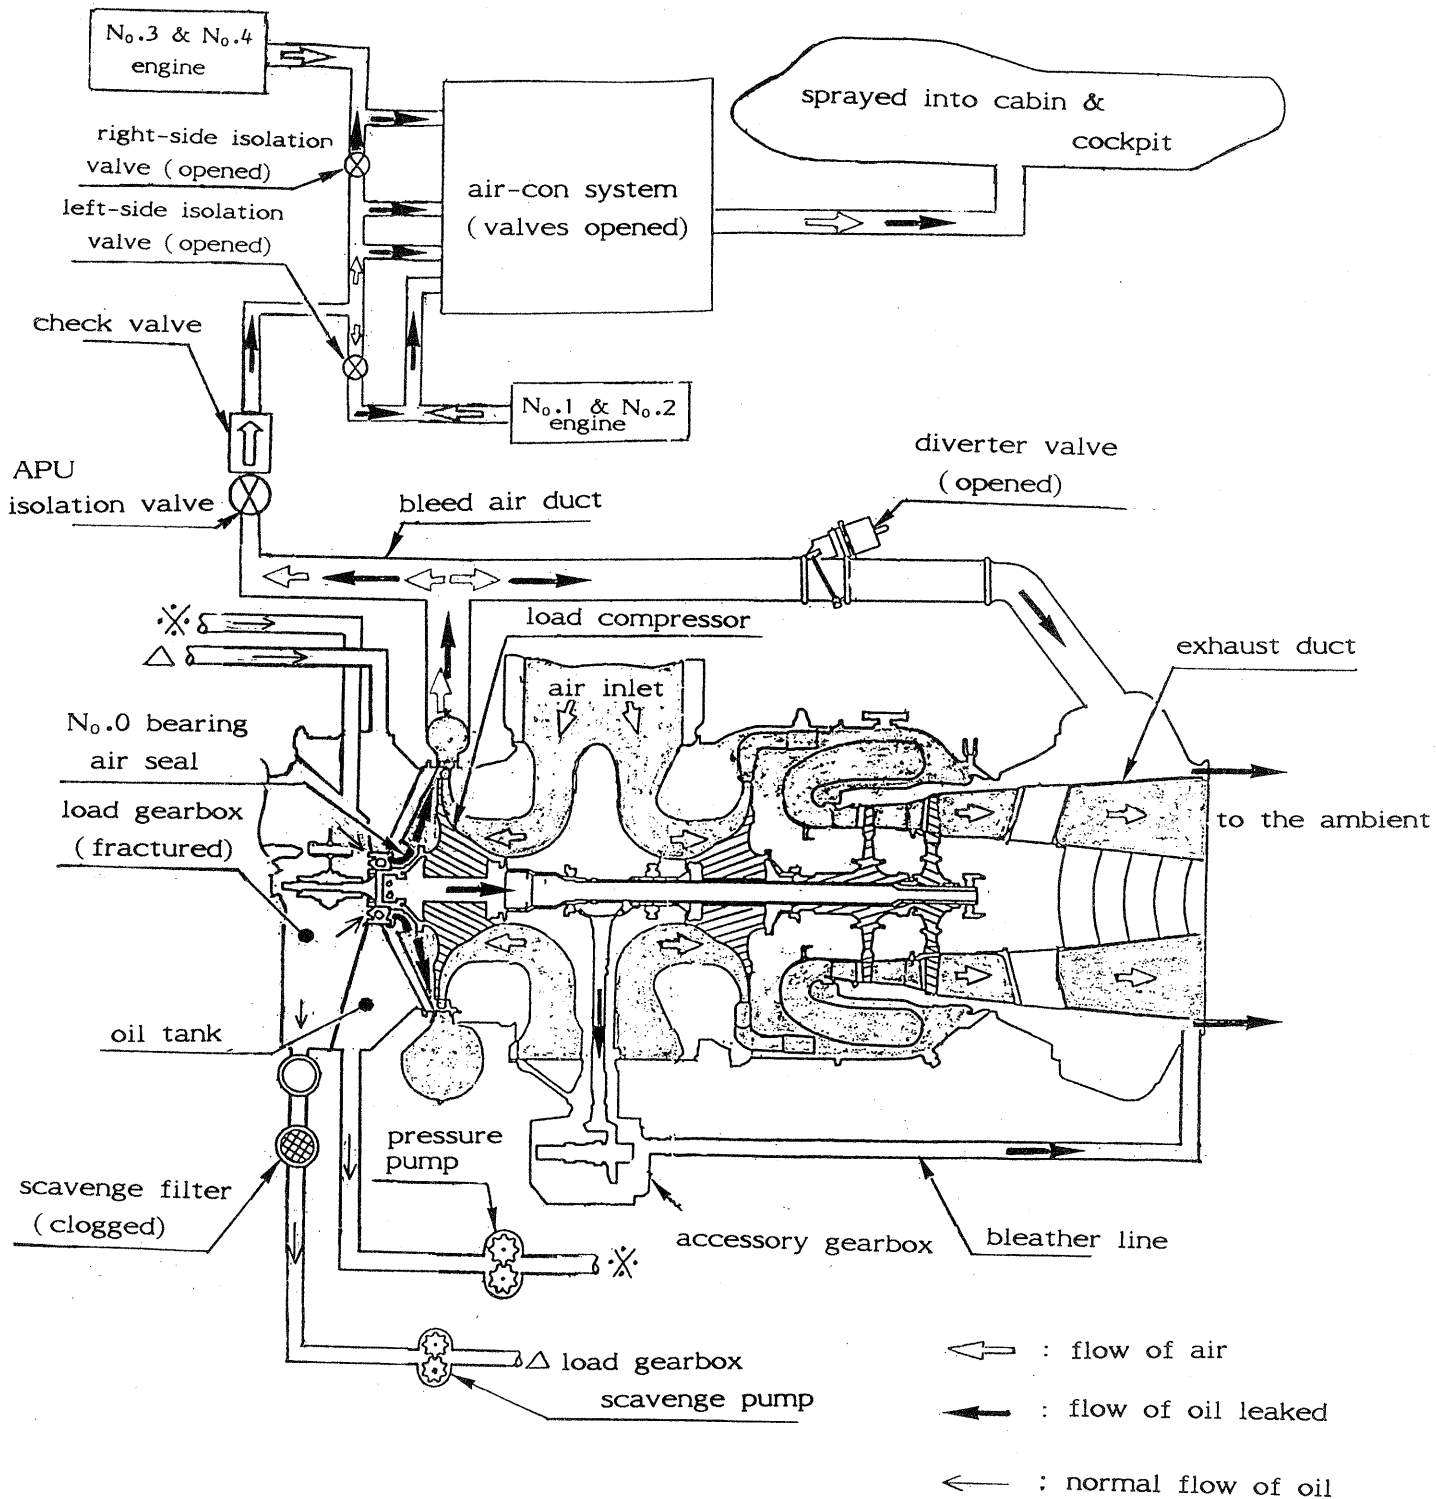
Fig.7 Estimated Route of Oil leaked from APU Oil System

3.2.7.5 また、エア・シールから漏洩したオイルの一部はエア・シール内部の経路を通過してエア・ブリーザ・ラインから機外に排出されるとともに、当該ラインのラバー・チューブに割れがあったことから、この箇所からオイルが漏れてAPUアクセス・ドアにオイルが付着したものと推定される。(付図7参照)
